FINAL REPORT

on investigation of accident
of gliders type **LS8-18** and **Standard Cirrus**
Registration No. **SP-3893** and **OK-3712**

Reg. No.: **SKA2016001**

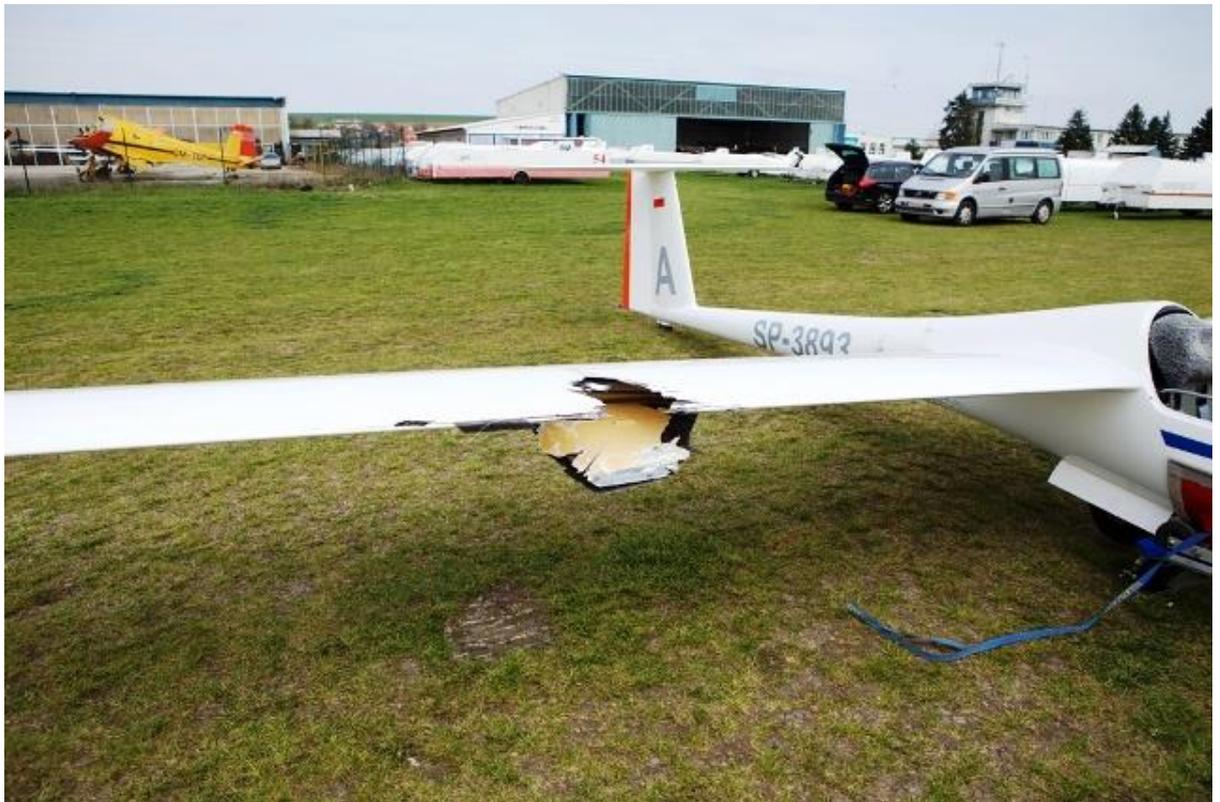
- Seriously damaged right wing

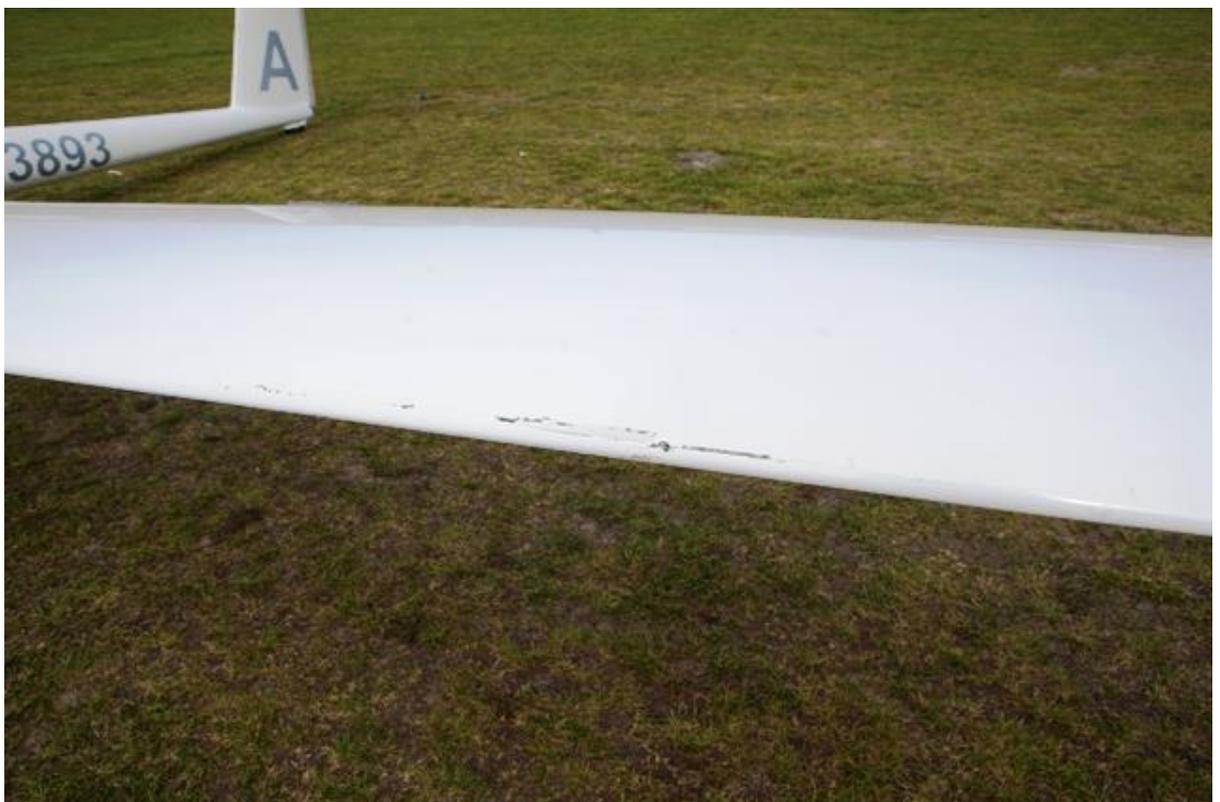
- Lightly damaged left wing

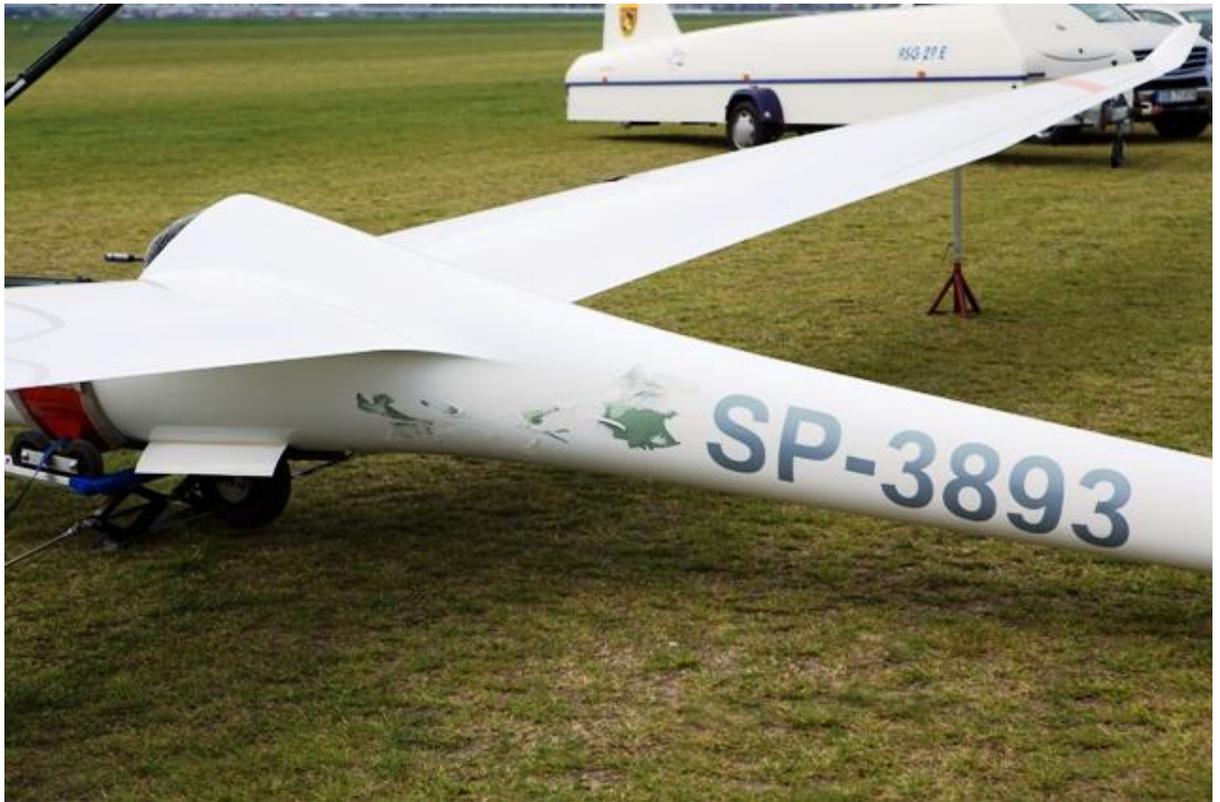
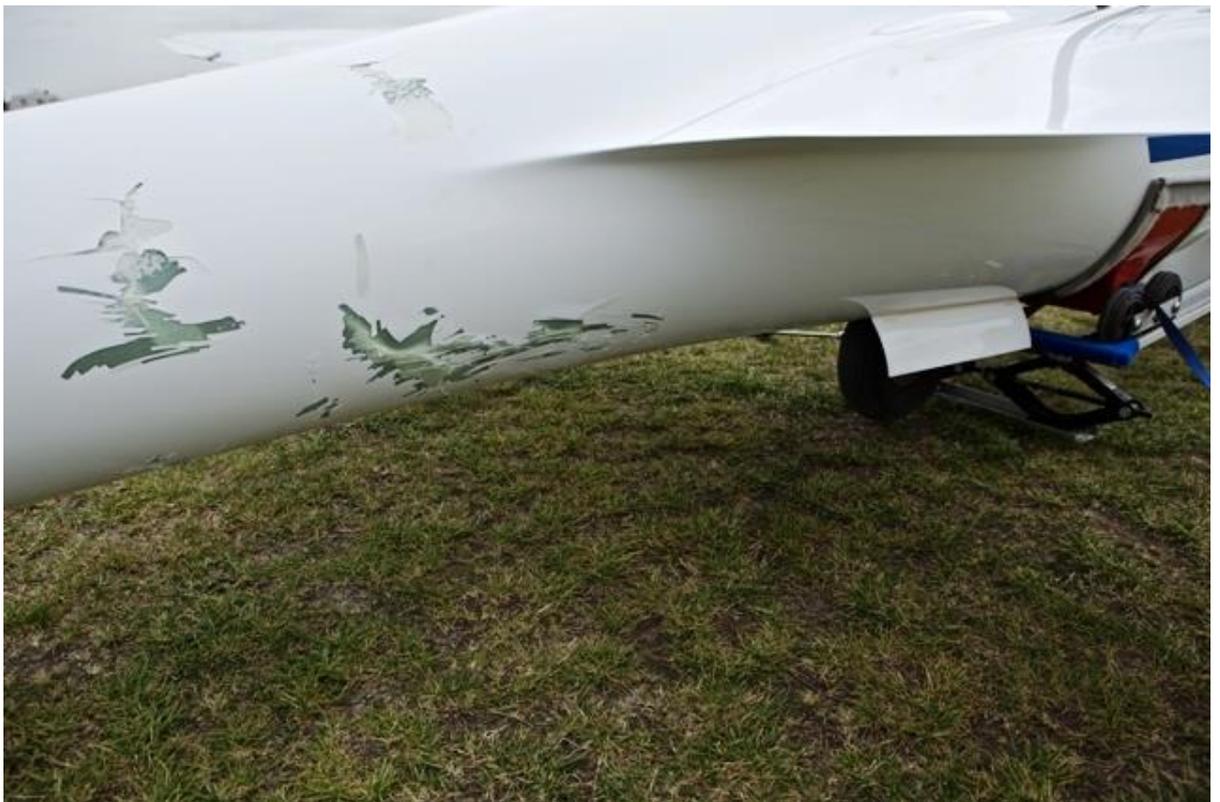
- fuselage damaged in the centre-wing section.

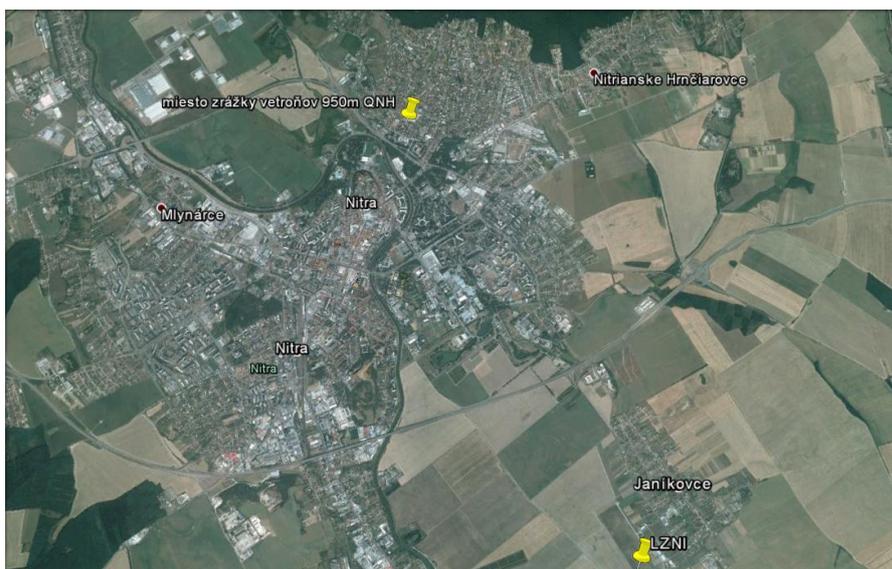
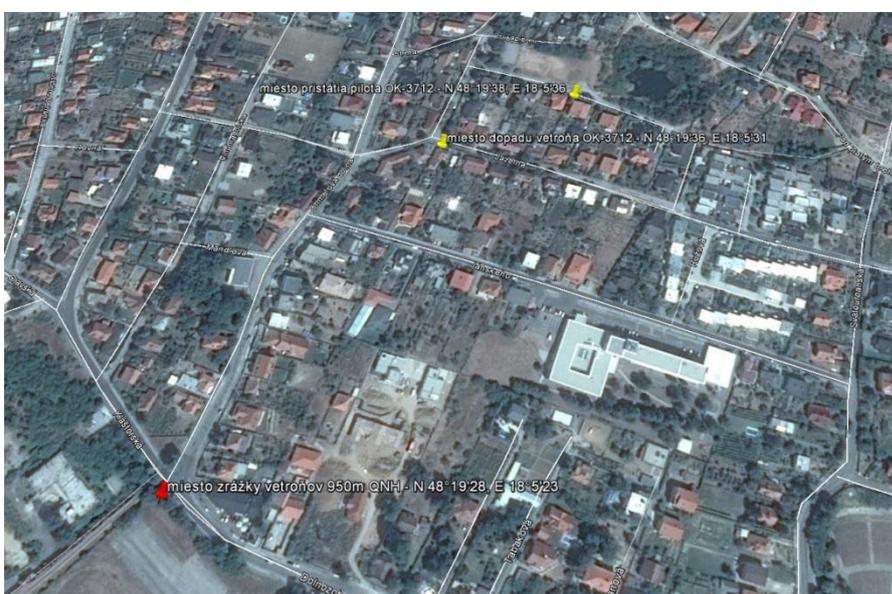
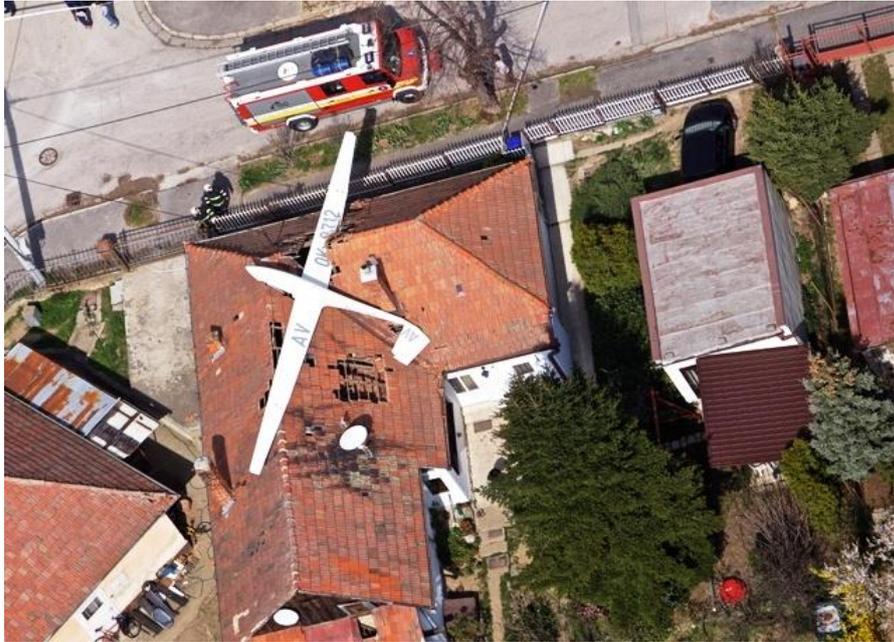
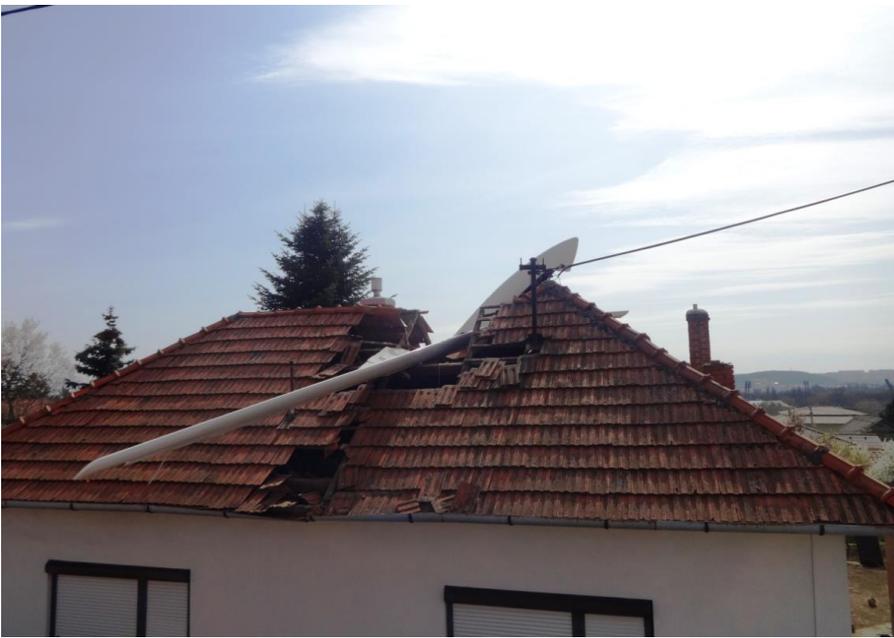
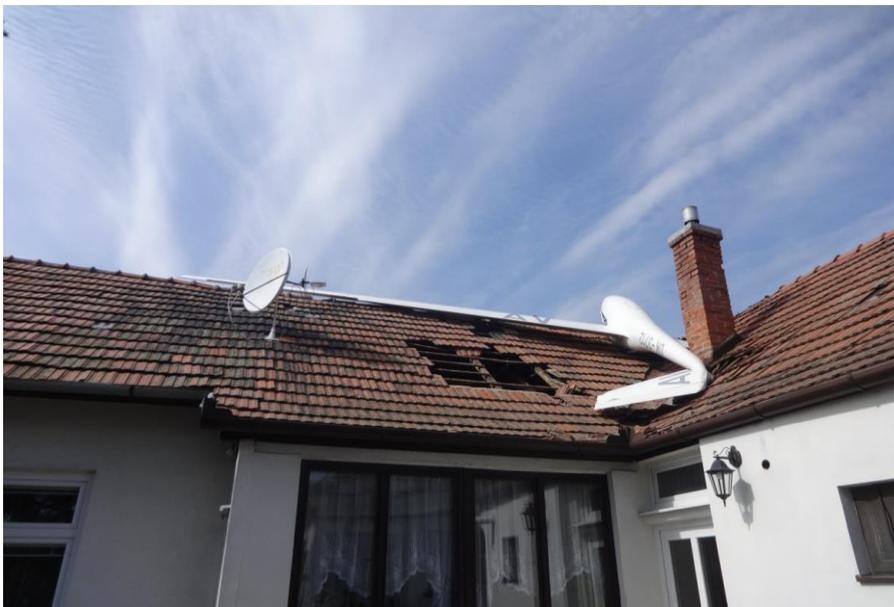
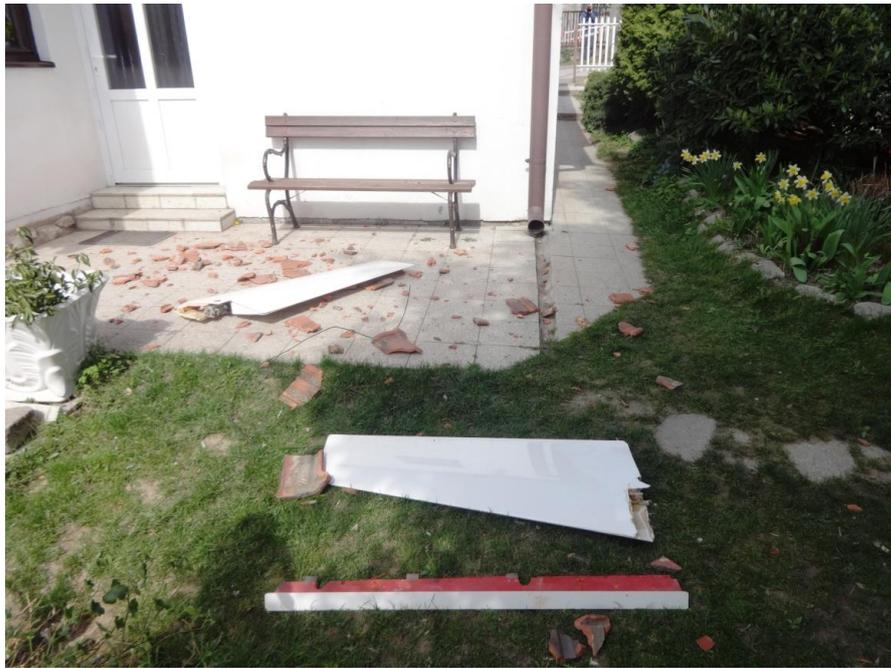
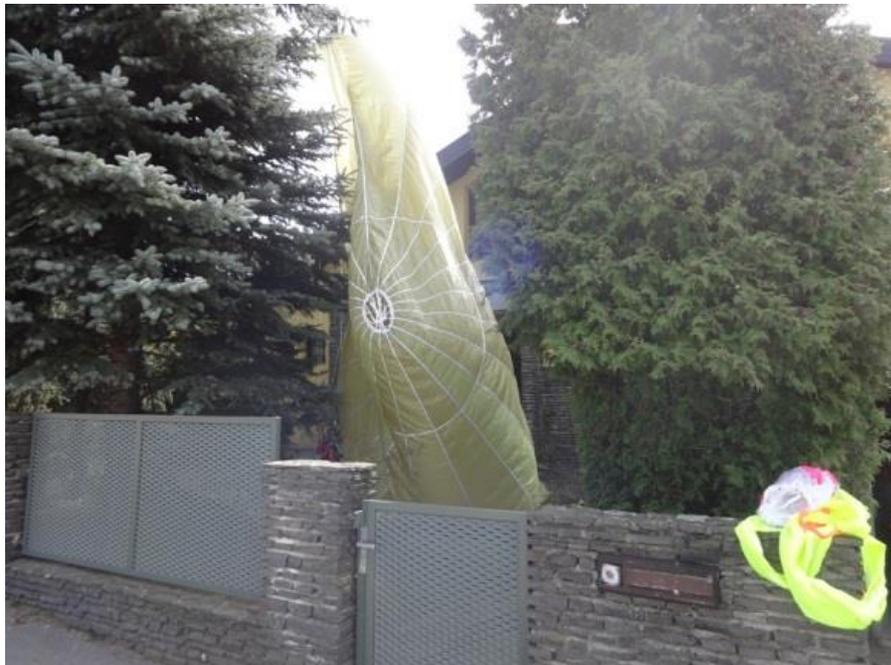
- Seriously damaged left wing
- Damaged right wing
- Broken fuselage in the tail section
- Broken horizontal rudder
- Destroyed cockpit canopy.

The glider OK-3712 crashed in the residential area of city Nitra – Zobor, on the roof of a family house on Jazerná street (N 48°19'36", E 18°5'31"). The pilot abandoned the glider and landed in a garden of family house about 120 m away from the place of impact of the glider (N 48°19'38", E 18°5'36").
