FINAL REPORT

on investigation of accident

of glider type **ASW 27-18E**

Registration No. **SP-3769**

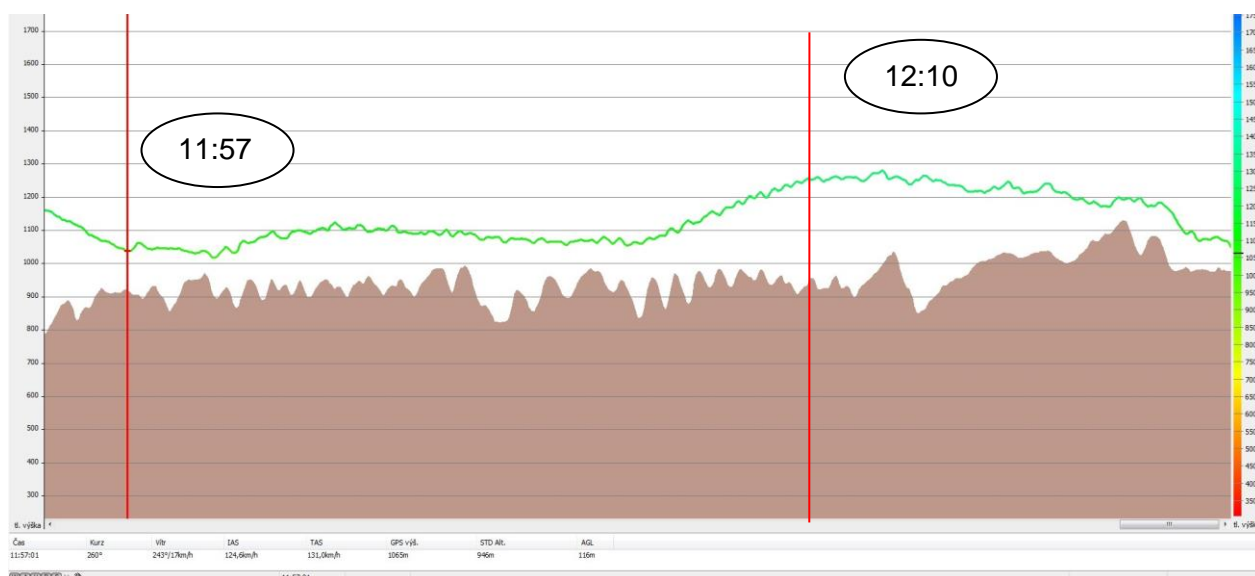
At 11:57 the pilot descended to altitude of 120 m above ground level east of the commune Jurgów and did not interrupt the competition flight, but headed to the commune Tatranská Javorina with higher ground in order to climb in this area to a sufficient altitude and then continue the flight on the route.

In the search for uplift currents the pilot flew within altitude range of 120 - 200 m above ground level; in some sections he reached critical flight levels under the altitude of 100 m above ground level in the mountain area until 12:10.

At this moment the pilot succeeded to achieve altitude above 300 m and at 12:11 he again set the course to the commune Tatranská Javorina.

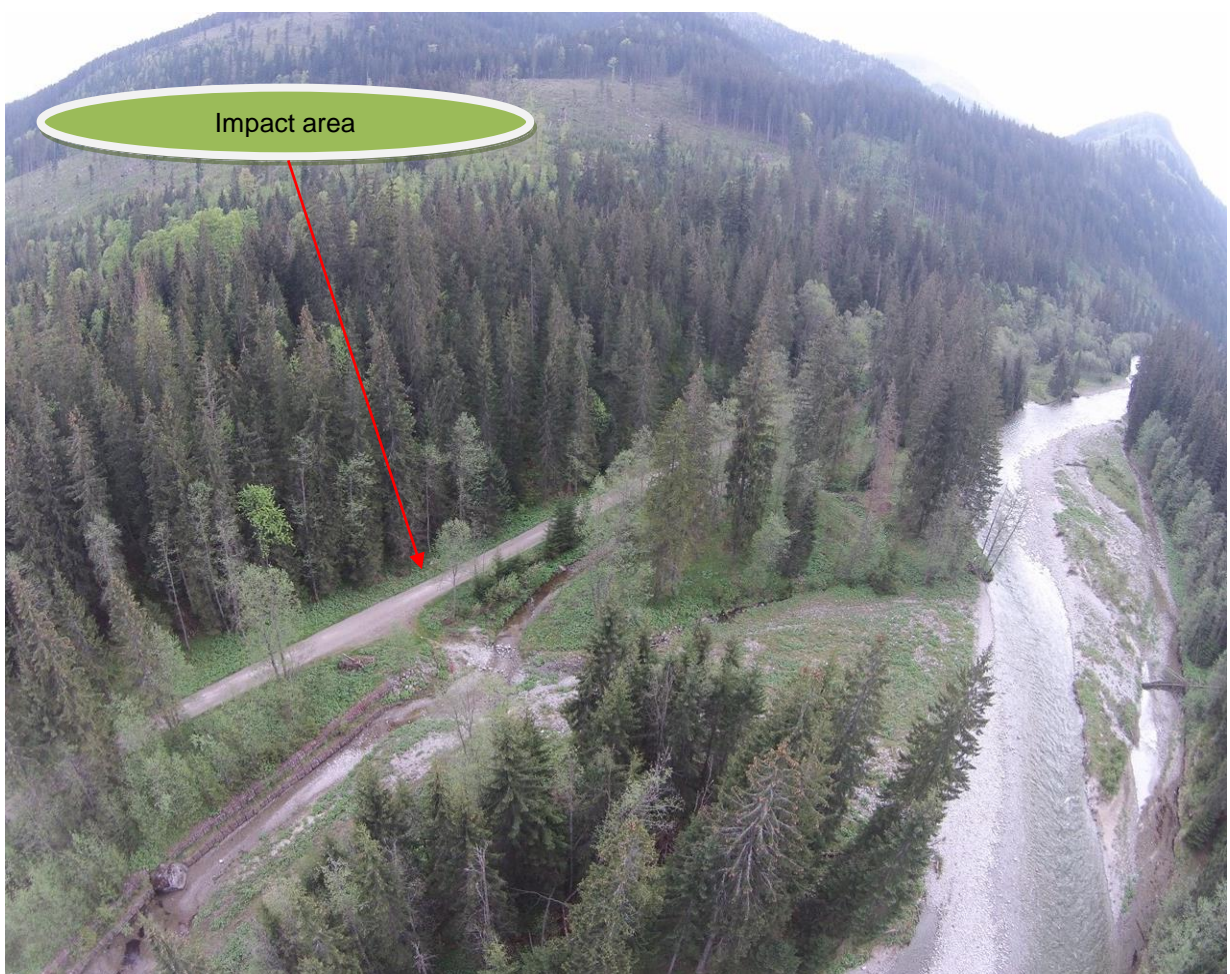
The glider crashed near a country road situated on the bank of river Biela voda in altitude of 970 m above sea level and 130 m south-west of the border crossing Lysá Poľana – between the Slovak Republic and Poland.

On 25 April 2016 the wreckage of glider was inspected in the premises of company Aerospool, spol. s r.o. for the purpose of determining whether some control elements had or had not been defective. The result of inspection was negative, with the following findings:

Both parts moderately damaged, the control surfaces moderately damaged, functional – movable. Wing control elements functional, without signs of blocking – all parts movable – functional;

Internal wing fully destroyed, about 1 m away of the wing butt, flap and aileron broken at several points, but movable in attachment, wing control elements movable – functional. Wing stub 18 m broken near the root rib and torn covering on the leading edge in a length of 0.8 m. The stub aileron movable – functional;

Stabilizer broken at the point of attachment to the fuselage, functional attachment to the fuselage, elevators damaged but movable – functional;

- Cockpit from the fuselage tip to the front main partition fully destroyed, hood (also plexi) broken at several points, emergency hood release functional;
