AVIATION AND MARITIME INVESTIGATION AUTHORITY
Námestie slobody 6, P.O.BOX 100
810 05 Bratislava 15

FINAL REPORT

from the expert investigation of the air accident of
a paraglider of type **AXIS PARA / PLUTO 3ML**
identification number **OM – L041**

Reg. No.: **SKA2016004**

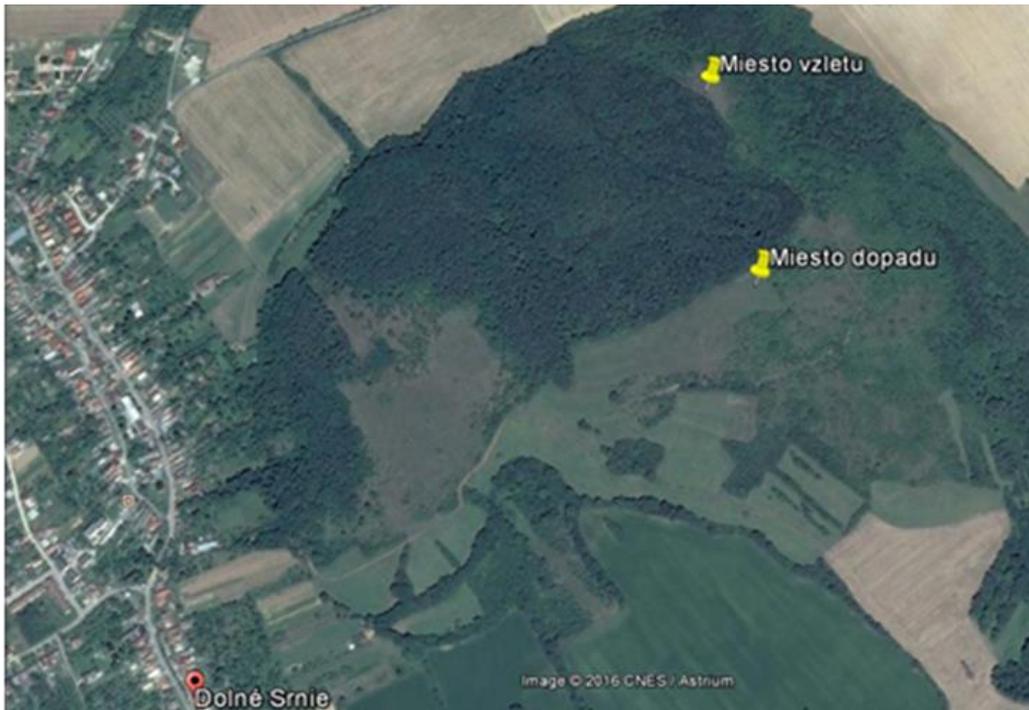
The pilot crashed in a meadow above the take-off site.
