FINAL REPORT

on the Expert Investigation of an Aviation Accident
involving a **Gradient / BiGolden 3 42** flying sport vehicle
registration number **OM – P704**

Ref. No.: SKA2016005

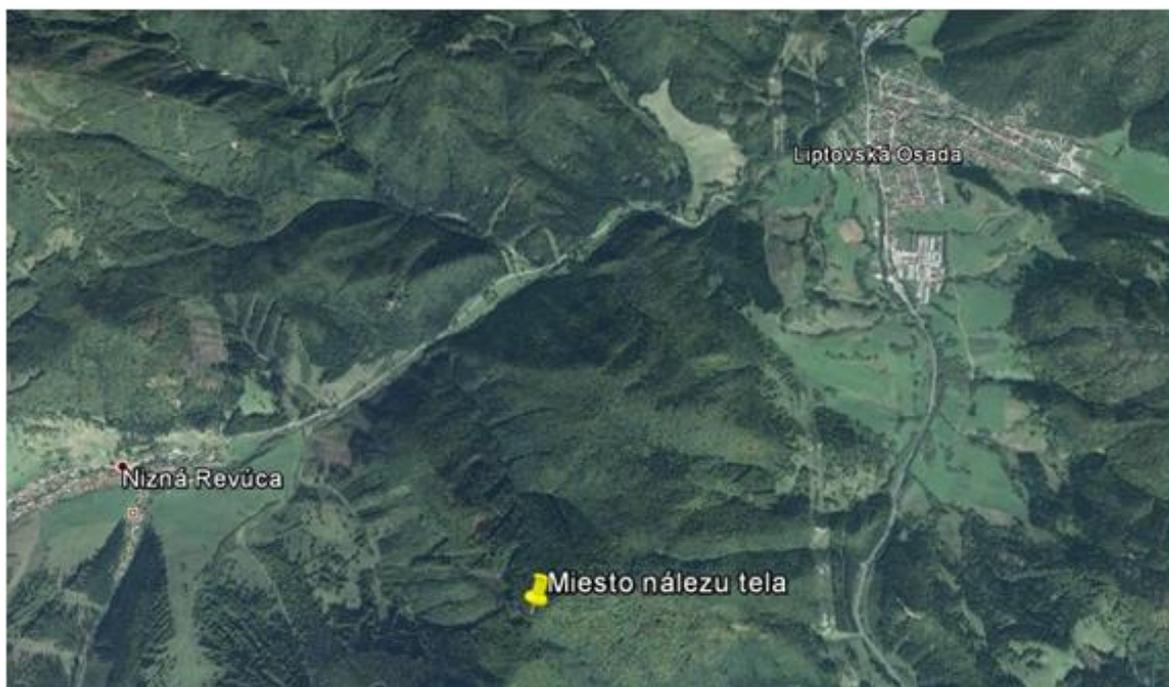
The pilot landed in a clearing near the summit of Smrekovica Mountain (N 48° 55'35,9 '' E 019° 14'14,5'').
