FINAL REPORT

from expert investigation of an air accident
of a glider, type **STANDARD CIRRUS 75**
identification number **OM-0601**

Reg.No.: **SKA2016006**

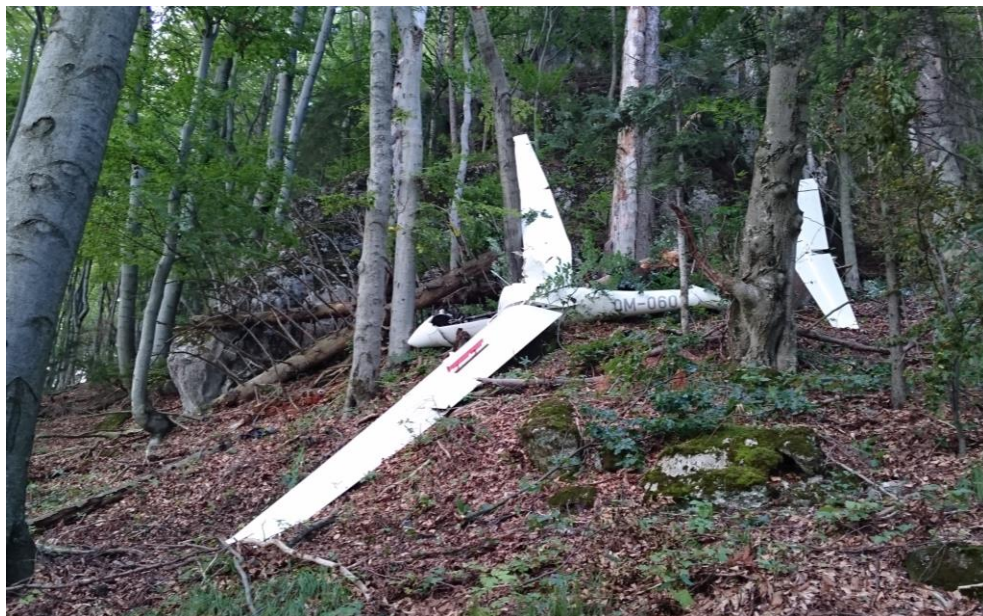
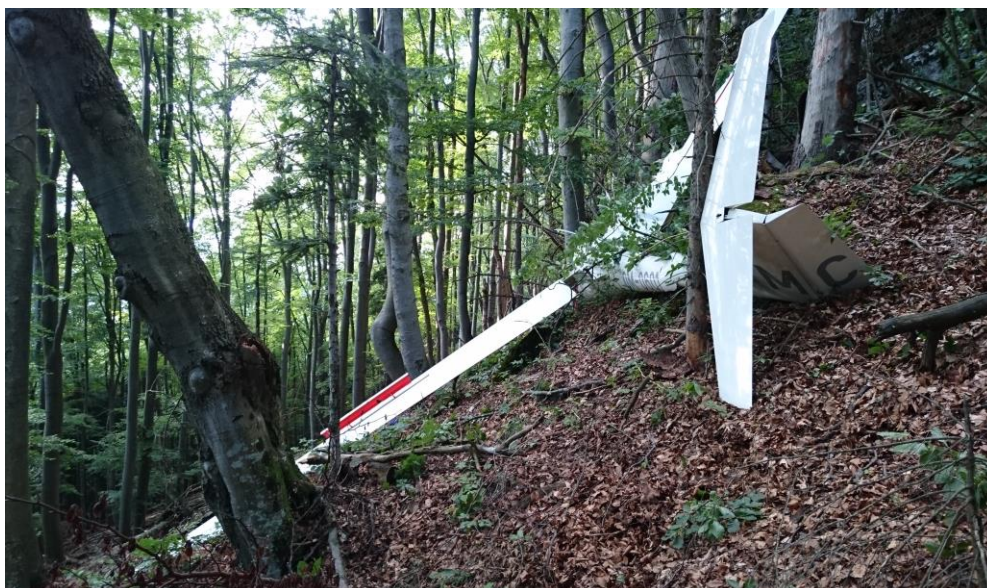
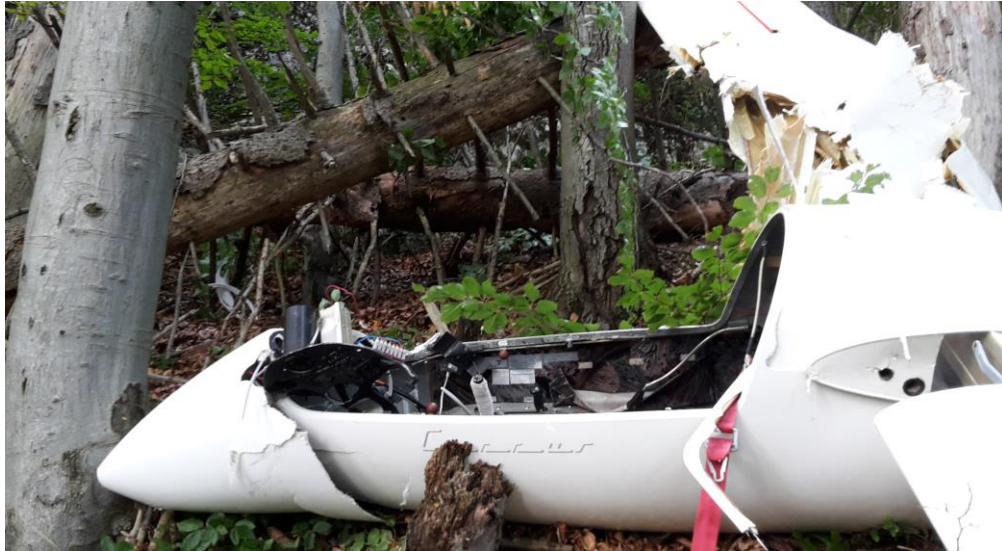
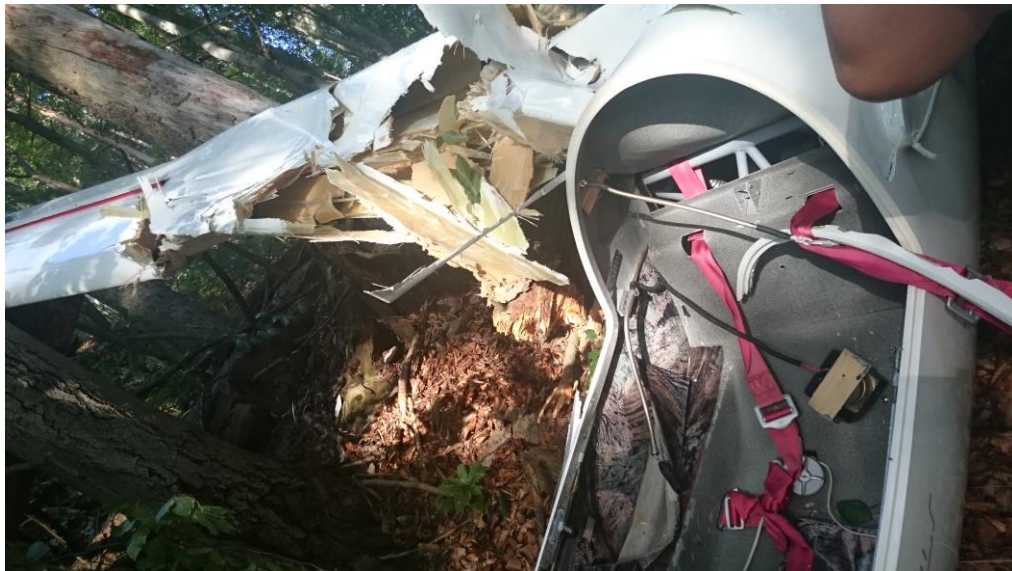
The glider was damaged during the air accident:

- broken right wing
- major damage to the left wing
- broken tail section
- destroyed cabin.

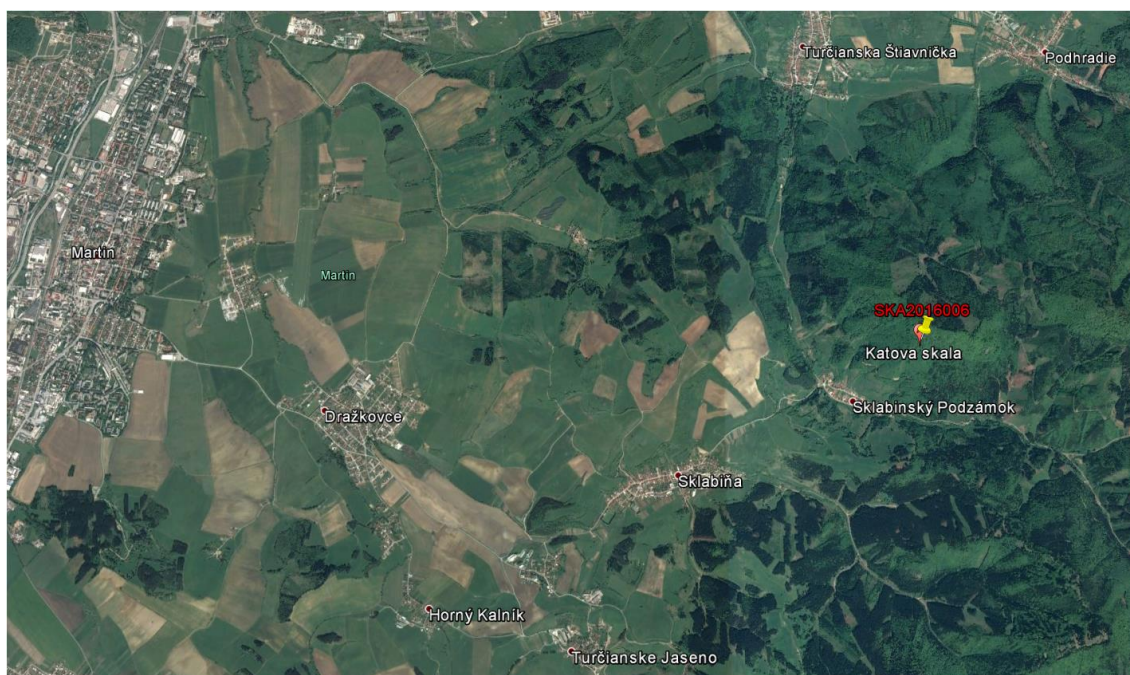
The glider fell onto a mountainous terrain with trees, approximately 20-25 m high.
