# FINAL REPORT

on the safety investigation of the air accident

helicopter type **Bell 429**

Registration Mark **OM-ATR**

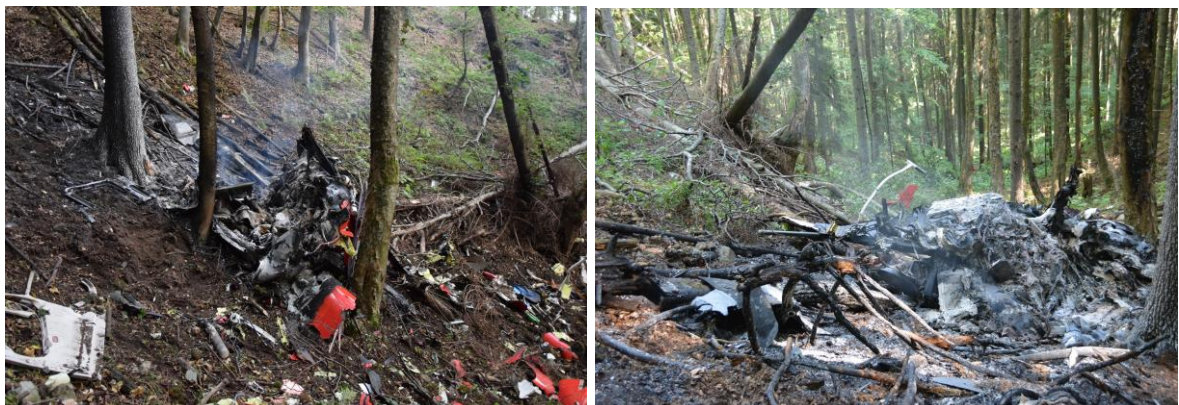
The helicopter was destroyed in the air crash due to impact and subsequent fire.

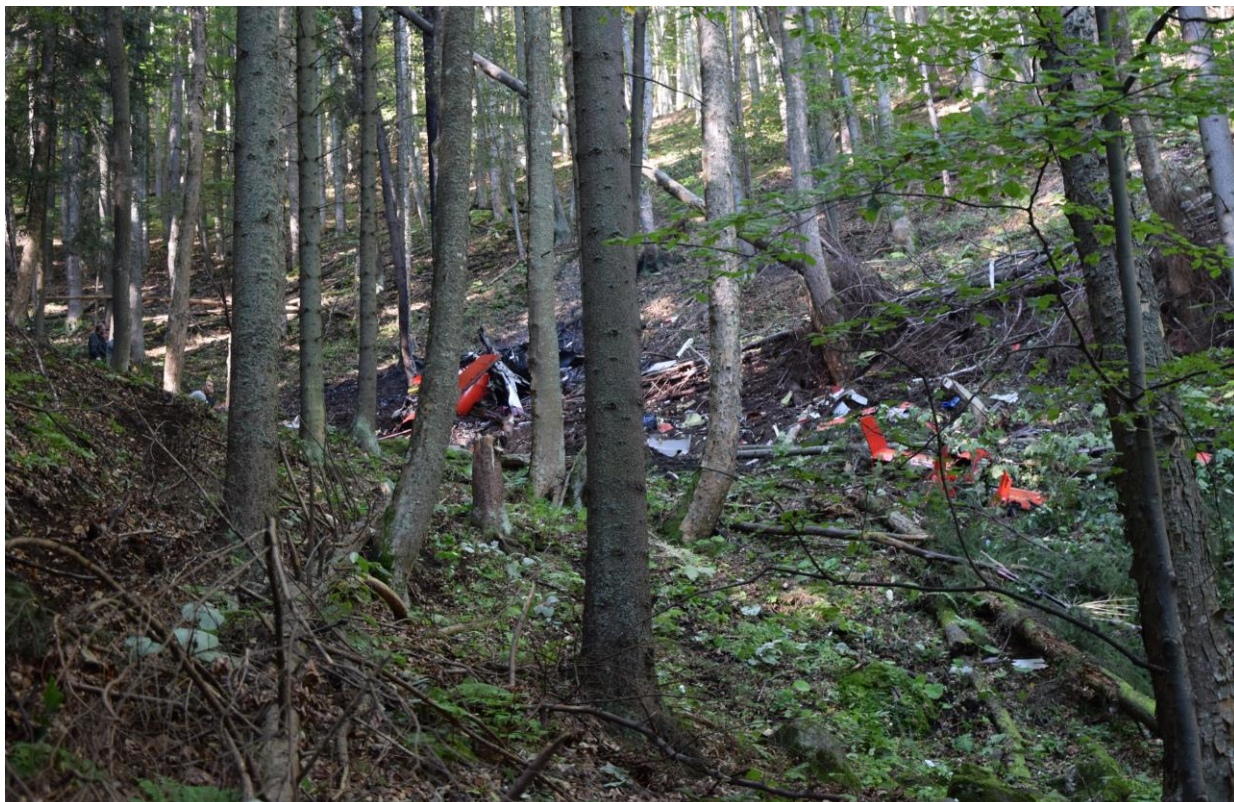
The helicopter fell into the forested mountainous terrain – the difficult-to-access part of the gorge, the debris scattering from the point of first contact with the trees to the main part of the helicopter fuselage, where the crew's bodies were found. The distance between the first contact with the trees and the debris was 85 meters.

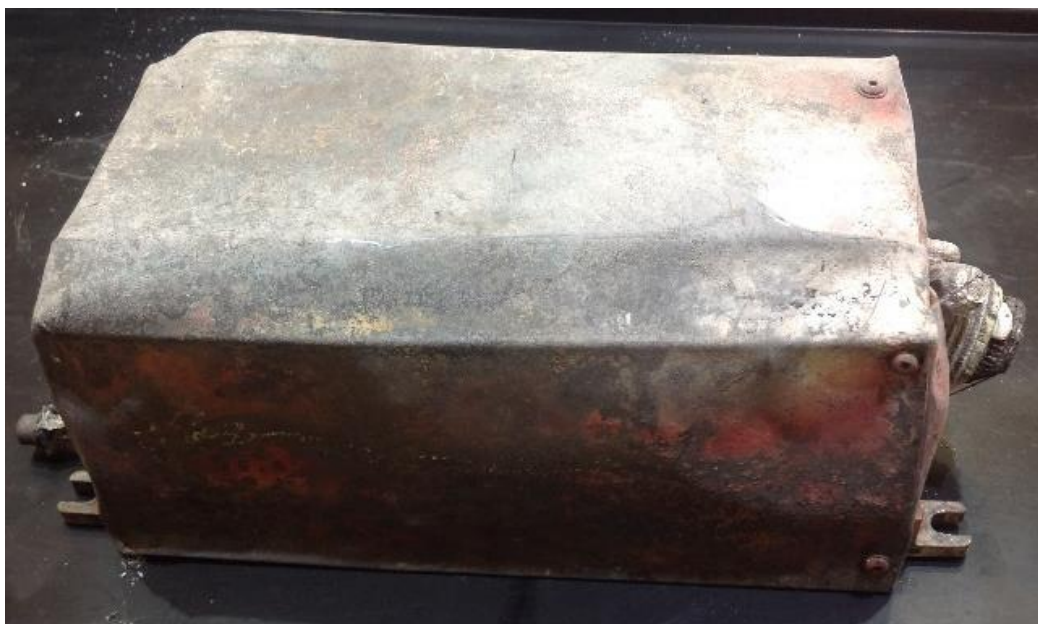
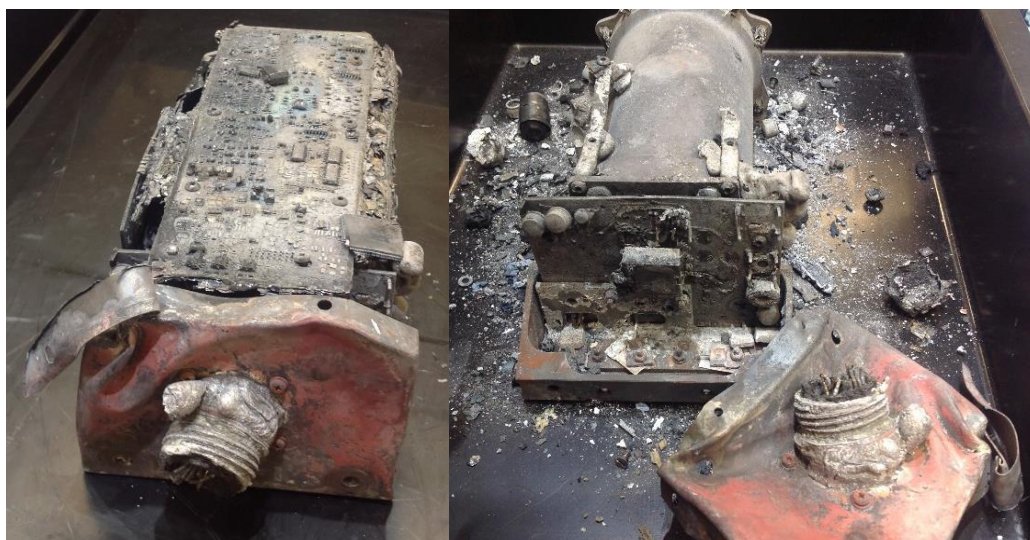
AAIB UK examined the device on behalf of LNVU, which had no identification mark and had clearly suffered mechanical and thermal damage during the fire.

*The outer layers were stripped from the device, and four broken memory chips were selected (CVR 1, CVR 2, FDR 1 and FDR 2)*

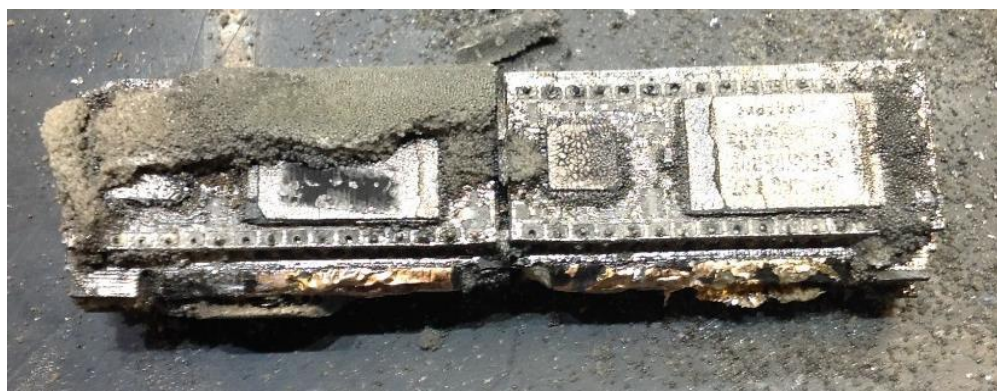
*Damaged memory chips CVR 1 and CVR 2*

The memory chips were packaged in TSOP-48 plastic packaging coupled to the printed circuit board of the memory module, which showed considerable damage to the packaging of the chips, which began to crumble and crack. Long term exposure to radiant heat would cause disruption to the interfaces of the gold and aluminium wires (Kirkendall Effect). It weakened the wire joints and so it was not possible to re-connect them using conventional ultrasonic methods.

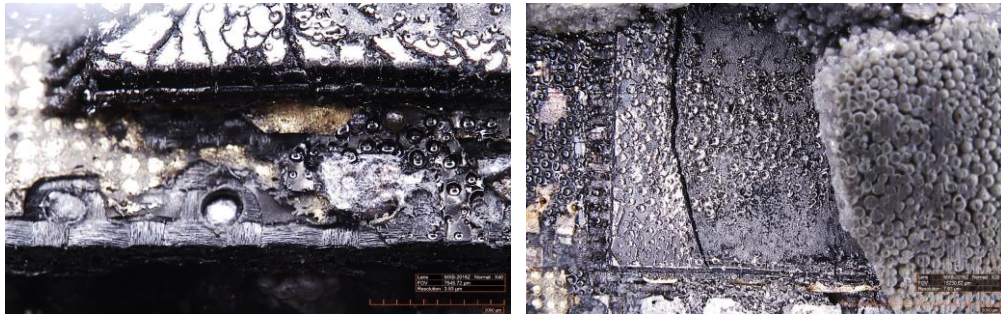
*Damaged memory chips FDR 1 and FDR 2*

Due to visible damage to the FDR chip and the fact that the glass filler around the memory modules softened and distorted, it is suspected that the FDR modules were exposed to temperatures of at least 660 °C or even higher. In addition to damage to the physical structure of the device, these temperatures accelerated data loss.

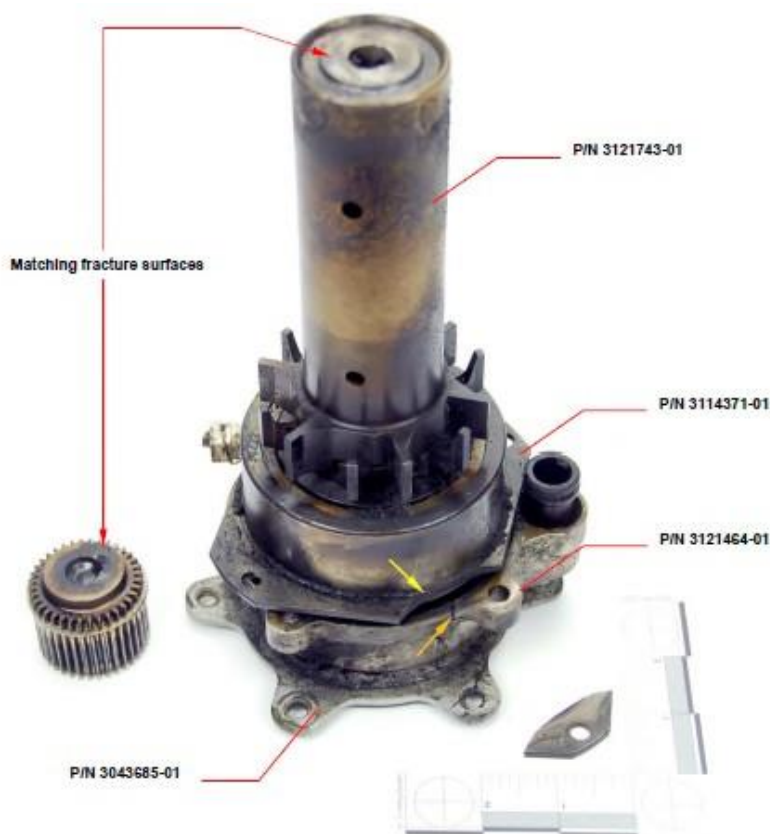
The left S/N BL0295 engine had a broken output shaft, bearing flange No. 8, a turbine speed sensor arm and a grid on the intake. An analysis in the material laboratory revealed that these components were damaged due to tensile overloading as secondary damage due to impact and fire.

*Output shaft and bearing No. 8*

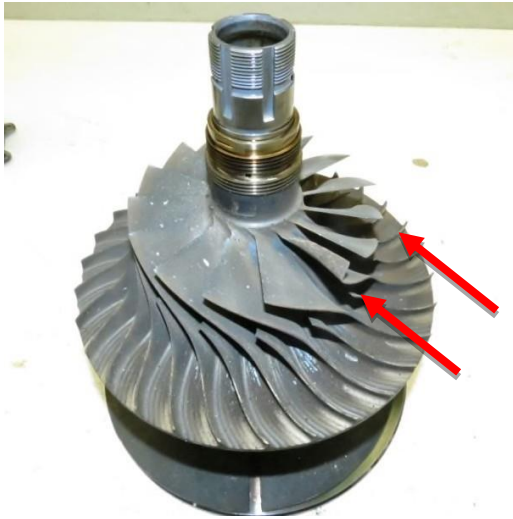
The left engine S/N BL0295 had two bent blades on the rotor mast. One blade was bent back (counterclockwise) along the entire drainage edge. Another blade was slightly bent. Scanning electron microscopy analyzes showed that the oppositely bent blade exhibited a considerable number of notches and scratches of various sizes, indicating that the front edge of the blade was hit by hard particles of varying sizes. Energy dispersive X-ray spectroscopy (EDS) analyzes were performed on the silicone rubber replica and on the bent blade and adjacent blades. All EDS spectra (non-standard and semi-quantitative), regardless of area, showed significant oxygen content, as well as chemical elements corresponding to minerals/salts from the environment (surface soils and soot) and the base metal of the mast. A metallographic analysis revealed that both blades meet material specifications.

*Rotor mast,  
bent blades (arrows)*

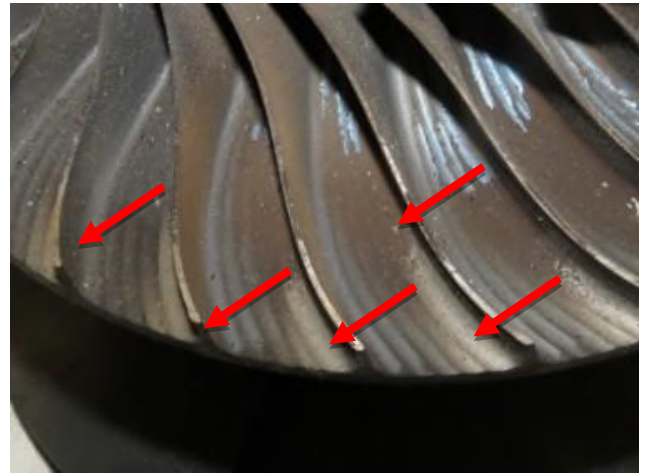
*Blades of the rotor mast  
with friction marks (arrows)*

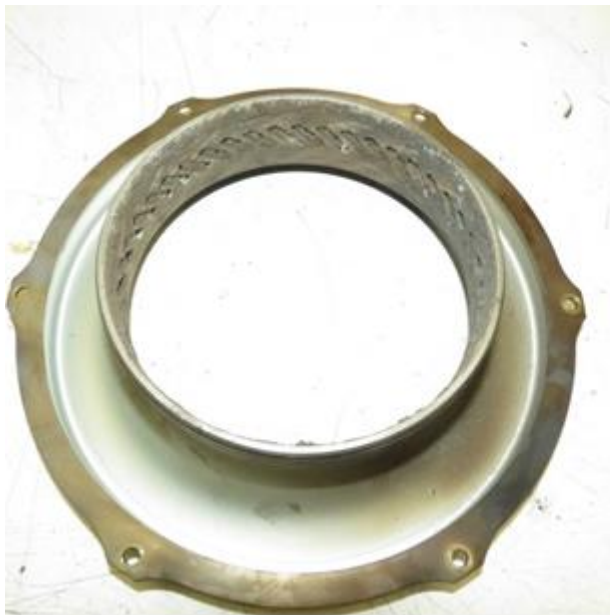
*Ring of the rotor mast against  
the direction of the current,  
clay deposits (arrows)*

The left BL0295 engine exhibited severe deformations of the shell at the 9 o'clock position (in a clockwise direction from the pilot's seat), and the output shaft broke due to shear overload. The damage observed at the rear of the bent blade of the rotor mast revealed scratches and deformations due to contact with a number of small hard particles. It is clear that in the collision a lump of clay and stones caused the puncturing of the grid on the intake. The lump was sucked in, striking and deforming one blade of the rotor mast. The lump was then transformed into dust detritus that was found in various places on the engine. These findings are indicative of the large amount of clay sucked in by the engine during the crash.

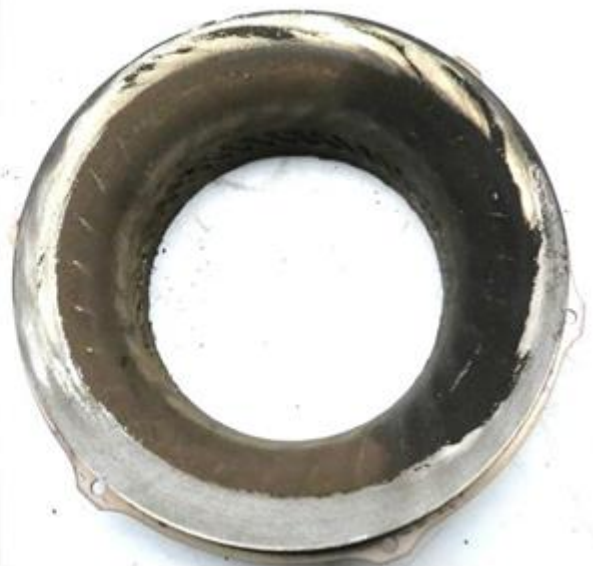
*Ring of the rotor mast in the direction  
of the current, with friction marks (arrows)*

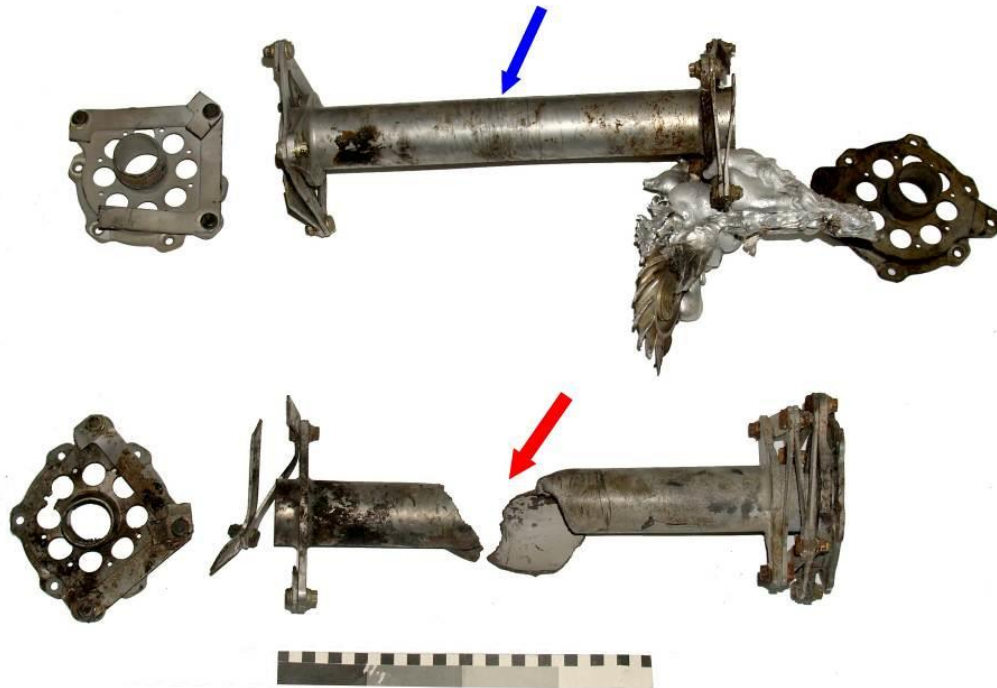
The left drive shaft was broken in two. The shaft fracture has an angle close to  $45^\circ$  with respect to the longitudinal axis of the shaft. It is clear from this fact that, at the time of damage, the shaft was subjected to a significant torque, i.e. the left helicopter engine was operational at the time of the helicopter crash or active. The flexible coupling in front of the shaft was not significantly damaged. The flexible coupling for shaft was broken in two. Due to the nature of the shaft damage and the presence of significant torque on the shaft, it was not necessary in this case to perform a detailed examination of the fractures on the individual damaged couplings, since at the time of the fracturing on the shaft, both flexible couplings had to be (also in front and behind the shaft) clearly able to transfer the torque damaged the shaft, i.e. they had to be functional.

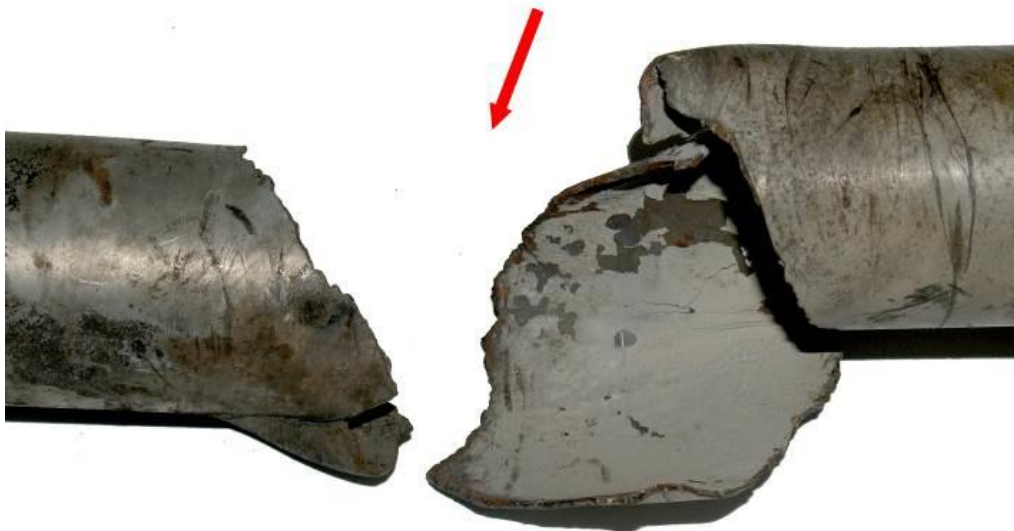
*Half detail of the fraction on the left-hand drive haft*

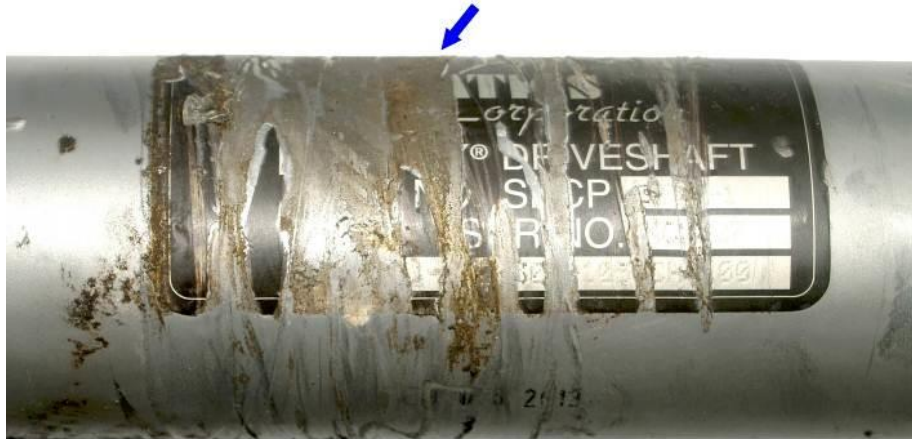
The right drive shaft was not broken. Both of its flexible couplings were split. In the central part of the shaft there were clear traces, surface scratches after contact with the rotating shaft with the edges of the respective circular hole in the metal partition between the engine and the main rotor driving gear.

*Circumferential scratching showing shaft rotation at the time of the emergency*

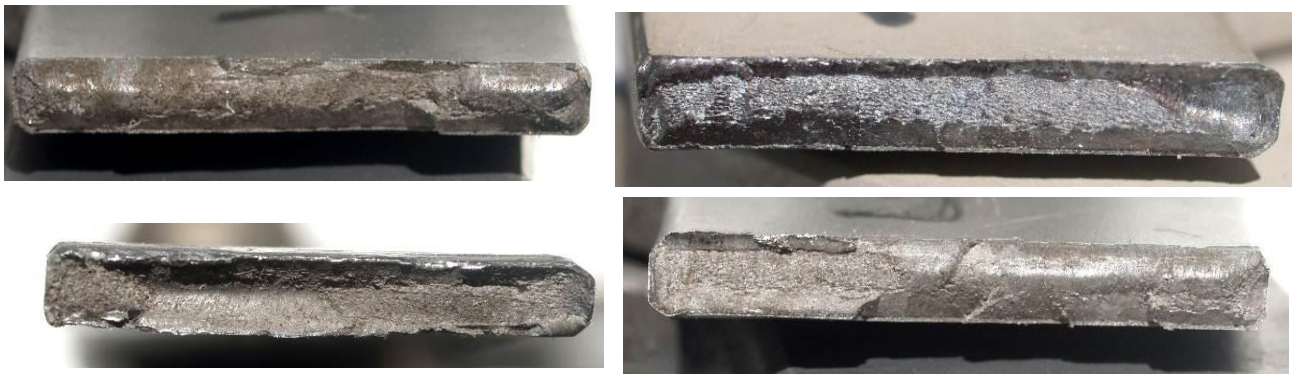
All the fracture areas present on the submitted parts of the couplings were microscopically examined, and the basic characteristics of the fatigue mechanism of the material damage (the initiation site, the clear area of the processing and relaxation belts and the visible area of the final material degradation) were not found on them.

*The fractures on the blades of the output flexible coupling of the right-hand drive shaft – no trace of the fatigue mechanism of material damage*

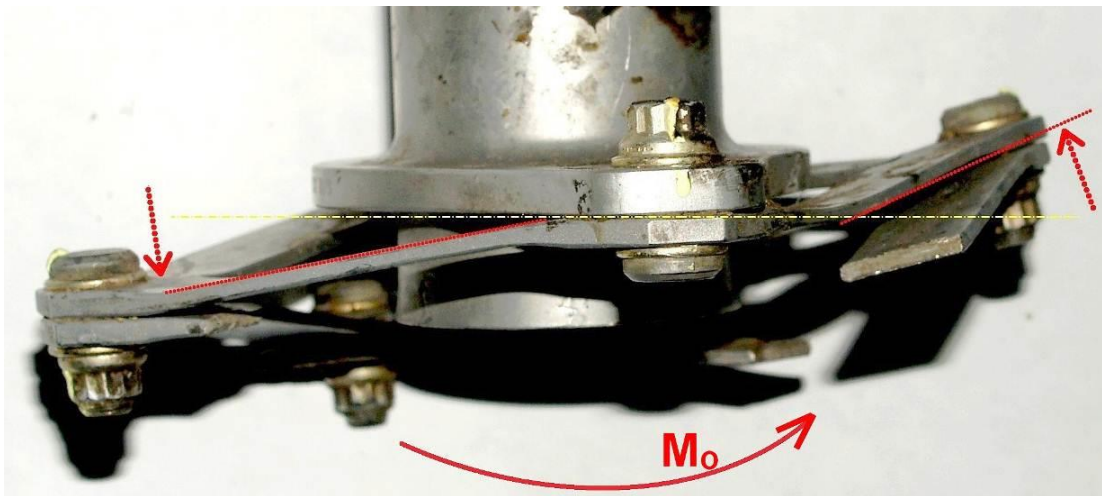
The first blade rectangle of the output flexible coupling of the right-hand drive shaft directly attached to the shaft flange was clearly deformed by the flexural load  $M_o$ . It is clear that at the time of this deformation the remaining part of the coupling had to be compact and functional to be able to transfer this bending load. Thus, it can be clearly stated that damage to this flexible coupling occurred only when the helicopter crashed.

*Bending deformation of the first blade square of the output flexible coupling of the right-hand drive shaft*

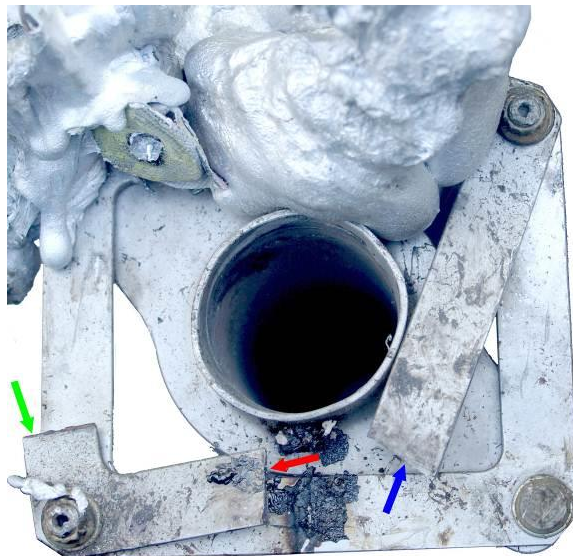
At the input flexible coupling of the right-hand drive shaft, the intermediate blade rectangle was broken (see fractures marked with arrows). The resulting fracture areas were significantly secondarily damaged by the effects of high temperature.

*Part of the input flexible coupling of the right-hand drive shaft*

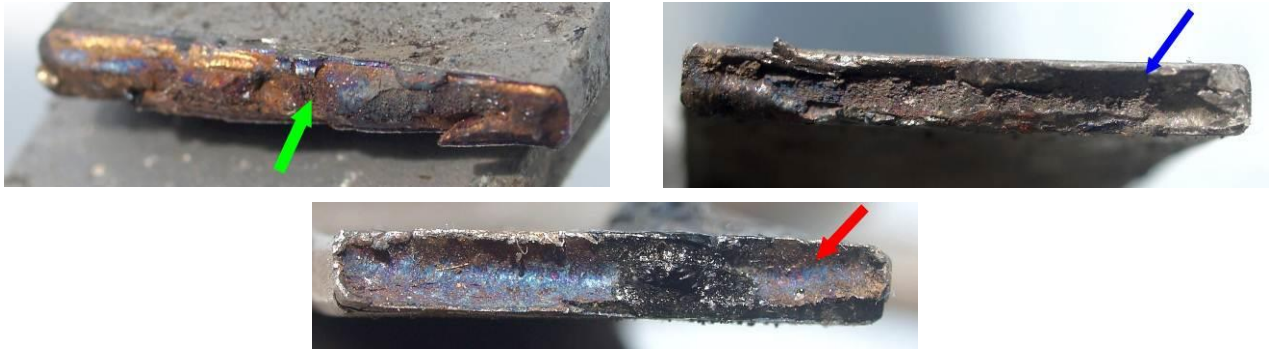
However, the macroscopic fracture morphology remains legible, and it can be concluded that the basic features of fatigue damage to the material were not found on the fracture surfaces – the arrow color corresponds to the arrow colors.

*Detail of the fractures on input flexible coupling of the right-hand drive shaft*

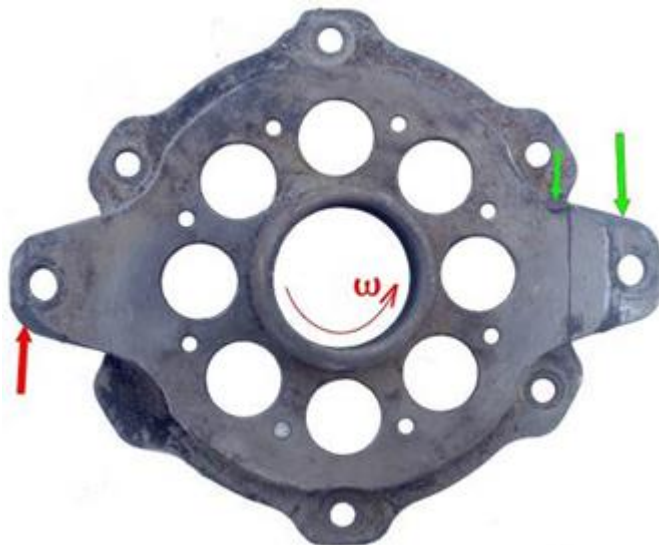
At the edges of the input flange of this flexible coupling, marks (significant compression of the material) after the impact of the elastic coupling were found in the fixed obstacle. The above-mentioned obstacle could have been some part of the helicopter engine space and the flange coming into contact with it until the helicopter was destroyed. From the range of these burns and from the very high strength of the flange material, it can be assumed that a large torque was applied at the time of the occurrence of these impacts; thus, at the time of the helicopter crash its right engine was operating or active.

*Input flange of the input flexible coupling of the right-hand drive shaft – the arrows indicate the edges damaged by the impact of the flange into the fixed obstacle*

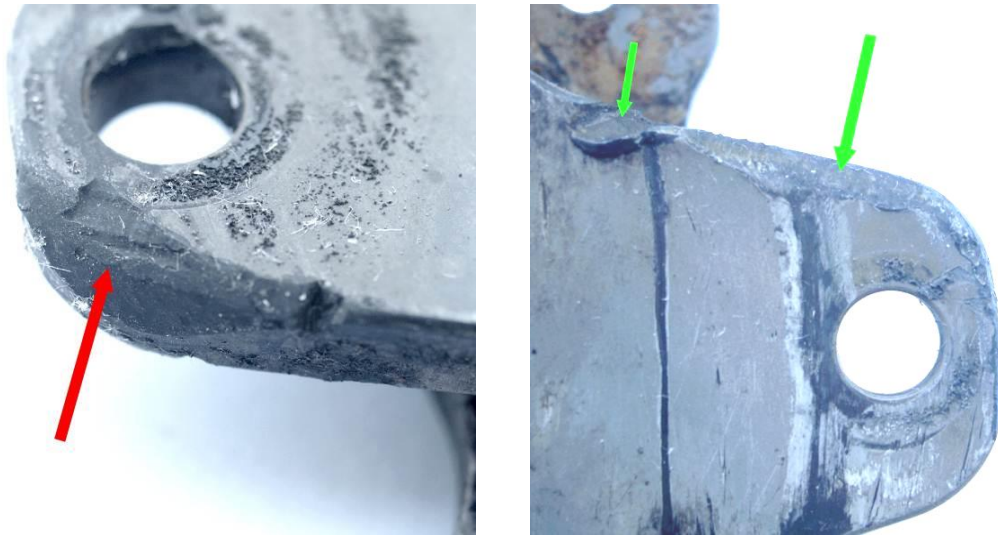
*Significant deformation of the material at the edges of the input flange of the input flexible coupling of the right-hand drive caused by the impact of the rotating flange into the fixed obstacle*

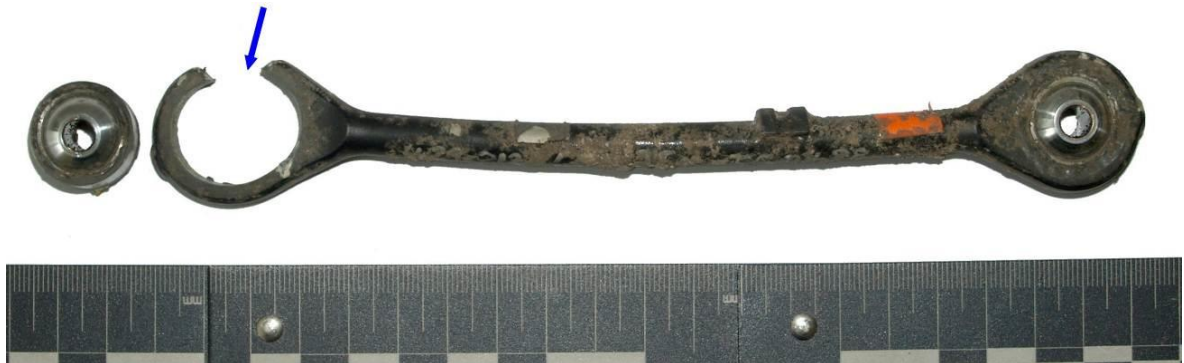
Furthermore, a damaged rod of the rear rotor blade mechanism was submitted for examination. One of the rod's bearing lugs was broken.

*Damaged rod of the rear rotor blade mechanism*

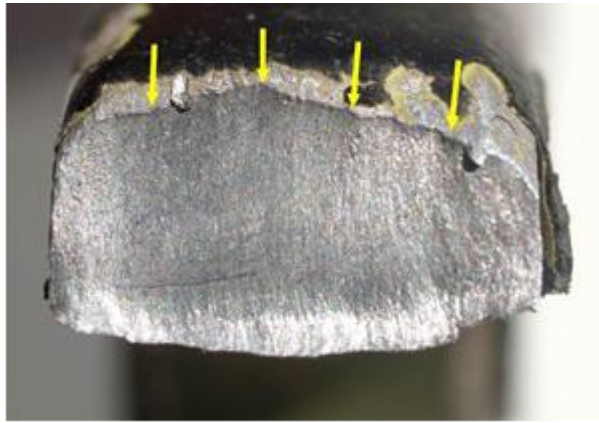
By examining the fracture surfaces on the lug of the rod, it was found that this fracture originated, or it proceeded from the outer side of the eye to the bearing, with obvious traces of a foreign object entering the mesh material (also some of the damaged helicopter with a quasi-sharp edge). The penetration of the foreign object into the lug material demonstrated the compression of the lug wall near the fracture, as well as the outer edge of the fracture area facing the bottom into the fracture area (see the edge indicated by the yellow arrows). In the bottom part of the fracture area (on the bearing side), the lug material was clearly stretched in a tangential direction (see the stretching of the material in the direction of the red arrows), which fully corresponded with the stretching thrust of the entire lug when it was damaged.

*Traces of the foreign object's penetration of the bottom into the lug at the peripheral edge of the fracture area*

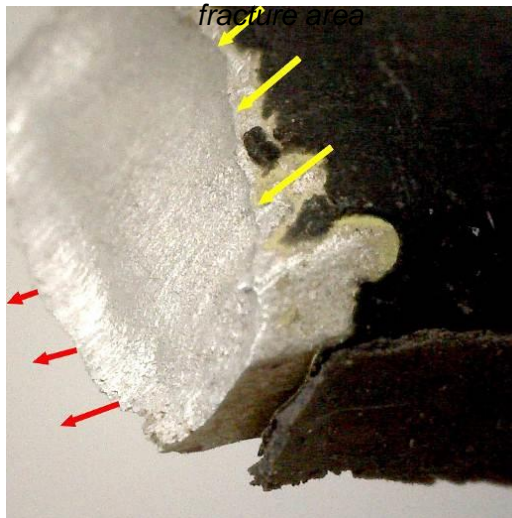
*Traces of the foreign object's penetration of the lug wall and traces along the accompanying stretching deformation of the material in the bottom part of the fracture*

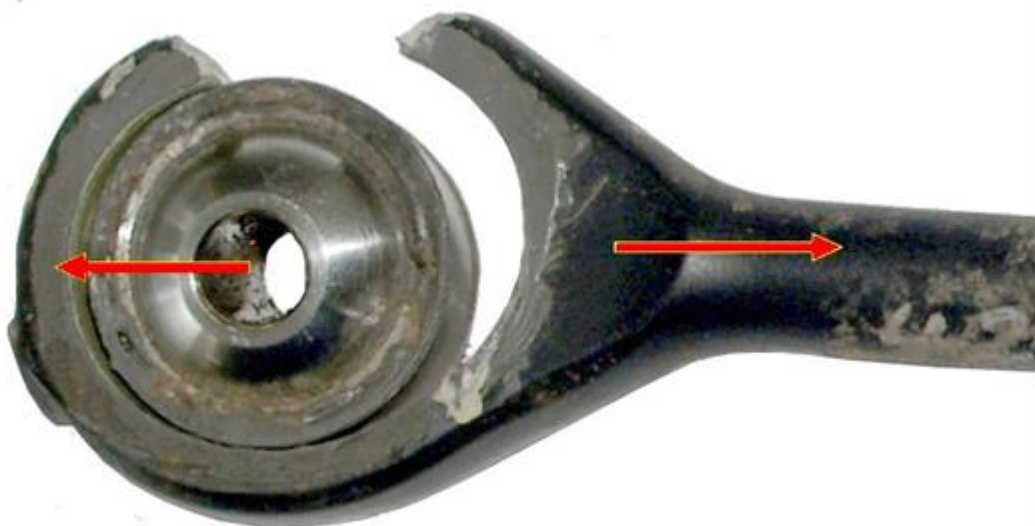
*Final thrust of the lug by the stretching strain*

Damage to the stretched lug occurred when a foreign object entered the lug in a radial direction from the outside in conjunction with the extreme tensile pulling load. Both of these lug loads as well as their damage occurred during the helicopter crash.
