FINAL REPORT

of the safety investigation of the aviation accident

HALLEY / APOLLO CXMD flying sport vehicle

Ref. No.: **SKA2016008**

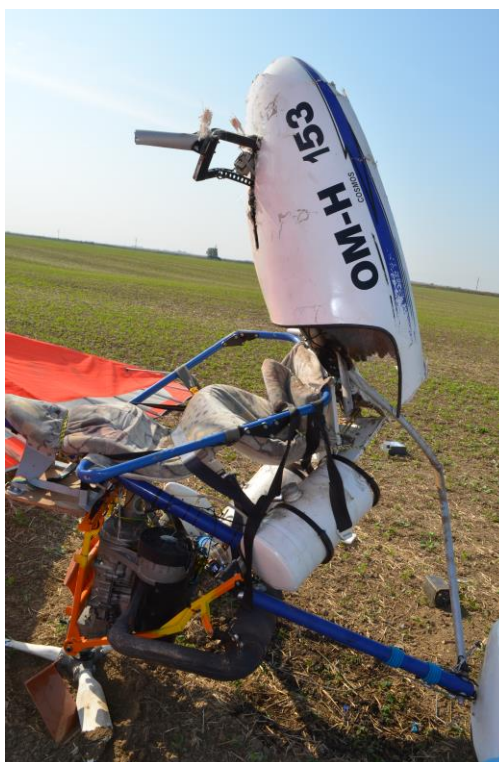
The FSV was destroyed in the occurrence.

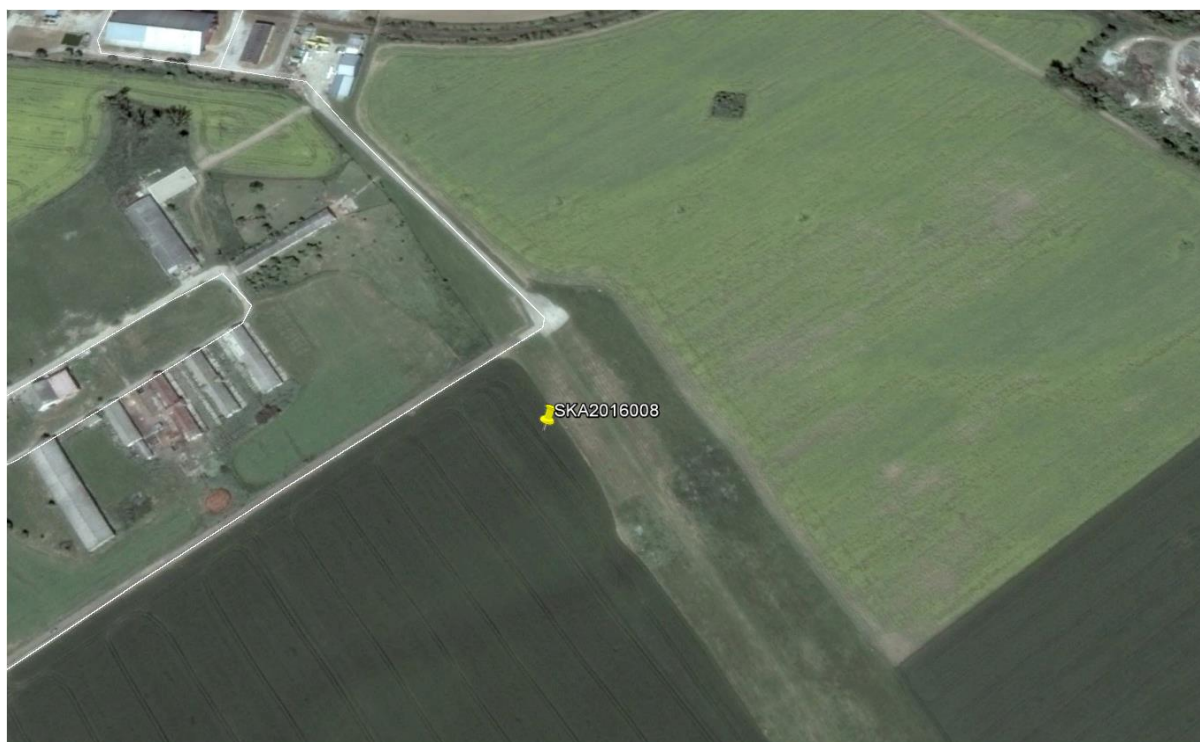
The pilot fell in a field near the airport LZSLAD.

The place of his fall is determined as being at the geographical coordinates of 48°11'28'' N 17°37'52'' E.
