FINAL REPORT

on the Expert Investigation of an Aviation Accident
of an aircraft type **NEICO Lancair 360**
registration number **SE-XRH**

Ref. No.: **SKA2016009**

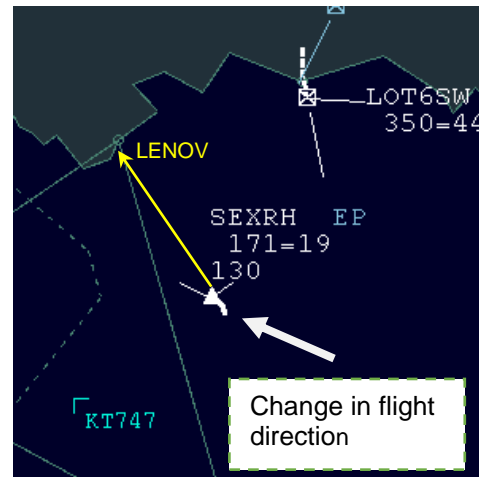
Figure 4

At **09:48:14**, there was a significant change in the direction of the flight SE-XRH (Figures 4 and 5).

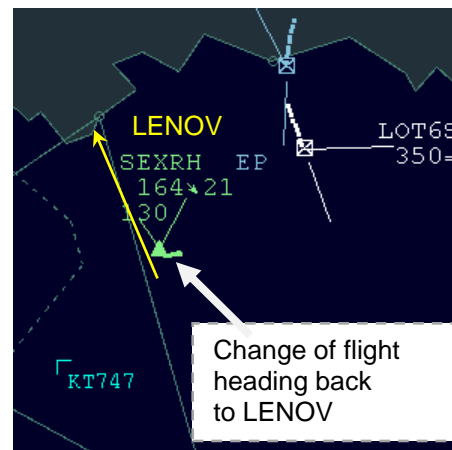
Figure 6

At **09:48:48**, there was a significant change in the heading of the flight SE-XRH (Figures 6 and 7).

At **09:49:16**, flight SE-XRH was again heading towards LENOV (Figure 7).

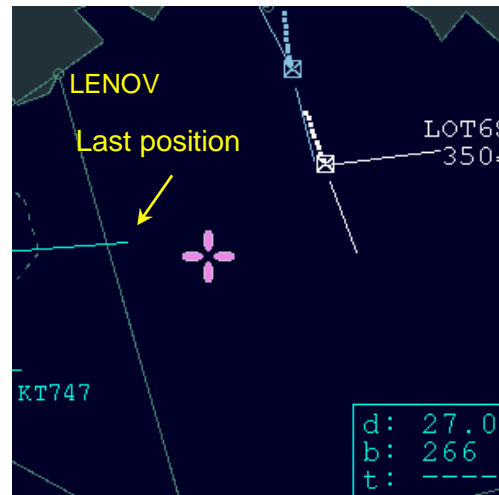
Figure 10

At **09:49:51**, radar contact with flight SE-XRH was lost (Figures 10 and 11).

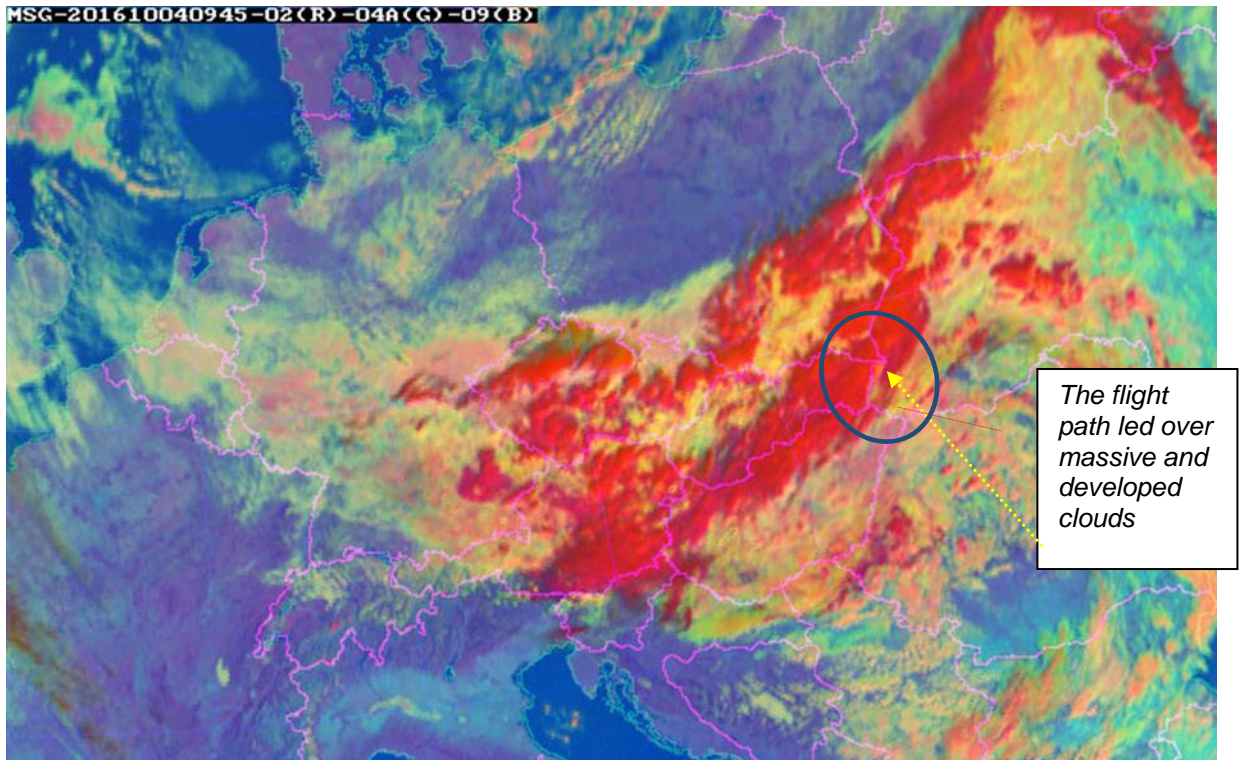
Fig. 12 Satellite images of the density of clouds over Europe

of icing on the leading edges of the wings and propeller; he incorrectly assessed the situation as reduced engine thrust and began to address this problem. It is likely that he also realised that he had been flying at the unsuitable FL190 for a relatively long period of time and requested a descent to FL130, despite the fact that there was massive cloud cover of the occluded front underneath him (*Fig. 12*), in which the likelihood of ice formation was even higher.

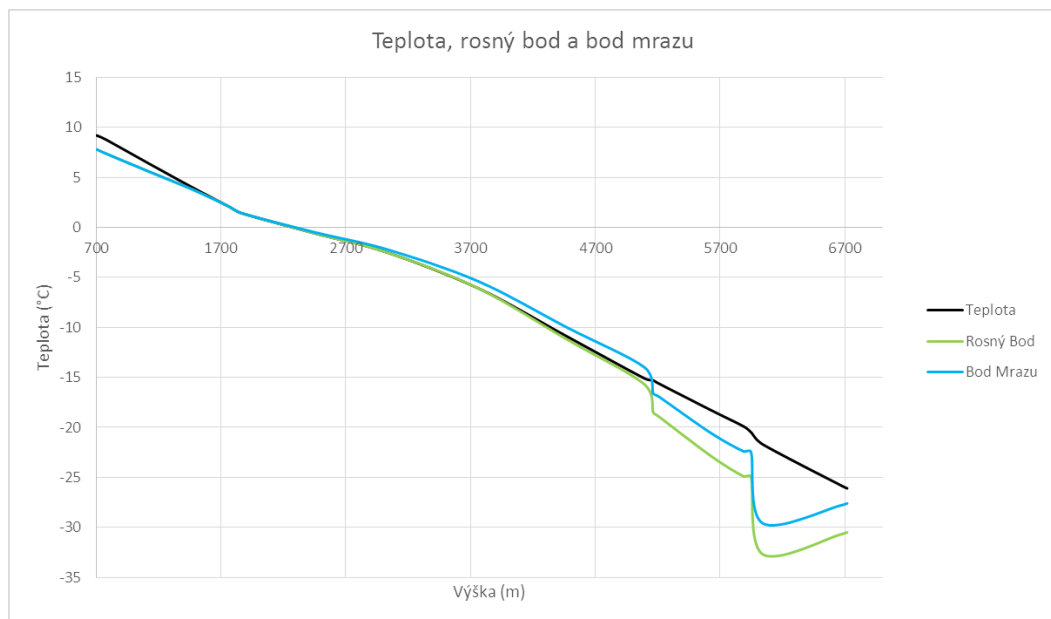
The zero-degree isotherm was at an altitude of about 2,300 m asl. From the altitude of 2,300 m asl to 4,400 m asl (-10 °C isotherm level), there were suitable conditions for the formation of moderate to heavy ice. At higher levels, with a further decrease in temperature as well as relative air humidity, there were worse conditions for ice formation. Only light ice could have formed above the altitude of 4,400 m asl to the cloud top.

Fig. 13 Temperature and humidity profile according to radio probing measurements on 4 October 2016, noon, in Gánovce (temperature, dew point and freezing point)

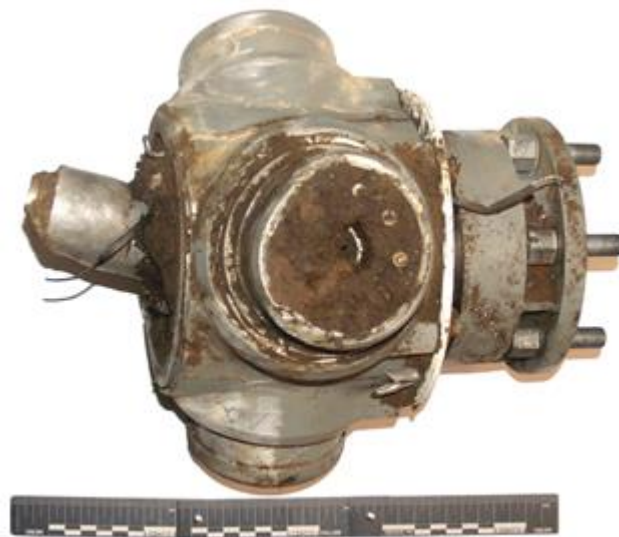
The propeller hub was submitted for investigation at the KEÚ Bratislava in order to **determine whether the propeller was driven by the engine at the time of the impact.**

Fig. 20 Propeller hub presented as evidence No. 1

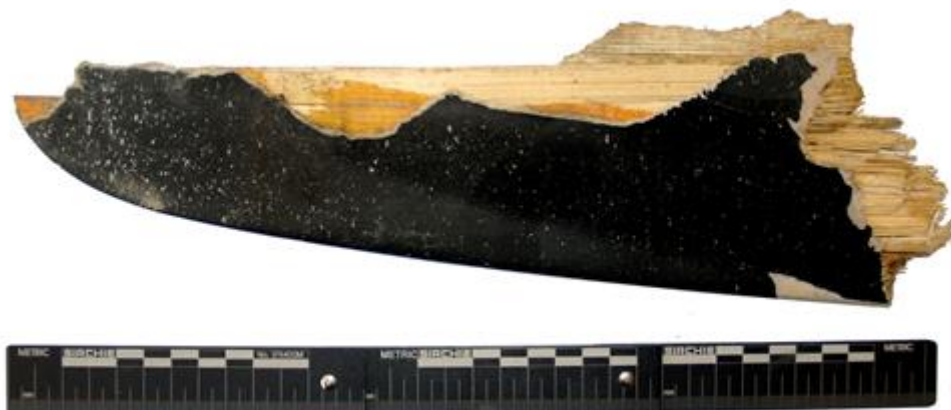
Fig. 24 Fragment of the propeller blade submitted as evidence No. 2

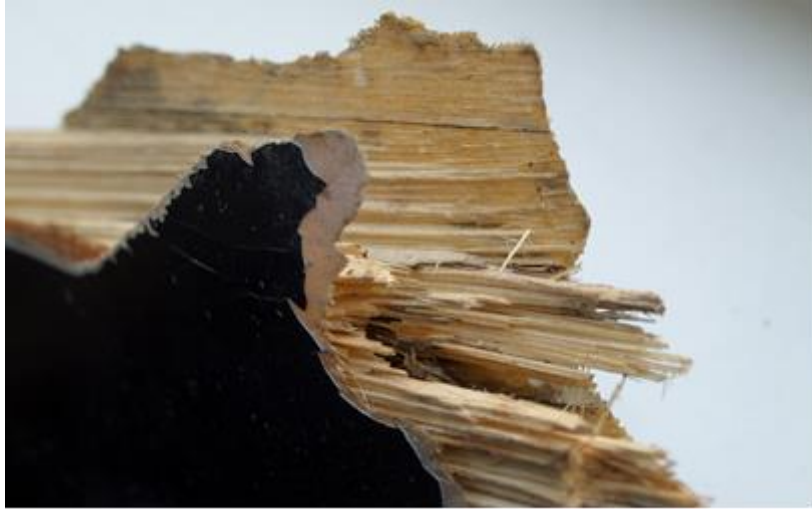
Fig. 25 Significant longitudinal cracks and missing material in the rear of the propeller blade

Based on the nature of the damage to the presented fragment of the propeller blade, it can be stated that the main part of the load that caused the break-off of the rear of the propeller blade had an impact against the direction of rotation of the propeller, i.e. perpendicular to the direction of movement of the aircraft. This finding therefore suggests that the aircraft propeller was driven by the engine at the time of its damage.
