AVIATION AND MARITIME INVESTIGATION AUTHORITY
Námestie slobody 6, P.O.BOX 100
810 05 Bratislava

FINAL REPORT

on the Expert Investigation of an Aviation Accident

Airplane type **WT9 Dynamic LSA/Club**

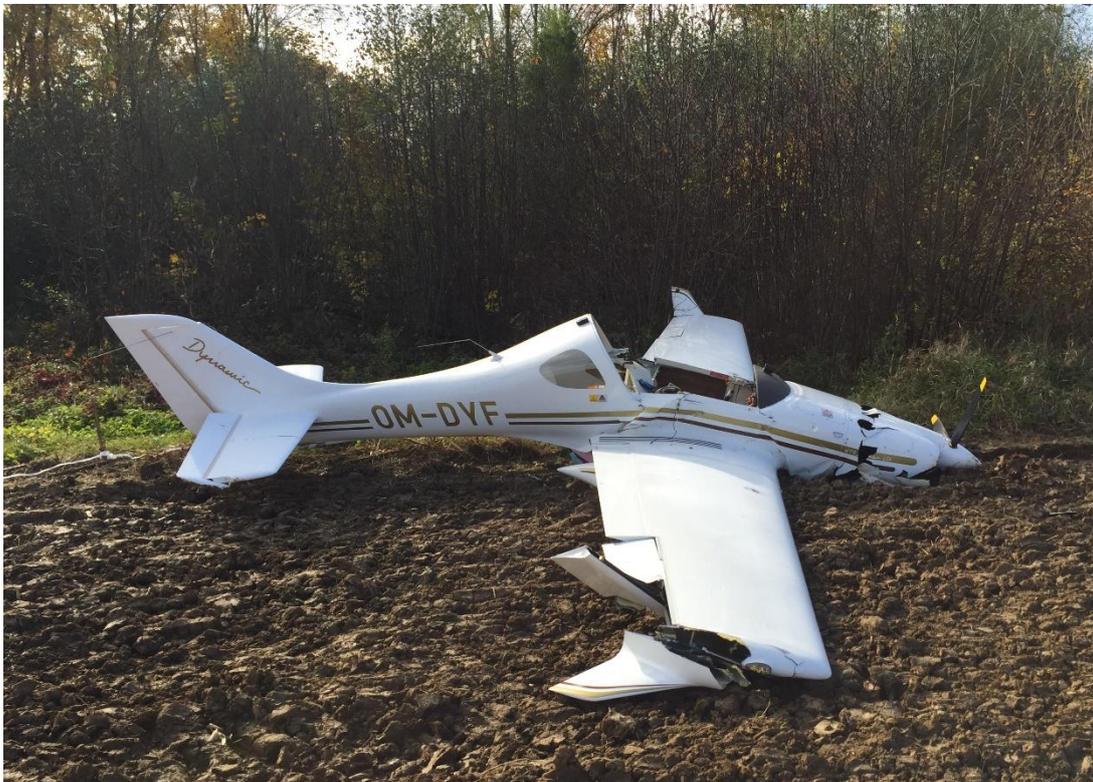
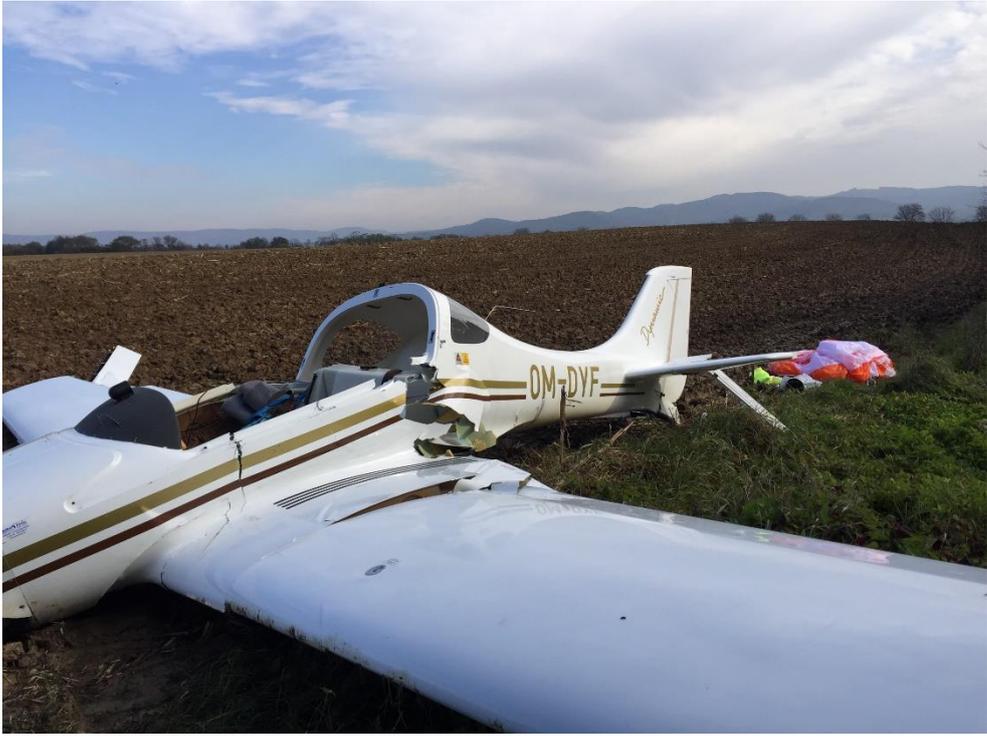
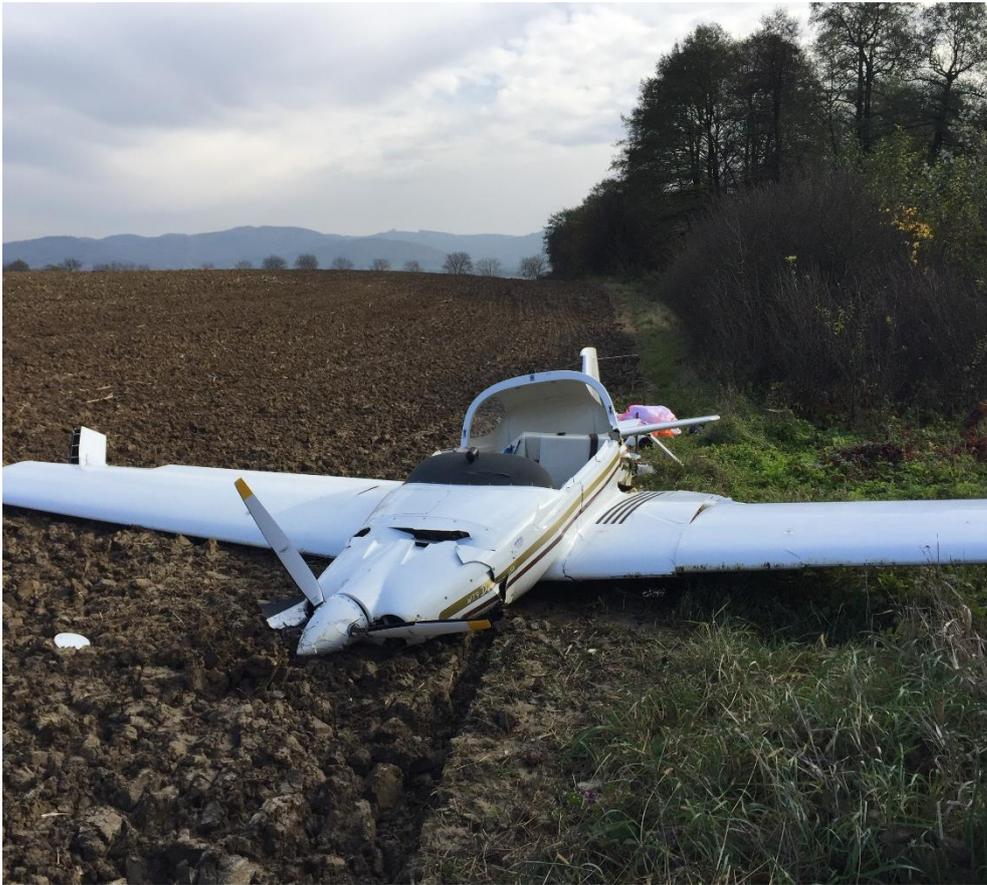
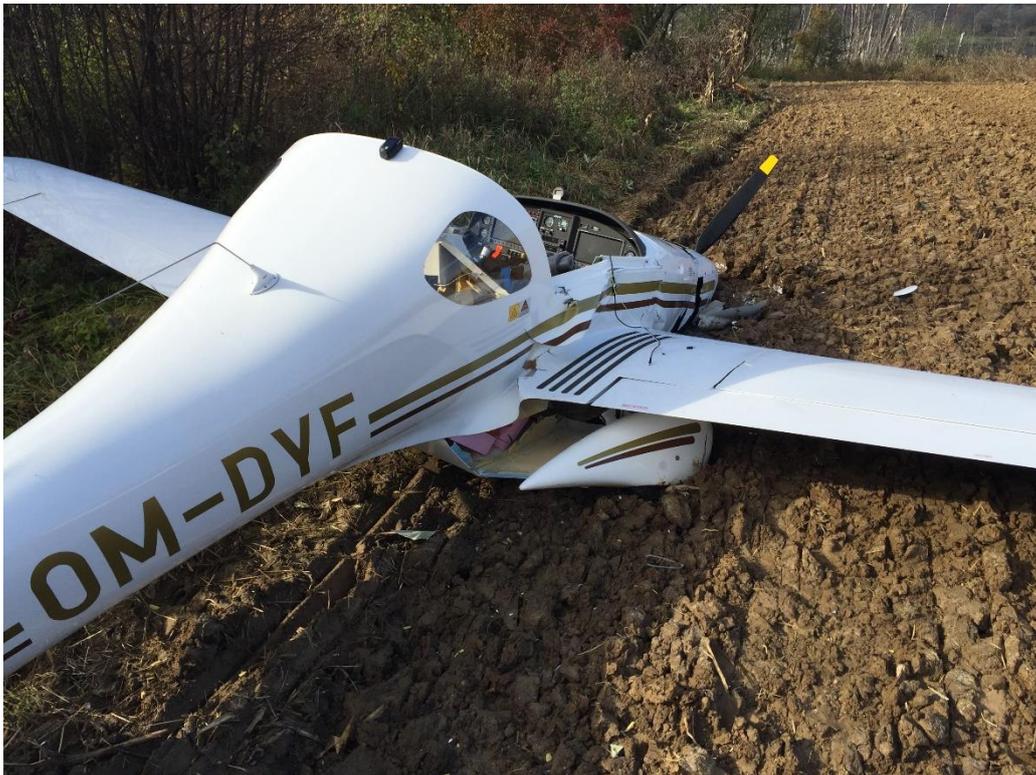
After falling at the edge of an agricultural plot, the airplane was destroyed.

The stabilizer and the altitude rudder were significantly damaged, the right part of the rudders was broken in half. The left side of the rudder was broken in 1/2. The keel surface and the indicator were broken in half.

The left half of the wing was broken off from the central wing and had a broken left flap at the distance of 35 cm from the central wing. The left wing was broken at 1/3 of its length. The bottom wing covering was cut and the left winglet was broken. The leading edge was cut at a distance of 80 cm from the wing end. The outer "stall stripe" was unstuck from the leading edge and the leading edge was detached at the level of the left fuel tank shutter.

The right half of the wing had a detached leading edge at the outer "stall stripe". The speed sensor was broken at the bottom part of the wing. The right winglet was broken and the right wing was broken at 1/3 of its length. The right flap was damaged at its bottom part in a compartment of the second hitch.

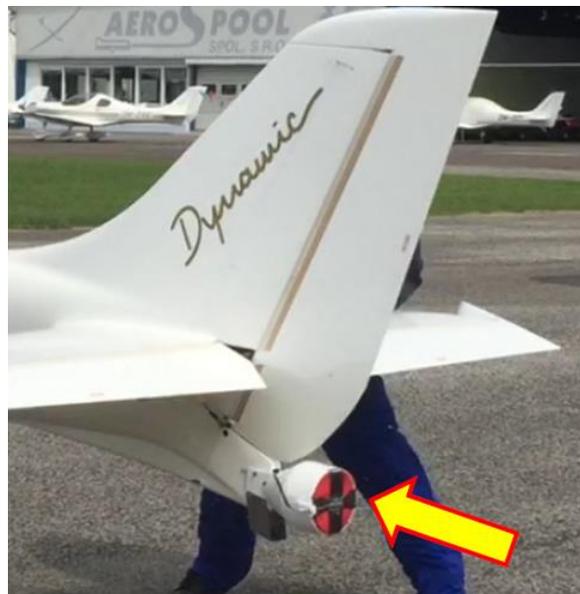
Fig. 1

The PP-2 type spin-recovery parachute was placed in a casing and attached to the rear part of the airplane fuselage under the directional rudder (fig. 1) The parachute was attached to the airplane by a towing device, allowing its discarding after opening and stabilizing the tail spin. The parachute is released by an extraction parachute. The pressed extraction parachute including the main parachute was secured in a casing with 4 straps. The release system is controlled by the pilot using a steel cable that secures the straps in the closed position. After activation, the steel cable is released from the straps securing cone and it unlocks 4 straps (fig. 2).

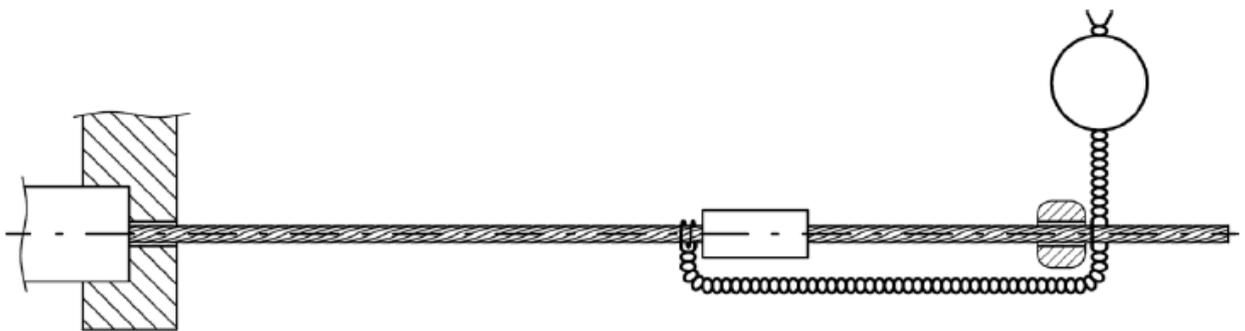
Fig. 3

A tin-plated copper cable was used for securing the steel cable with a diameter of 0.2 mm of the 44A0111 type and a seal.

The cable was secured in the way shown in fig. 3.

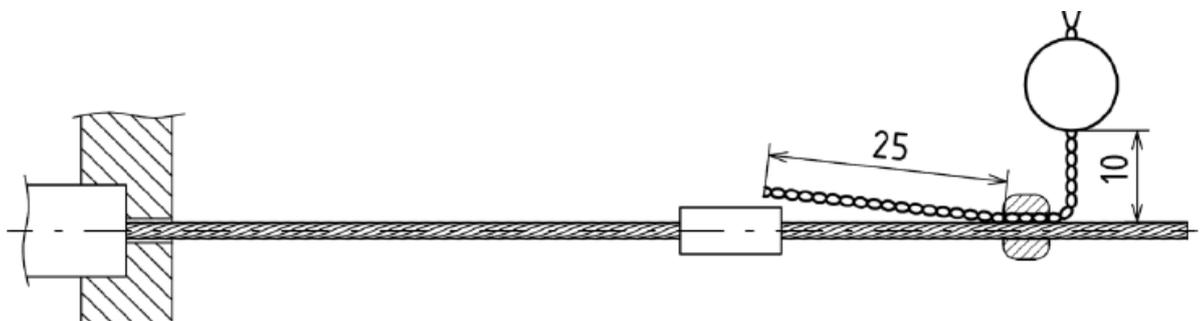
Fig. 4

In attempt No. 5, the securing cable was inserted into the opening of the securing cone for straps with an overlap of 25 mm and its other end was secured by the seal according to fig. 4.

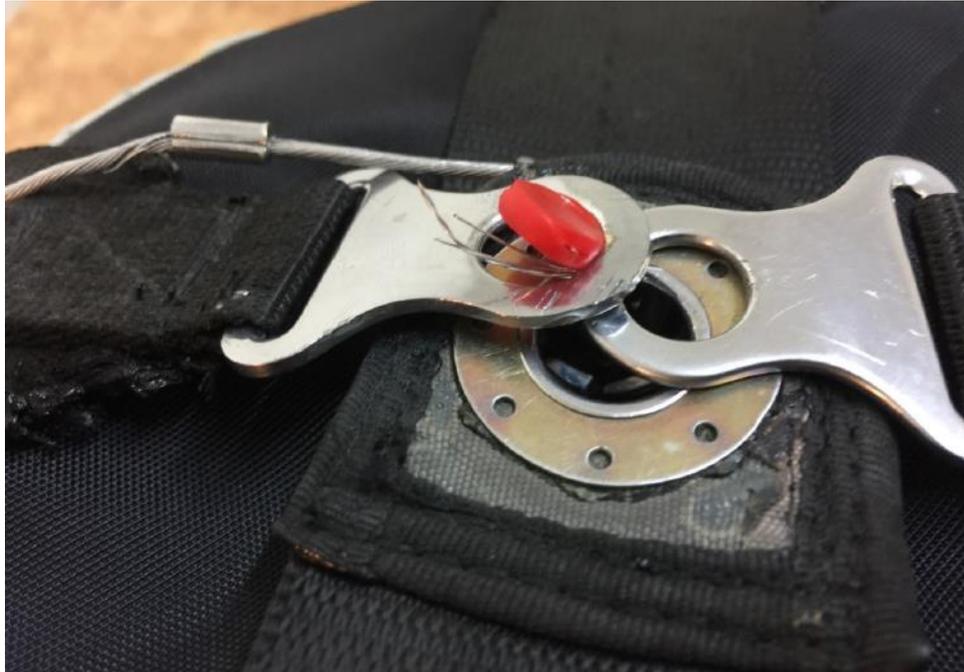
Fig. 5

In this attempt, unlike in previous experiments, the cable was slowly pulled out of the cone and the spring of the extraction parachute was held by hand for slow release. After the sliding of the last two buckles of the securing straps out of the cone, these, together with the securing cable, blocked the opening of the straps and the parachute did not open (fig. 5).

According to test result No. 5, it was proven that in certain conditions, the securing cable and the seal can cause the blocking of the securing straps and therefore the spin-recovery parachute would not open even after being activated by the pilot.

The commission supports the test result (test No. 5) which proves, that in certain conditions, the securing cable and the seal can cause the blocking of securing straps and therefore the spin-recovery parachute would not open even after being activated by the pilot.

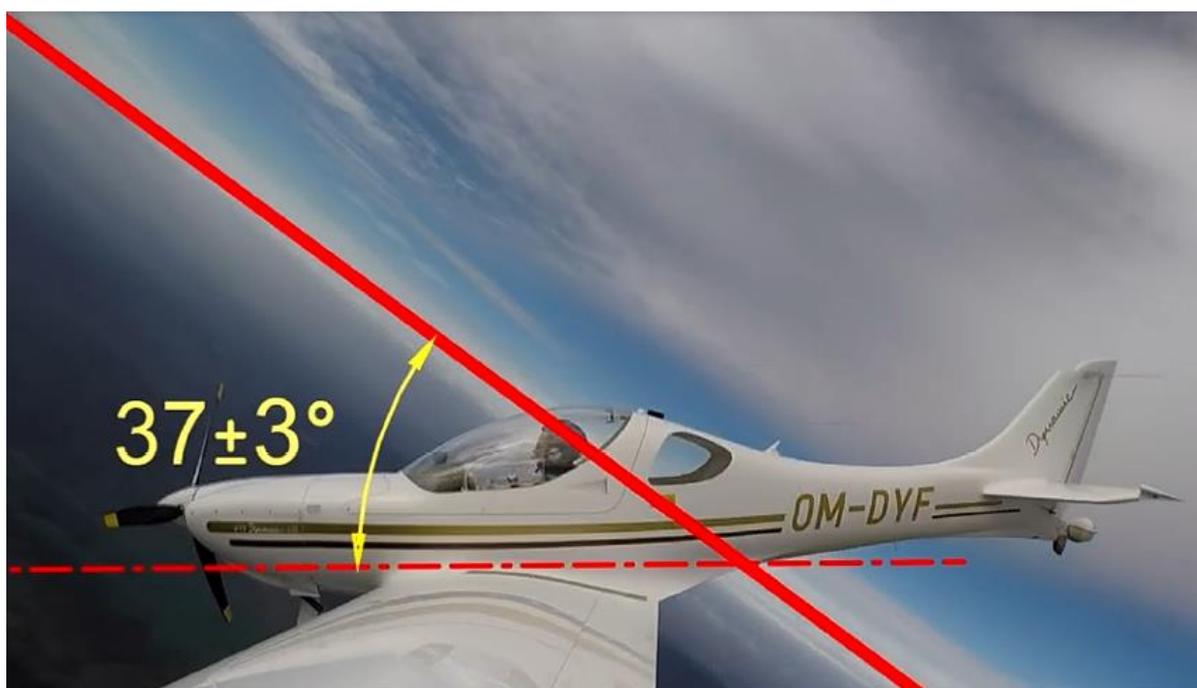
Longitudinal incline of the airplane in left tail spin

The measured value of the longitudinal incline demonstrates that during the negotiation of the tail spin, the airplane probably changed its position into a flat tail spin (a *flat tail spin* is a tail spin with an angle of longitudinal inclination lower than 45°. A more difficult negotiation is characteristic for the flat tail spin; a *normal tail spin* is a tail spin during which the airplane is in a position corresponding to normal flight with an angle of longitudinal inclination greater than 45°).
