AVIATION AND MARITIME INVESTIGATION AUTHORITY  
Námestie slobody 6, P.O.BOX 100  
810 05 Bratislava 15

# **FINAL REPORT**

on investigation of serious incident  
reduction of separation below prescribed separation minima of aircraft  
in flight between civil and military operation

**Reg. No. SKS2016001**

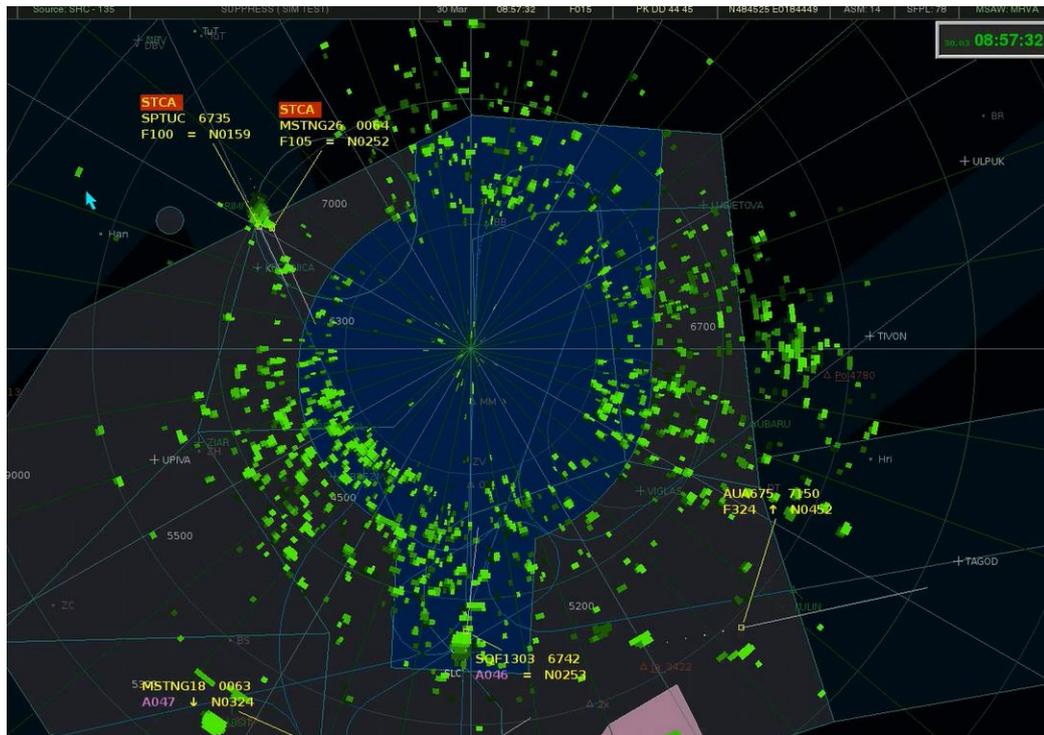
Based on FDR, the actual altitude of aircraft MUSTANG 26 was 10319 ft (FL103). At this moment the pilot under training ceased the descent and started to climb on the basis of the report from RC of APP Sliač (after 29 seconds of descent). Horizontal distance between the two aircraft was then 0.4 NM.
