AVIATION AND MARITIME INVESTIGATION AUTHORITY
Námestie slobody 6, P.O.BOX 100
810 05 Bratislava 15

FINAL REPORT

on Investigation of a Serious Incident
of aircraft type **PS-28 Cruiser**
registration number **OM-STR**

Ref. No.: SKS2016002

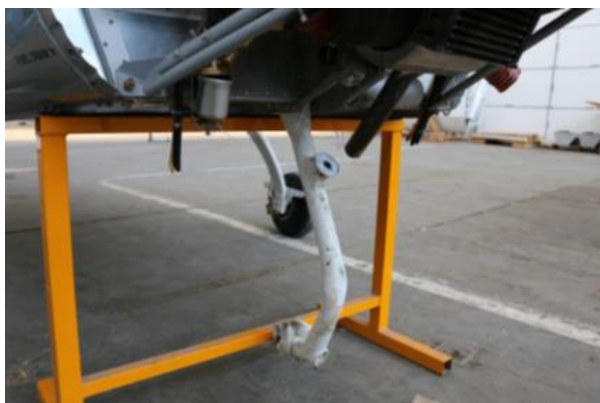
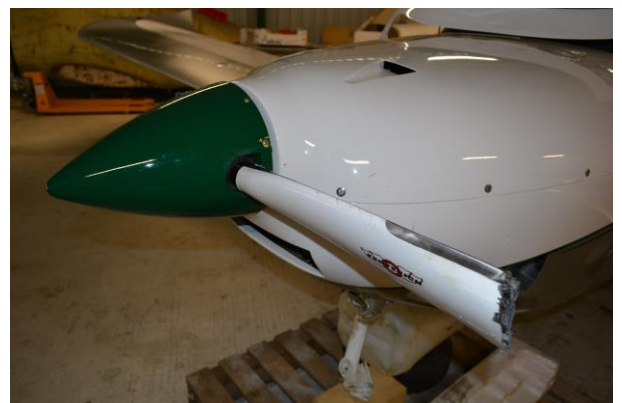
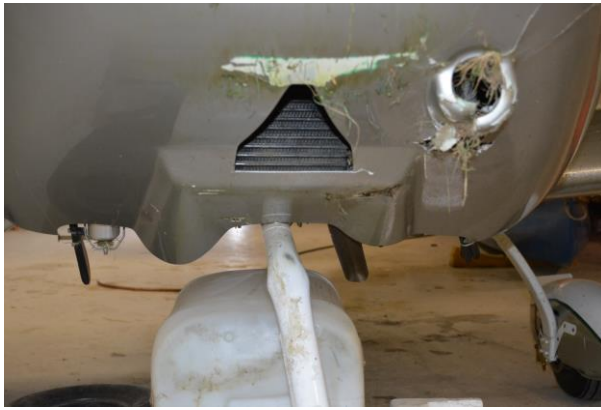
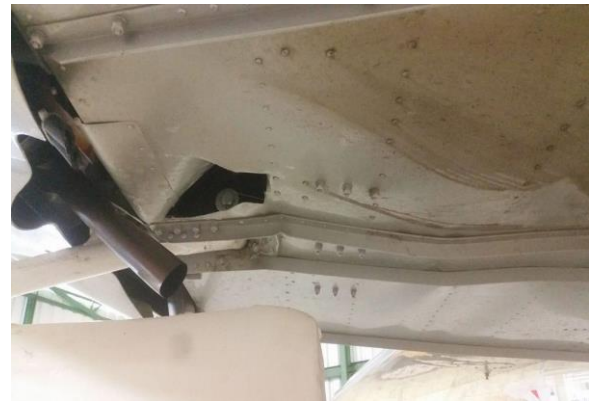
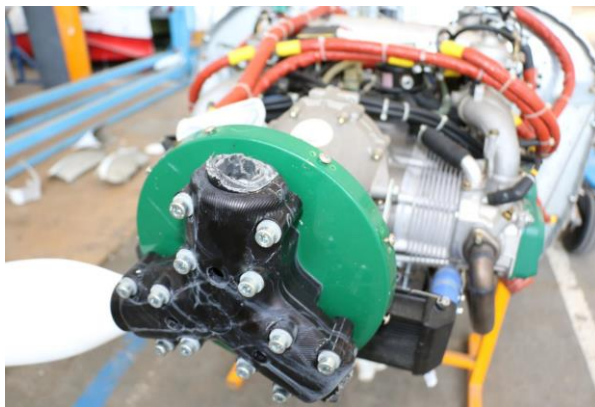
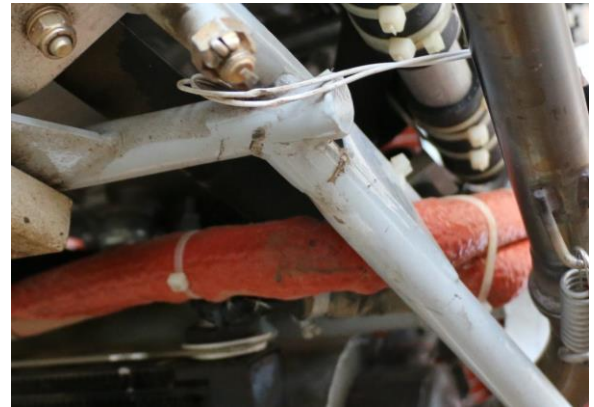
The front landing gear and propeller were damaged in the incident, the exhaust and the heating pipes were deformed, the engine mount was cracked, the cabin floor and the coating in the bottom of the fuselage were deformed.

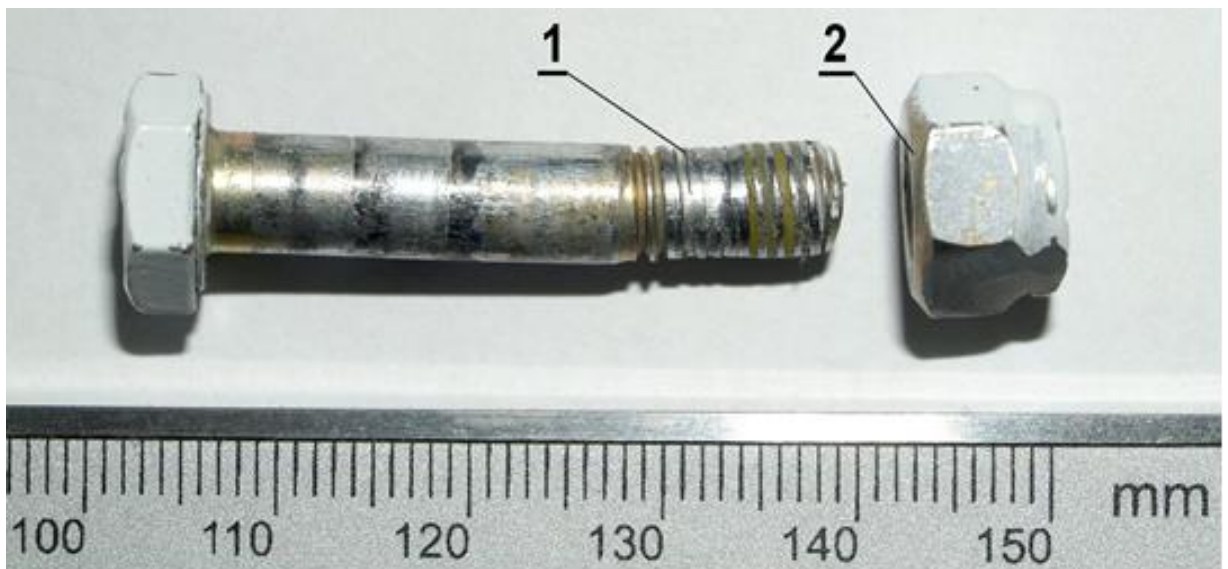
Bolt and self-locking nuts submitted for investigation

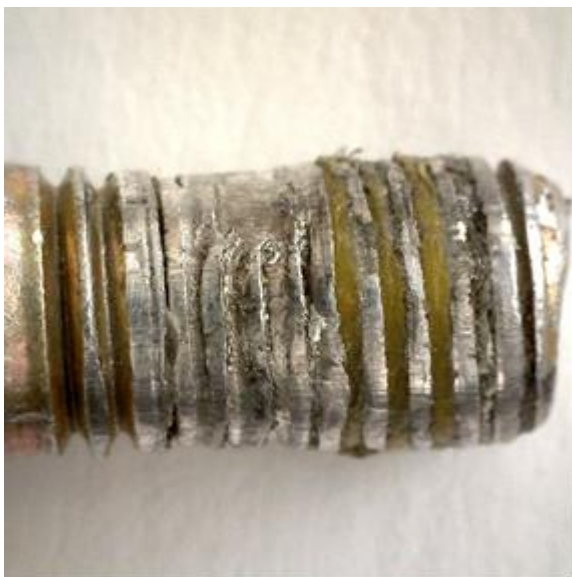
Detail view of the damaged bolt thread

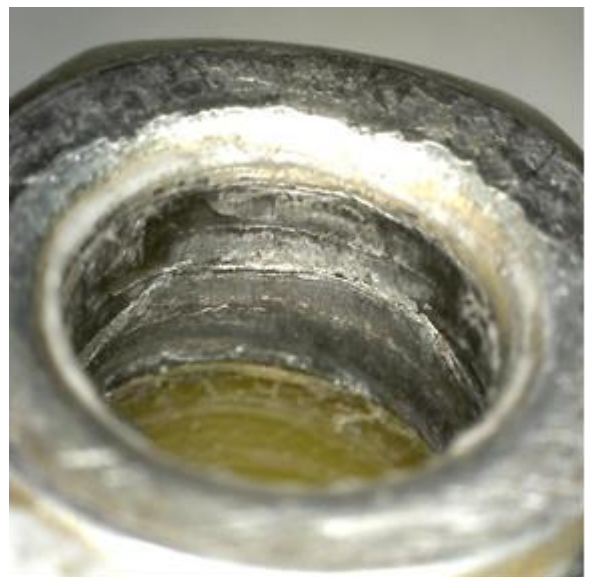
"Smoothed" internal nut thread

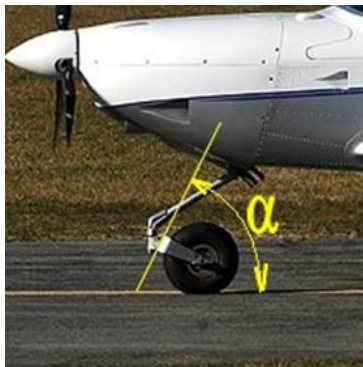
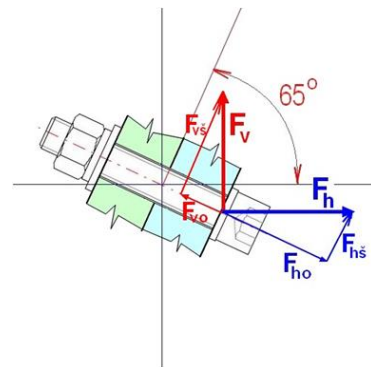
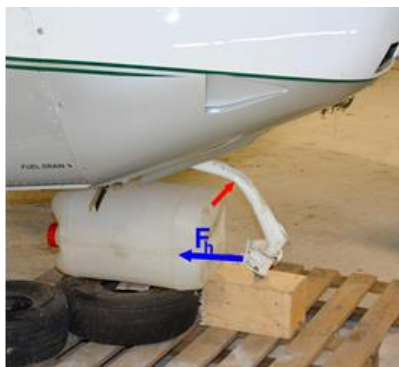
From the perspective of strength, the investigated bolt and nut complied with the declared hardness for AN174-12A bolts and AN365-428 nuts. Damage to the relevant bolted connection between the landing gear leg and the fork therefore did not occur due to insufficient strength of the materials of the bolts and nuts (provided that the remaining five bolts and nuts had comparable mechanical and strength properties), but due to overloading the relevant joint with an excessive load.

At the time of damage, the relevant bolted joint was overloaded with horizontal backward force as demonstrated by the actual bending of the landing gear leg backwards.
