AVIATION AND MARITIME INVESTIGATION AUTHORITY
Námestie slobody 6, P.O.BOX 100
810 05 Bratislava

FINAL REPORT

on the safety investigation of the air accident
of aircraft type **DA-40 D**
with registration mark **OM-SCS**

Reg. No.: SKA2017004

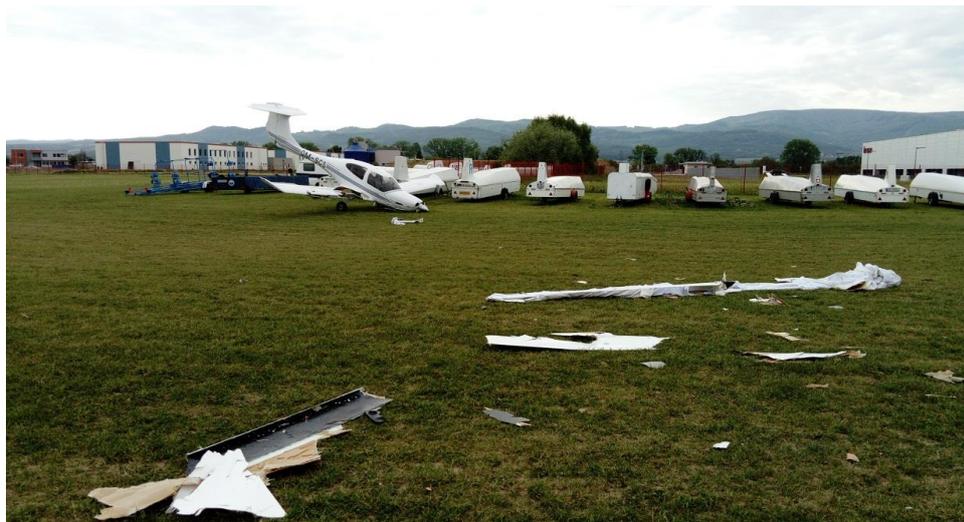
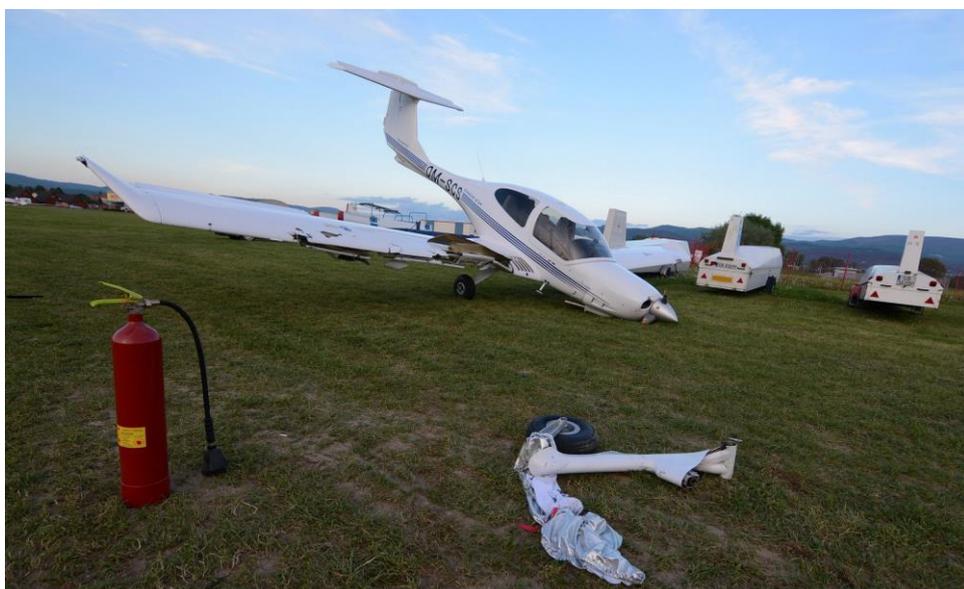
OM-SCS was destroyed during the aviation event:

- broken propeller blades, destroyed engine covers, important parts of the engine damaged, deformed structure of engine mount, damaged anti-fire wall, damaged attachment of the right wing to the aircraft body, main landing gear deformed, front landing gear leg broken off the aircraft body and broken in the place of attachment, casings for attachment of the landing gear pulled out of the support structure of the aircraft body, broken tail unit, damaged board devices due to their intensive overloading.

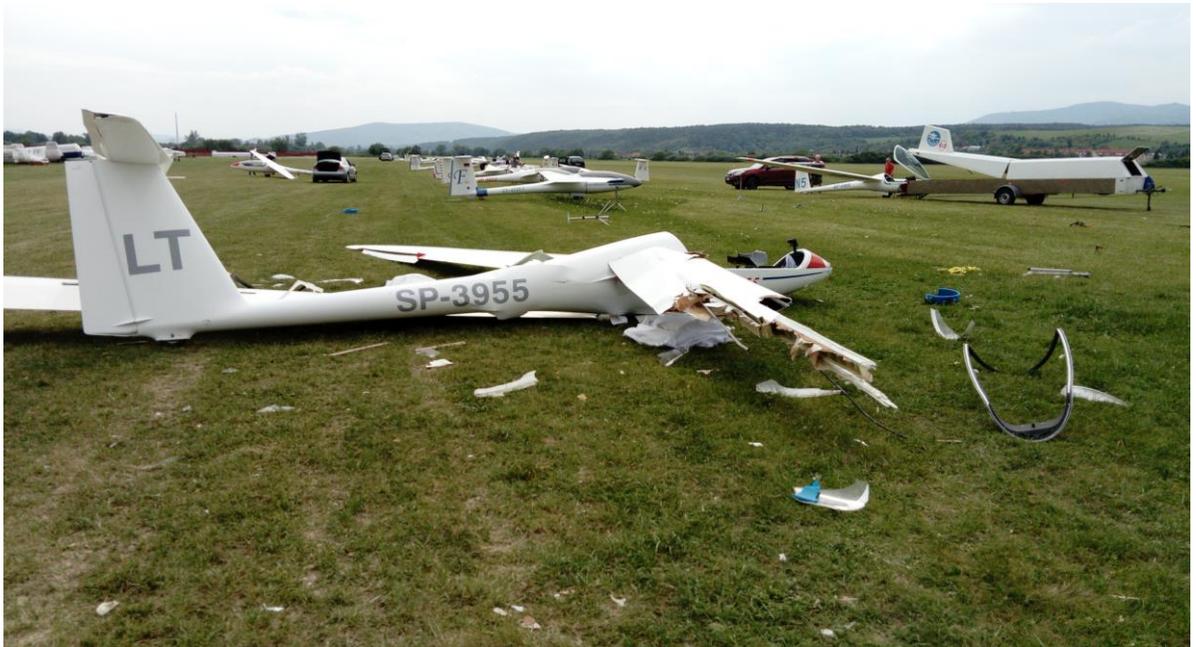
SP-3955 – destroyed

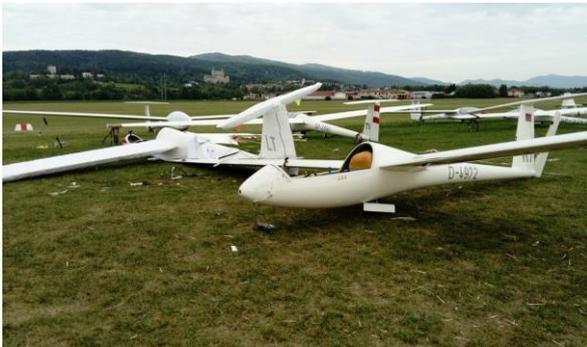
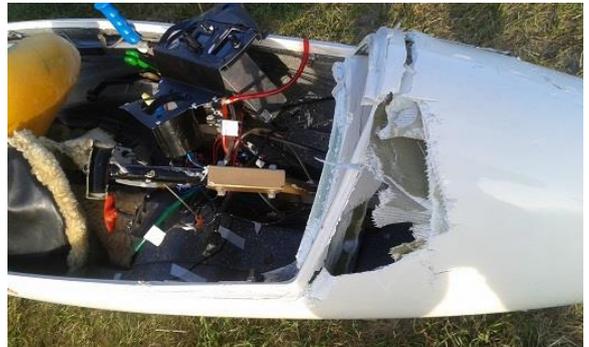
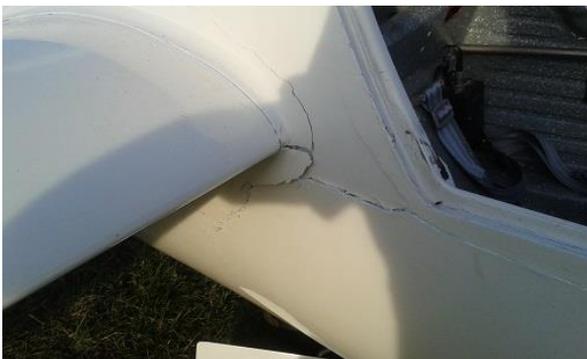
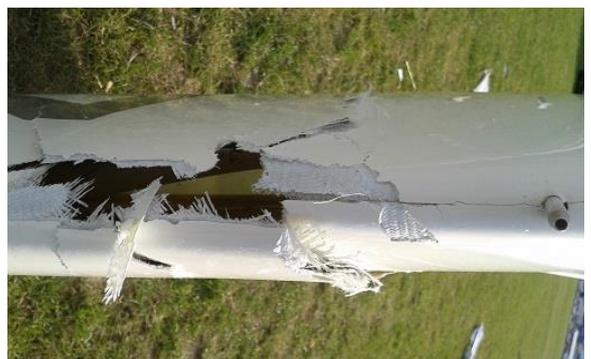
D-4972 – destroyed

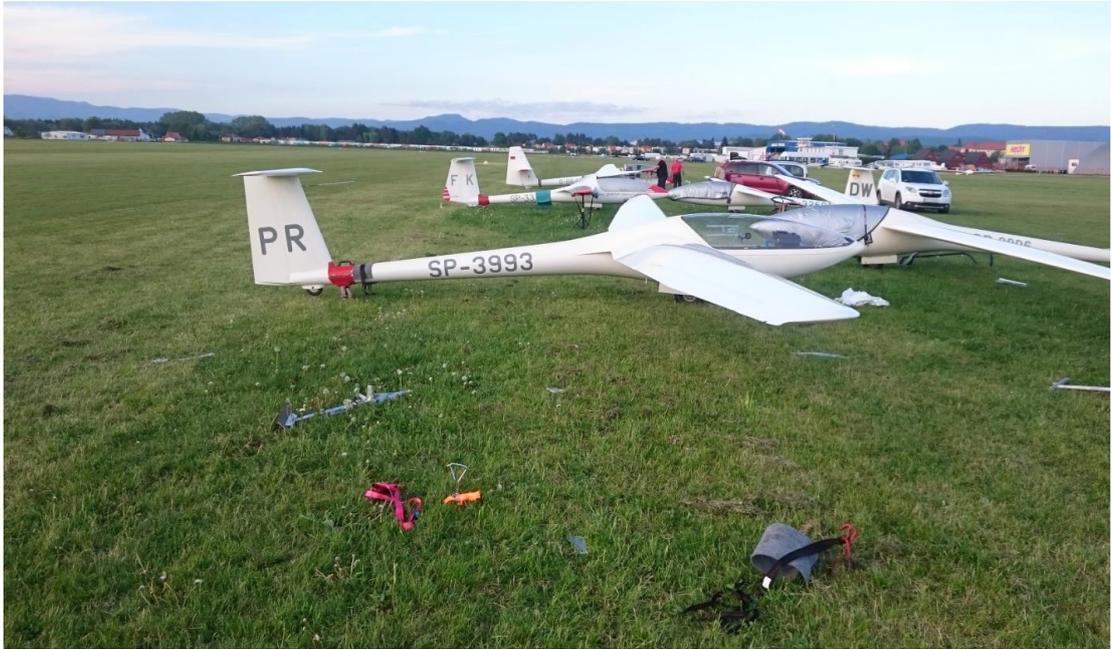
SP-3993 – substantial damaged

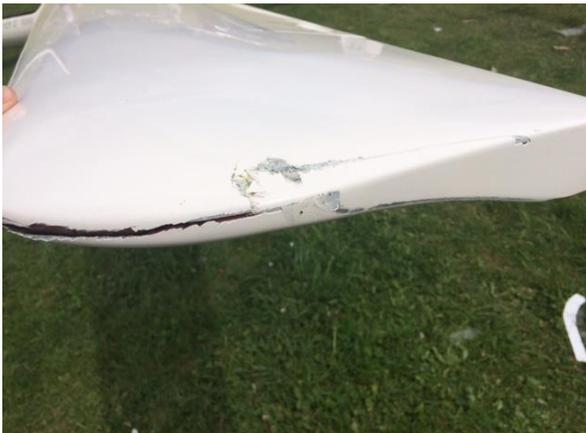
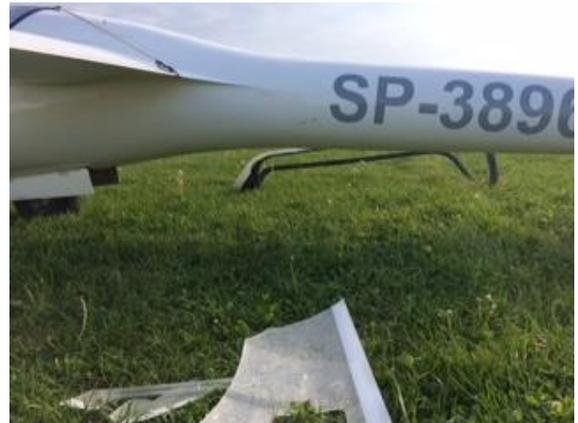
SP-3896 – damaged

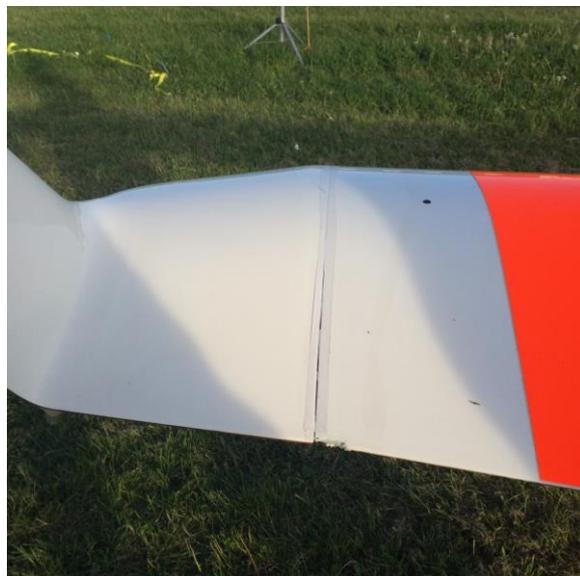
SP-3968 – damaged

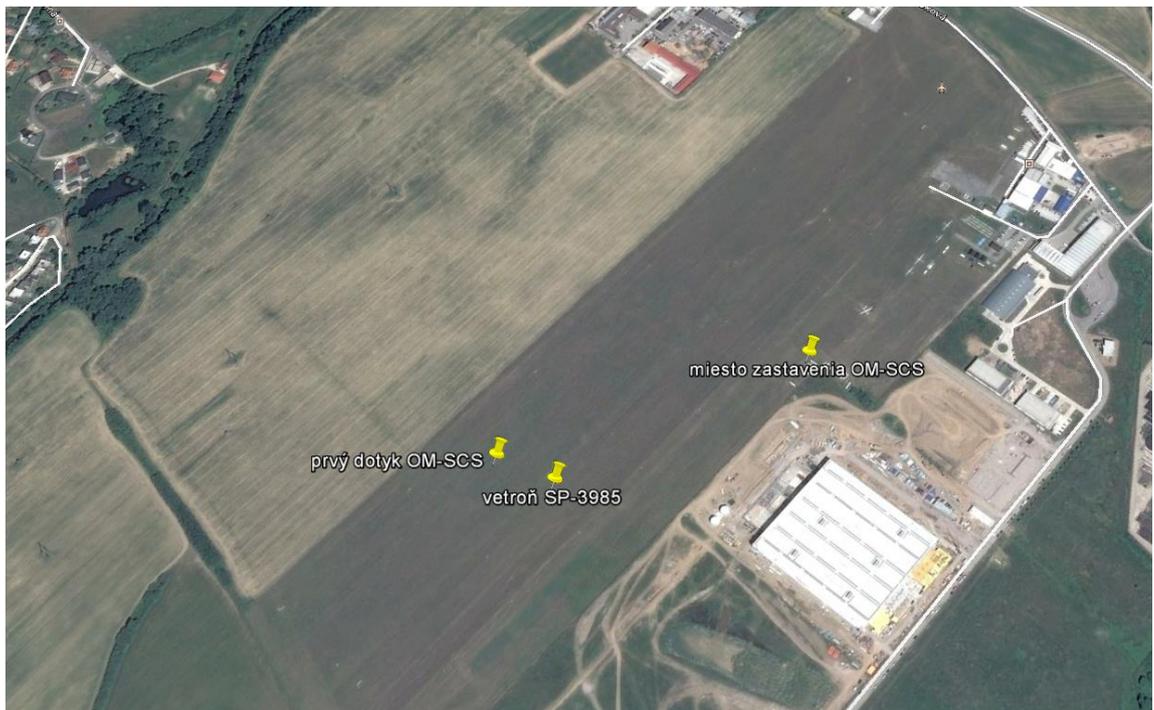
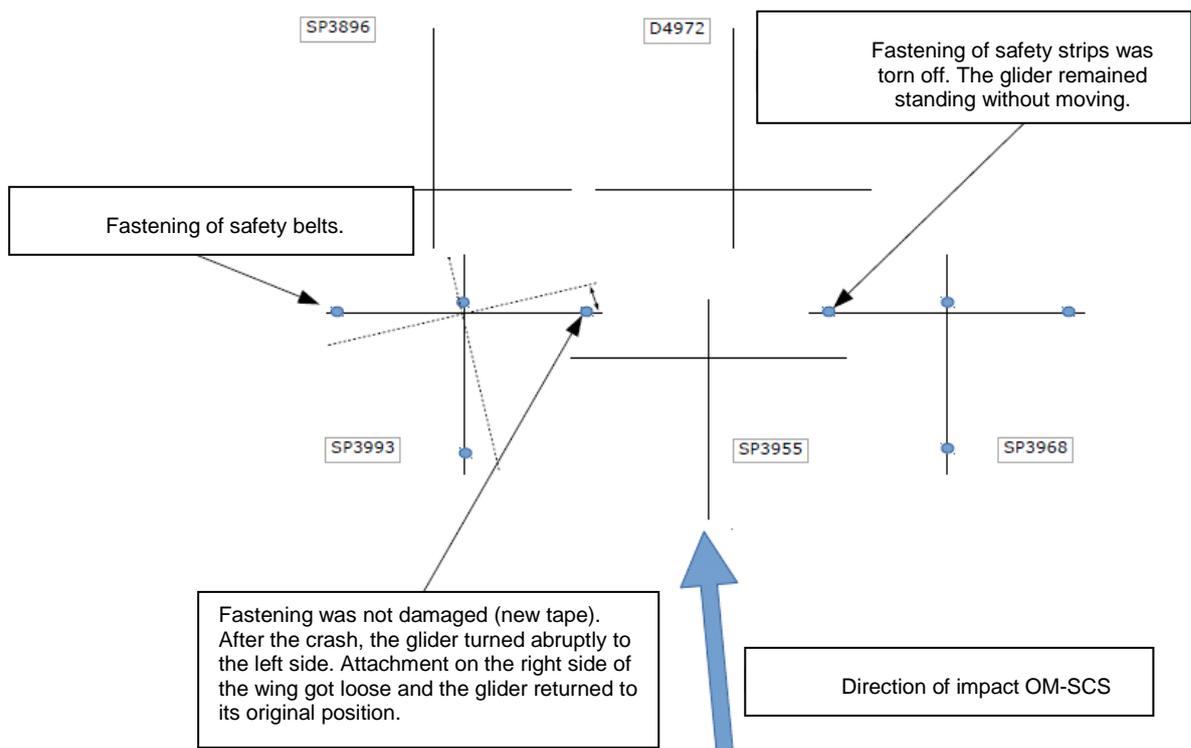
Glider position after landing SP-3985 48°45'52.00"N, 18°35'08.00"E

OM-SCS first contact with RWY 48°45'52.93"N, 18°35'04.81"E

Place of OM-SCS' stopping 48°45'57.21"N, 18°35'21.48"E
