FINAL REPORT

on the safety investigation of the incident
of aircraft type **Boeing 737-500**
registration mark **SU-GBK**

Reg. No: **SKI2017137**

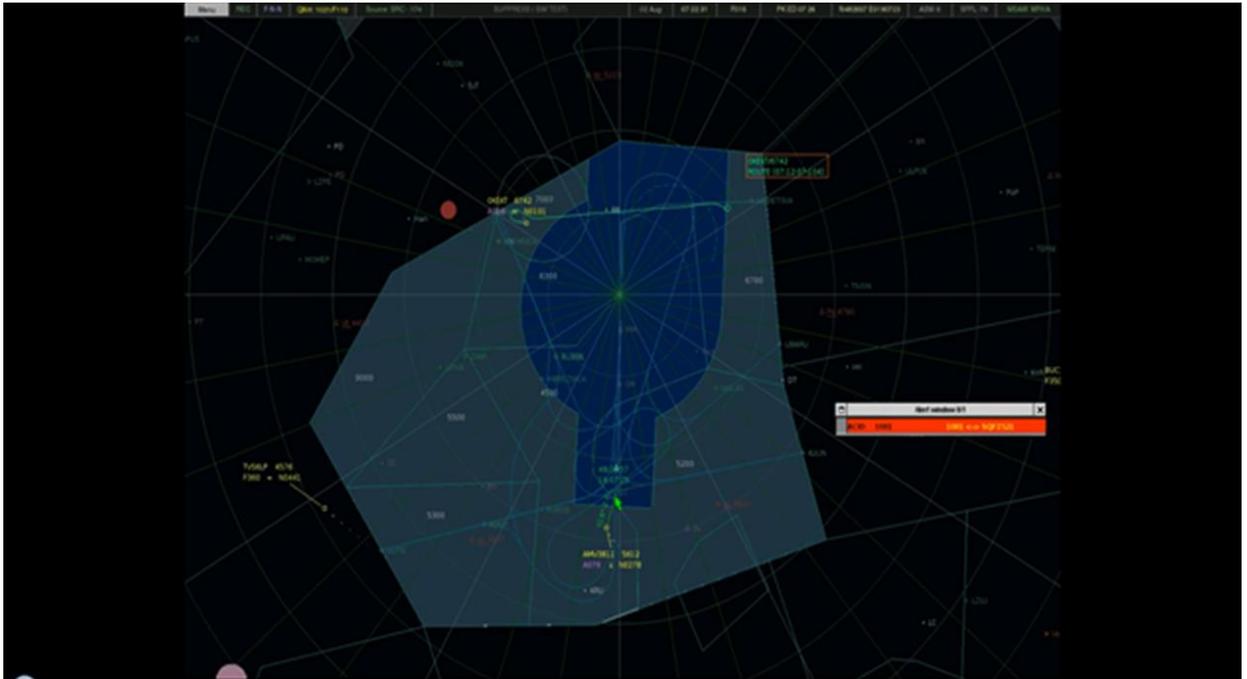
Picture 1 At 07:22:31, AMV3811 confirms being established on the LOCALIZER, altitude A076, speed IAS 278

However, according to the RC APP's statement, after the crew reported being established on the LOCALIZER, the aircraft was flying faster and at a higher altitude. According to the pilot, the aircraft was descending at 3.5° and landed at a speed of 175 kt.

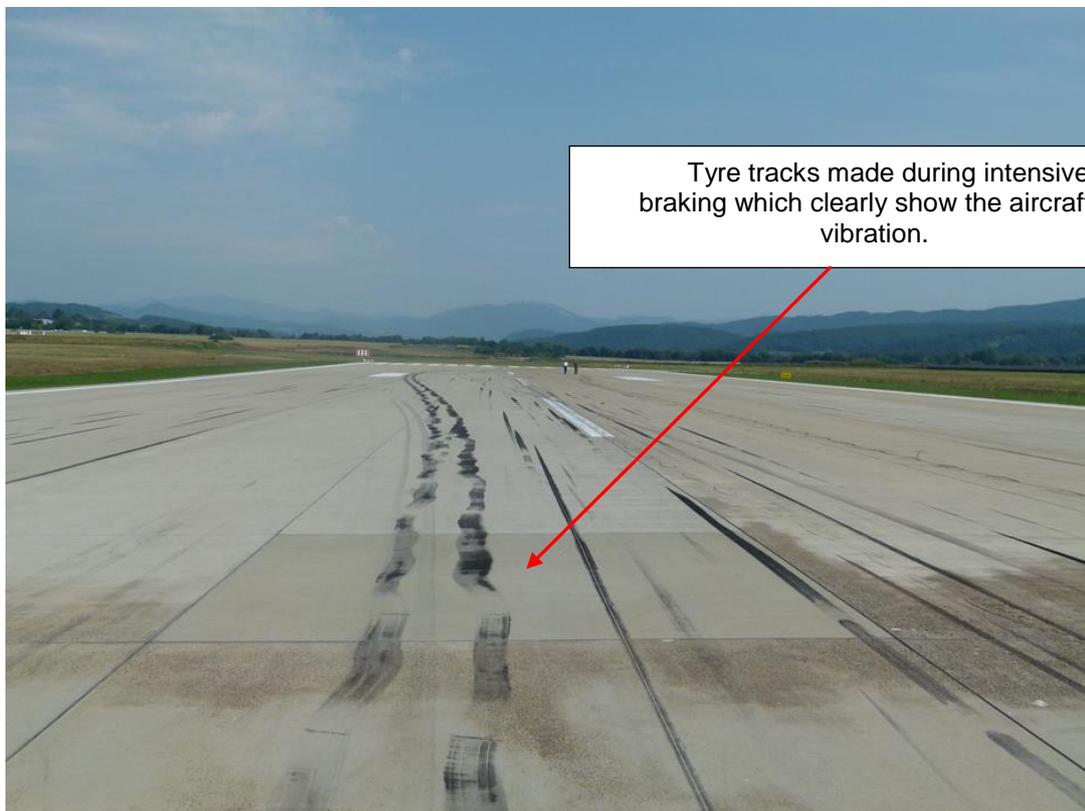
At 07:26, AMV3811 landed at a higher speed – 175 kt (according to the pilot's statement); the aircraft first touched the RWY 1,090 m from the THR (according to the tyre tracks on the RWY). After landing, the pilot started braking intensively, using the maximum braking effect, which caused the aircraft to vibrate; several parts dropped out of the main landing gear area and smoke started spreading from the wheels which the crew was notified of. After the aircraft braked, it made a U-turn and stopped on the RWY as instructed by the PC.

Picture 6 Tracks proving intensive braking

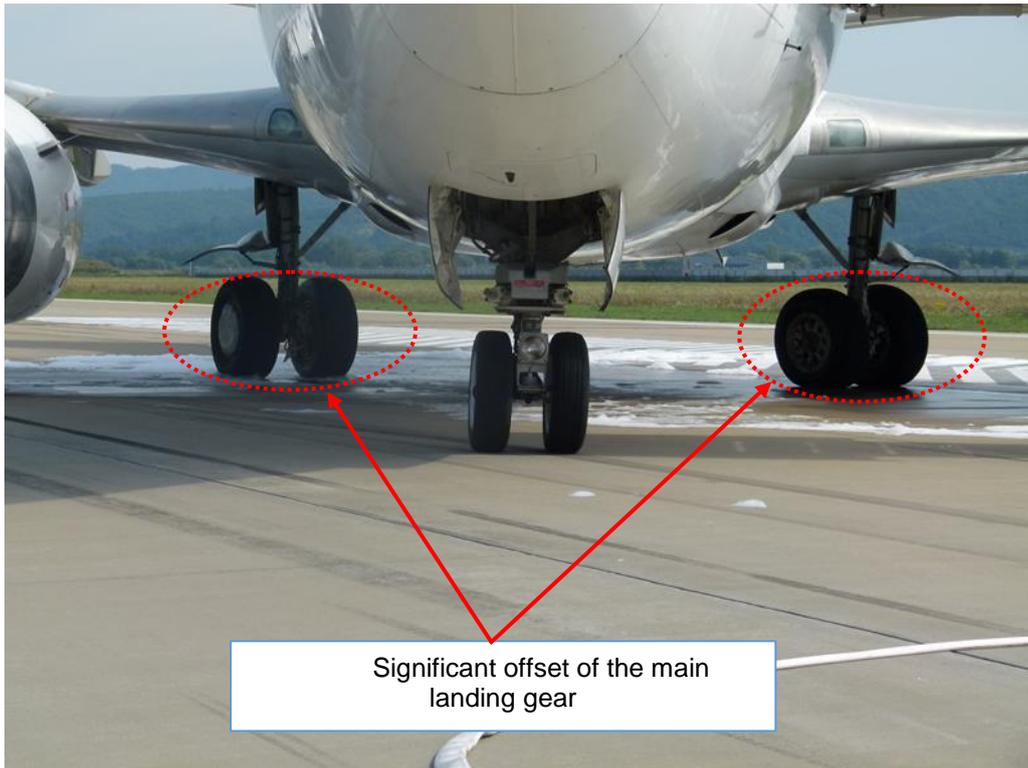
Its landing on RWY36 LZSL was performed at a higher speed (touch-down point: 1,090 m from THR RWY36). After landing, the crew braked intensively, causing vibration of the aircraft and subsequent damage to the landing gear and to the tyres. Both main landing gear legs were damaged during the landing roll. In this phase, the PC TWR spotted dense smoke behind the aircraft coming from the landing gear area.

Picture 7 Offset of the main landing gear

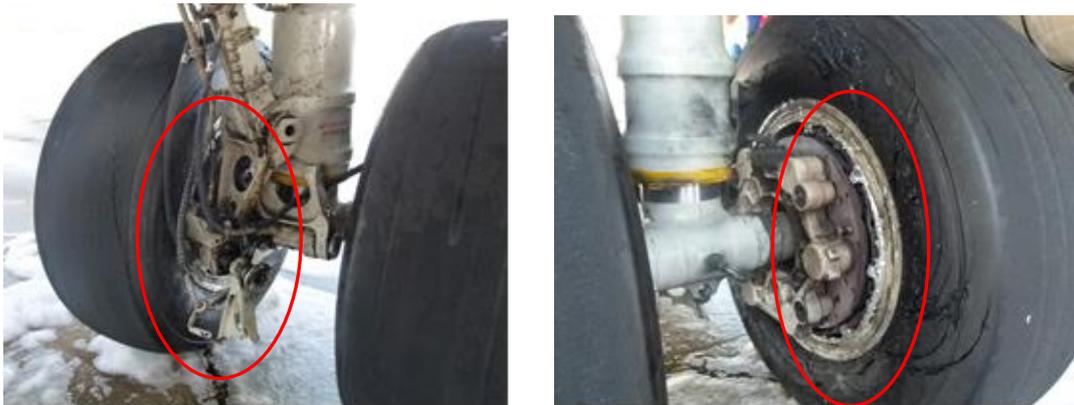
As a result of the intensive braking, the aircraft was damaged in the area of the landing gear and the tyres.

Picture 8 Details of the damage to the main landing gear

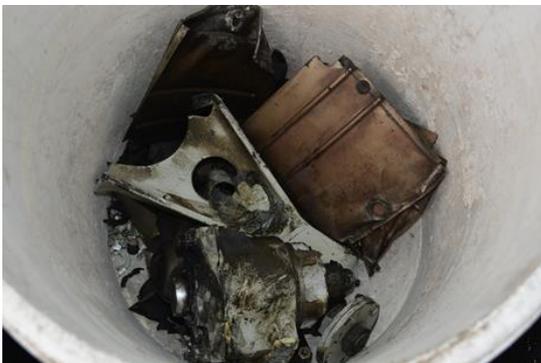
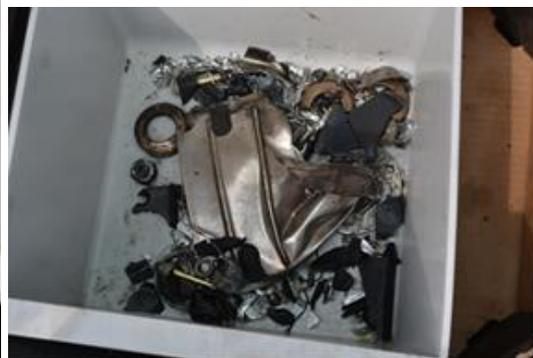
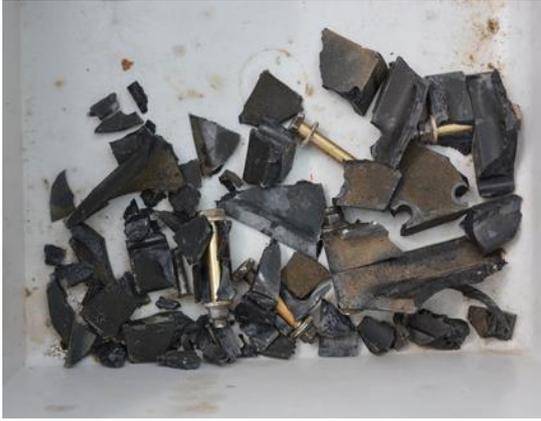
Picture 9 Fragments of landing gear components found on the RWY

Picture 10 Fragments of landing gear components found on the RWY

Picture 11 Fragments of landing gear components found on the RWY

Pictures 9, 10 and 11 show individual parts coming from the main landing gear which were found on the RWY.

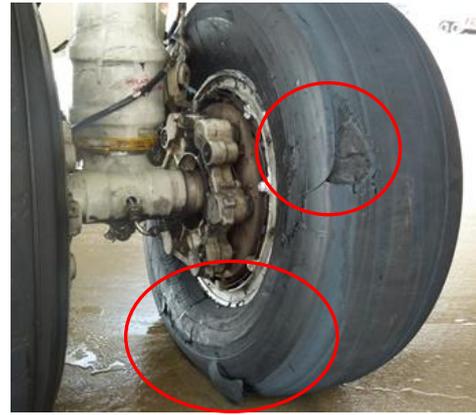
Picture 12 Detail of a damaged tyre

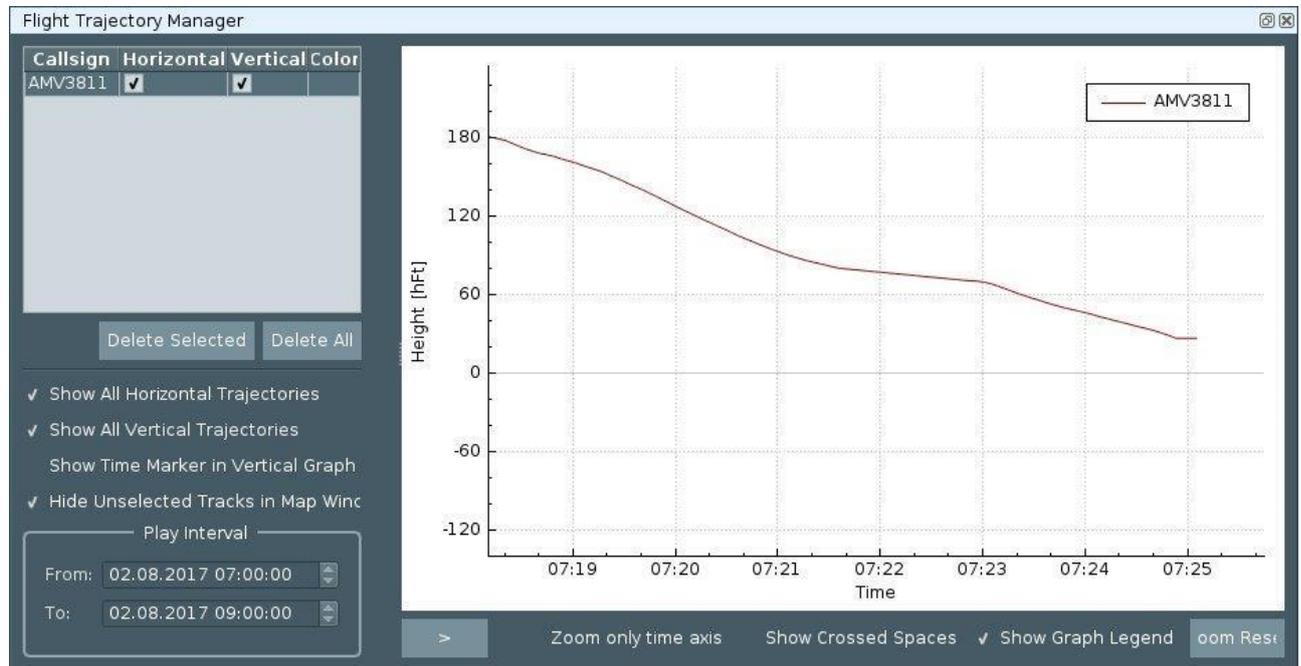
Picture 13 Vertical descent mode

When trying to shorten his approach, the pilot did not adhere to the determined altitudes stated on the instrument approach map and he was above the mode/above the glide slope during the entire period of his descent from FAP DME/SLC where he was supposed to be at 4,500 ft. According to radar records, at this point the aircraft was at 6,300 ft.

Then, the aircraft was supposed to descend at 3.5°; however, according to radar records, the angle of its descent with regard to the touch-down point ranged from 5.2° to 6.3° during the final phase of its descent between points FAP and OM.

it is our proposal to adopt internal measures to ensure that, during a non-stabilized approach, crews make a timely decision to perform a missed approach procedure;
