FINAL REPORT

on investigation of air accident
of aircraft **WT-9 Dynamic Club T**
registration No. **OM-PDA**

Date: 17.04.2012

Place: Prievidza Airport / LZPE

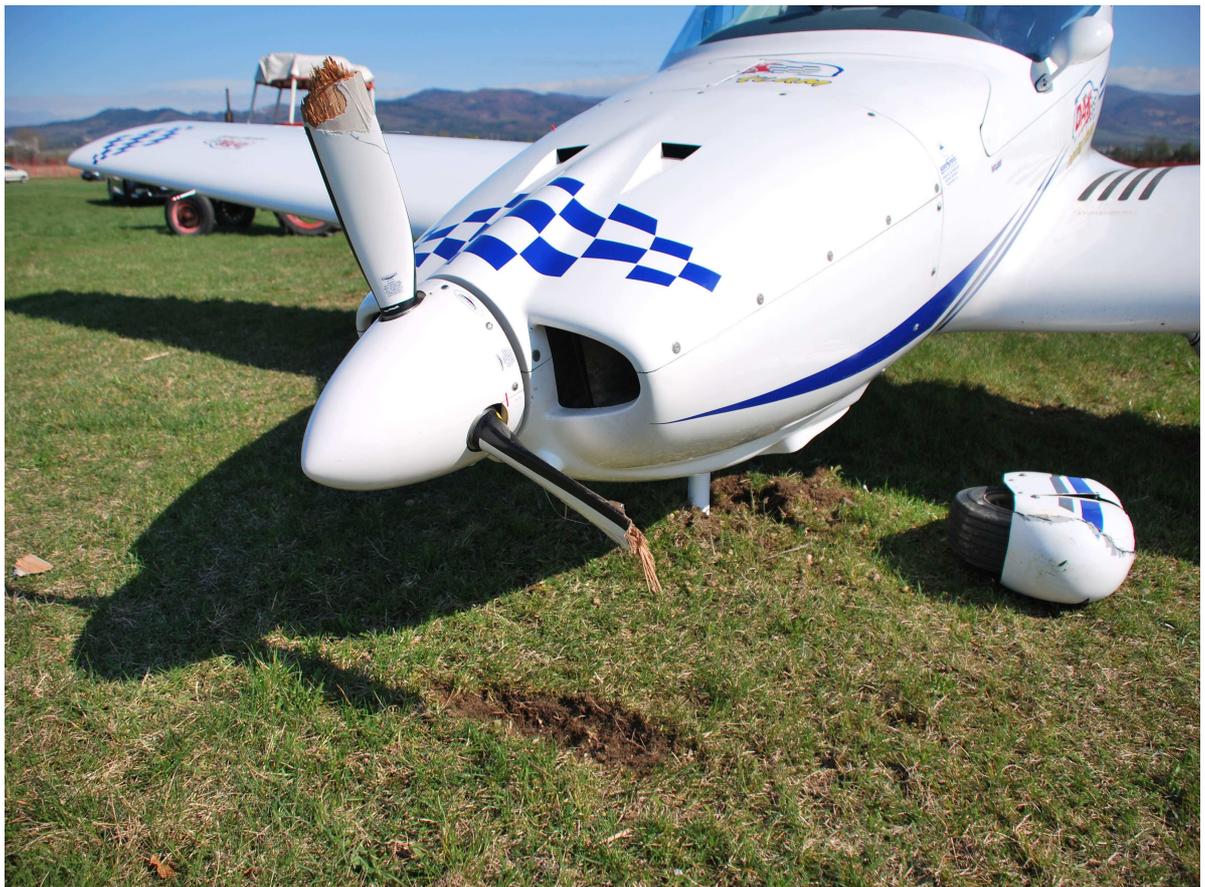
After the collision of the rotating propeller with the ground all the three propeller blades broke off in one third of the length of the propeller blade shank, the engine was stopped by force, and the fork of attachment of the front landing-gear leg wheel and the aerodynamic covers of the nose landing gear got broken.

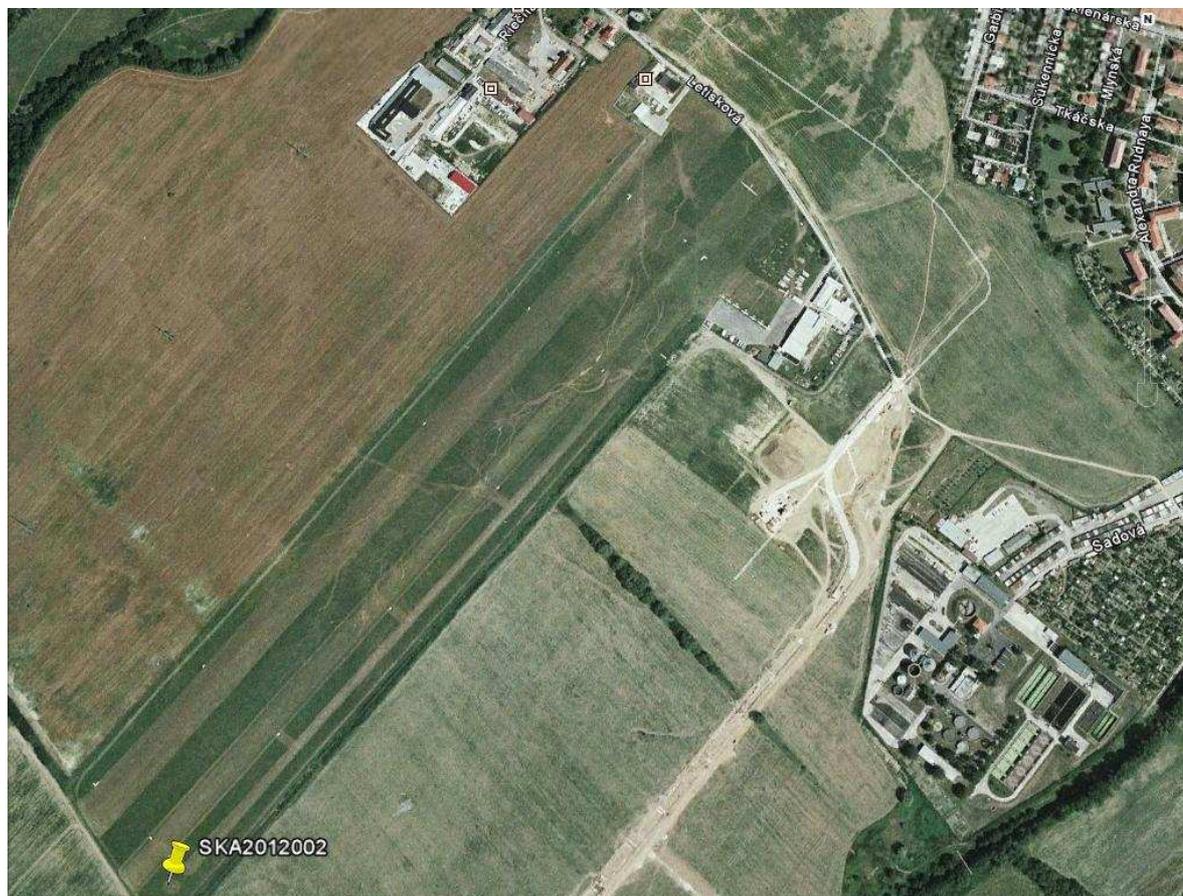
The place of accident is situated on the safety strip („SS“) of airport LZPE.

The final position of the aircraft after the air accident was documented, including preparation of photodocumentation.

The place of accident is delimited by coordinates: N 48°45'44,12", E 018°34'59,29"

- to check the non-reinforced areas of the airport safety strip for obstacles in the form of dug out holes before the start of the flight day.
