Reg. No. SKA2012003

FINAL REPORT

on investigation of air accident
of aircraft **DIAMOND DA40-180**,
Registration No. **OM-KLO**

Place: Airport of Holíč / LZHL

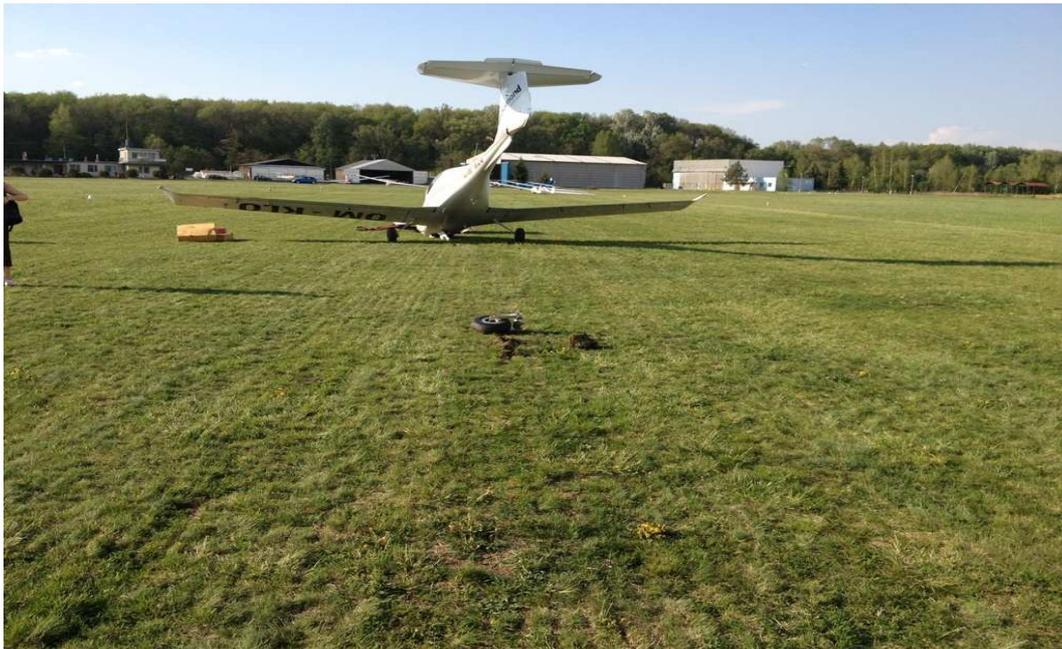
Breakage of tube of the front landing-gear leg

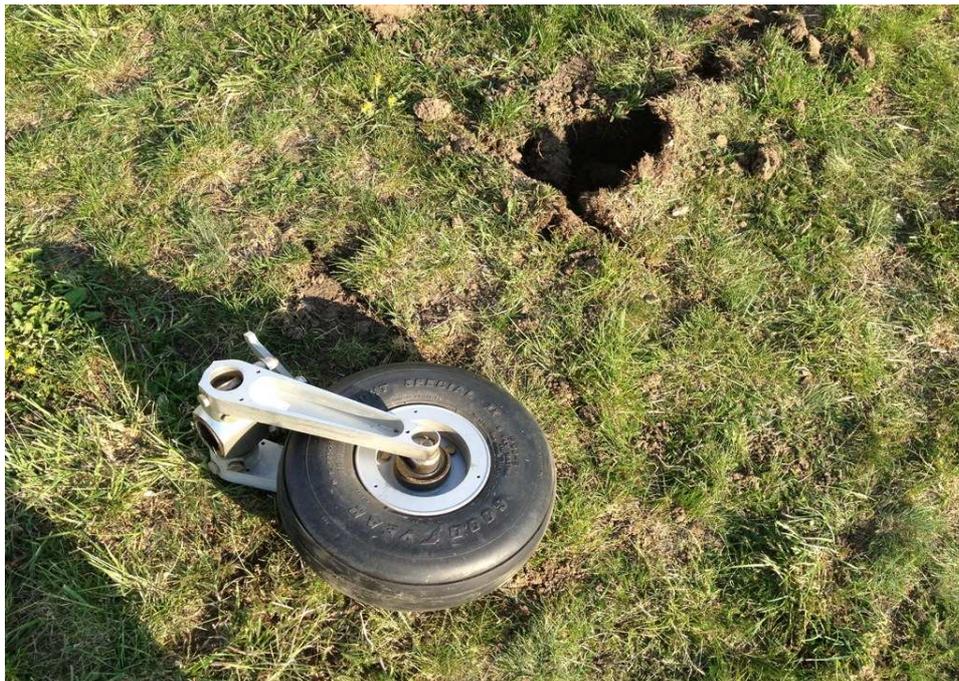
Breakage of fork and wheel of the front landing-gear

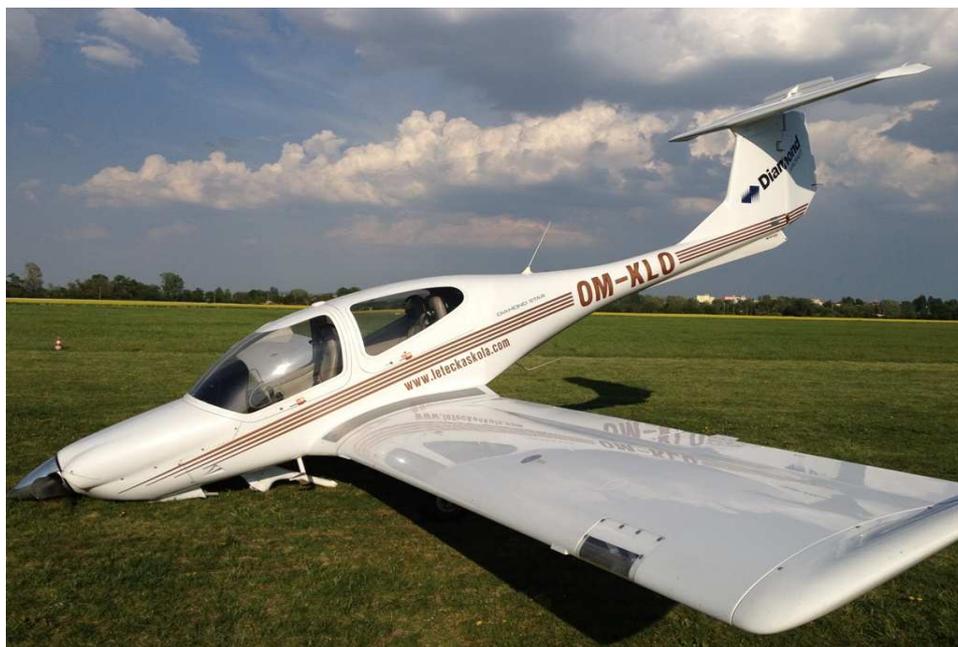
Breakage of the front landing-gear leg, damage to propeller and engine of aircraft

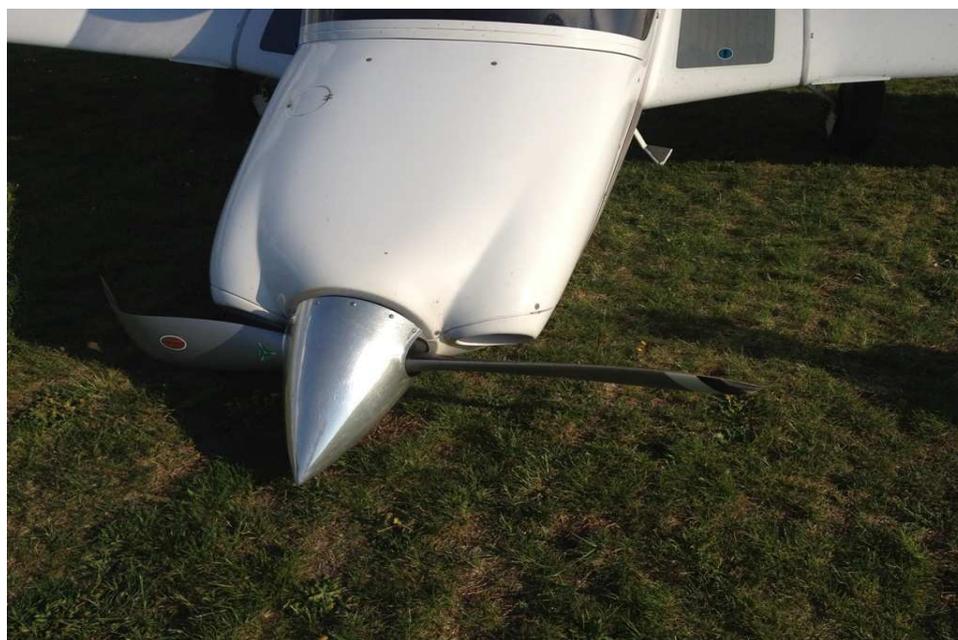
Damage to propeller and engine caused by violent stoppage when the propeller touched the ground.

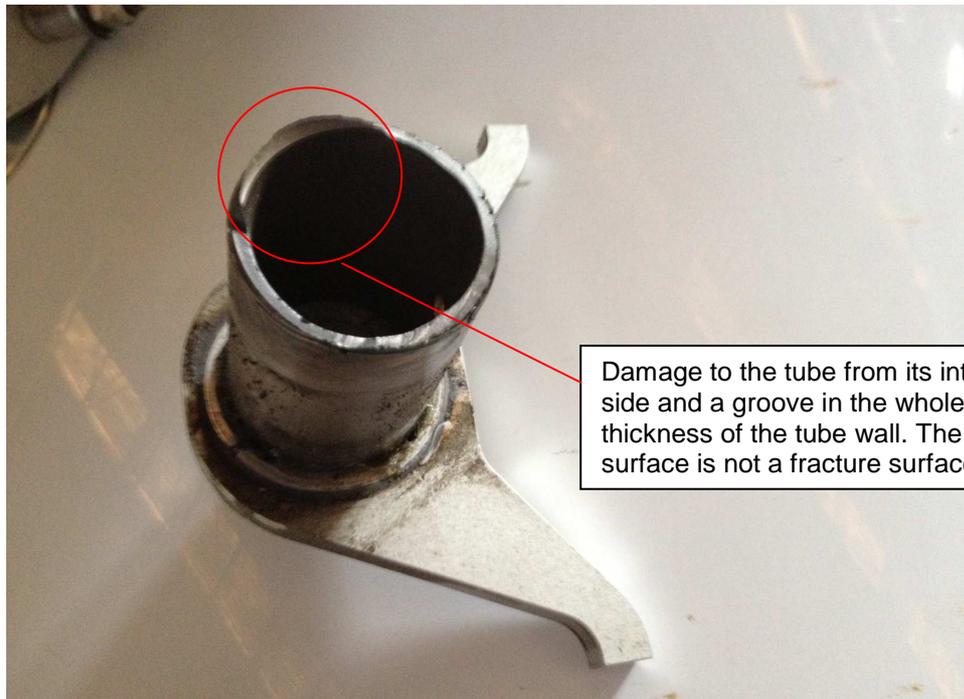
The steel tube of landing gear at the point of cranking – joint was broken in full profile, which caused the breaking off of the fork with wheel of front landing-gear leg.

More detailed inspection showed that the said tube was damaged on the internal side - groove almost in the whole thickness of the tube wall. The groove surface was provided with the same surface finish as the internal wall of the tube.

The damage to the tube wall seemed to be an error in construction of the landing-gear tube. After detection of this error the tube was sent for expertise to the Institute of Criminology and Expertise of the Police of SR.

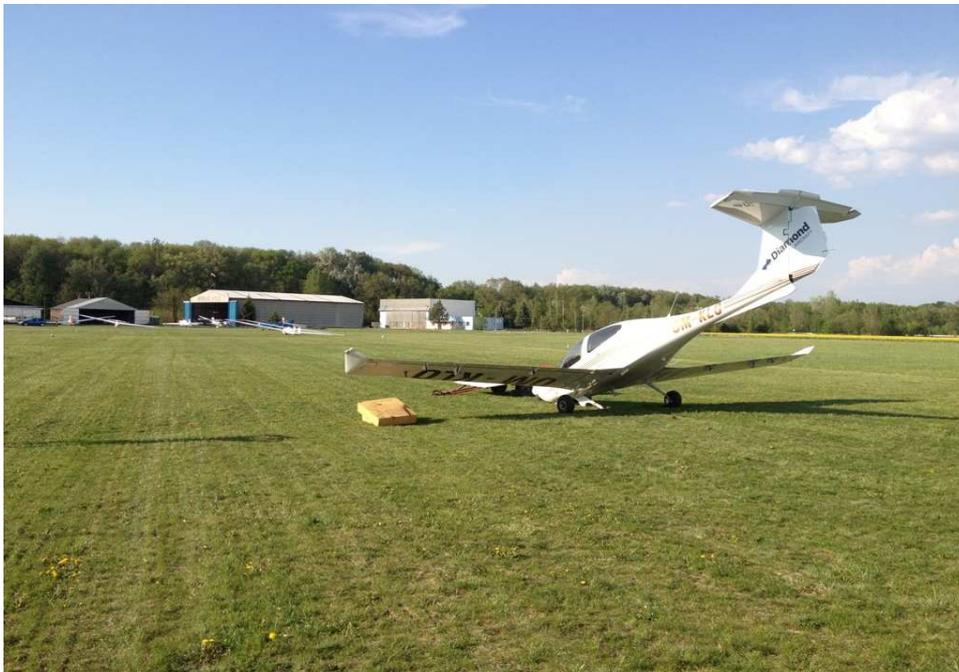
Position of aircraft – runway of LZHL in the direction to the parking area.

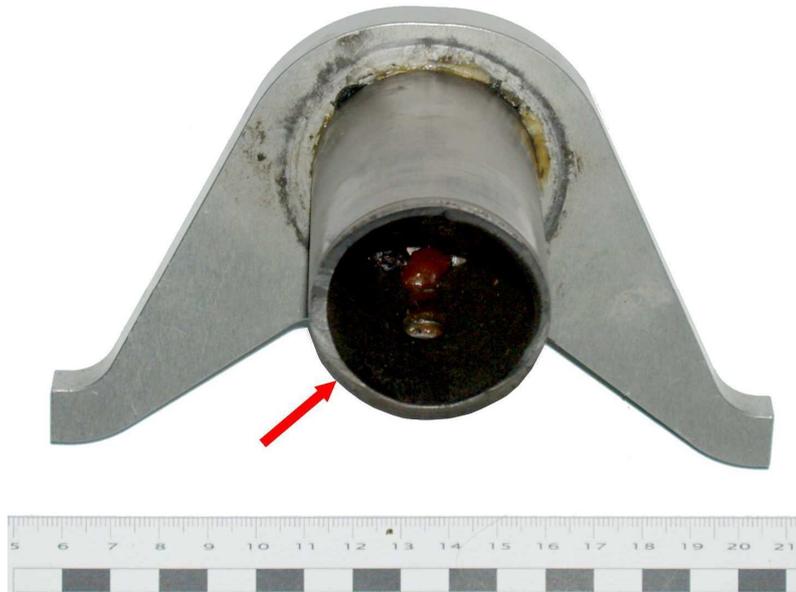
A fracture was detected across the entire circumference of submitted hollow axle with external diameter \varnothing 45 mm and wall thickness of 3.5 mm (fig.1).

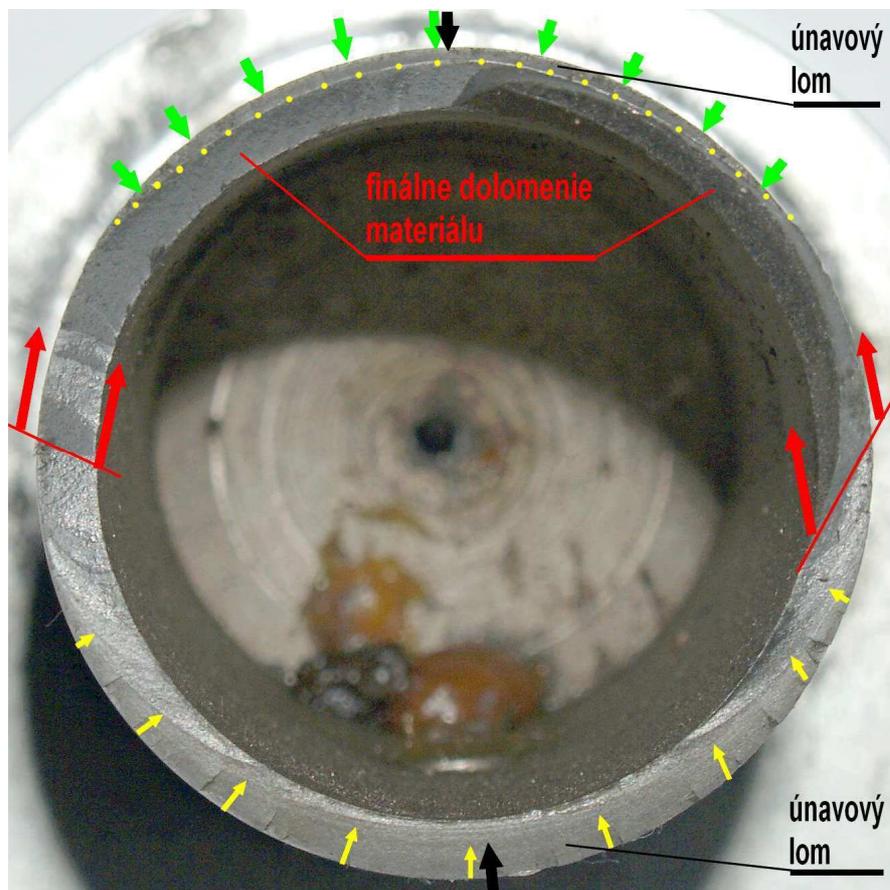
a) fatigue fracture was initiated on two opposite sides of the circumference of the axle (see the positions of black arrows on figure 2). One side of the axle showed much larger scope of fatigue damage – the lower main part of fatigue fracture shown on figure 2 covered about a half of total fracture surface, while the upper part of fatigue fracture accounted for a small part of the total fracture surface (see the distribution of fatigue fracture and the area of final rupture of material (fig. 2).

Fig. 2 Overall view of fracture surface on the axle

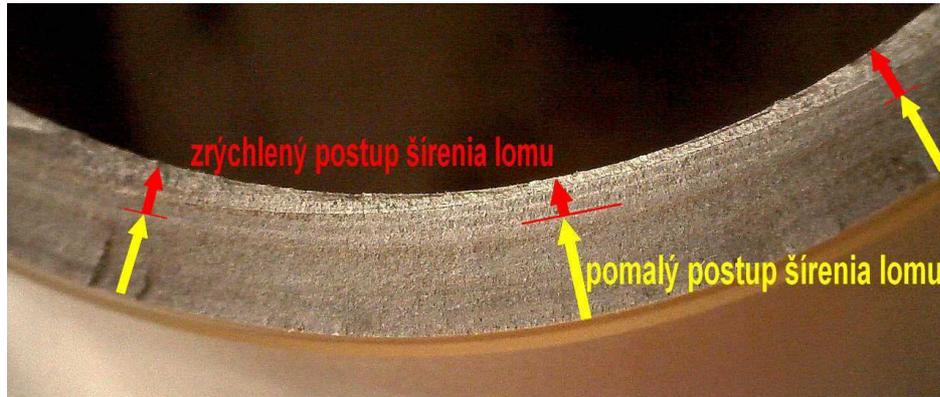
b) in the initial phase the fatigue fracture increased very slowly and its progressive formation was not grossly visible. With gradual reduction of the carrying section of the axle wall the fracture progressed faster and bands of its propagation started to be visible also by standard macrographic examination (fig. 3),

Fig. 3 Main part of fatigue fracture and visible differences in the speed of fracture propagation

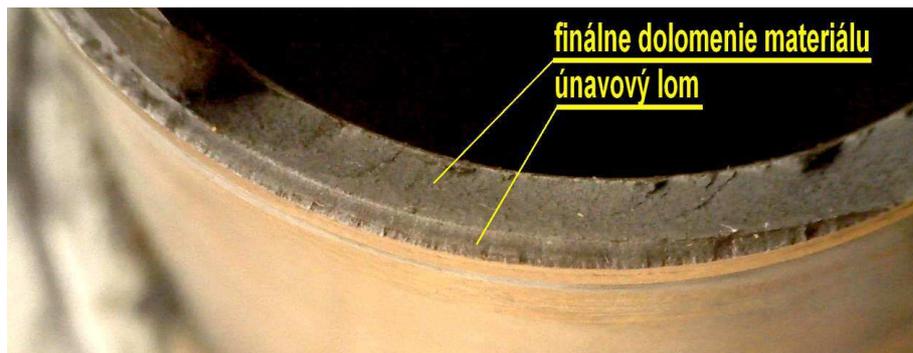
c) the smaller opposite part of fatigue fracture did not make it to pass through the whole axle wall and a major part of the material section in this area of axle was damaged by the mechanism of final material rupture (fig. 4a, fig. 4b and fig. 4c).

Fig. 4a Smaller opposite part of fatigue fracture and bevelled area of final material rupture

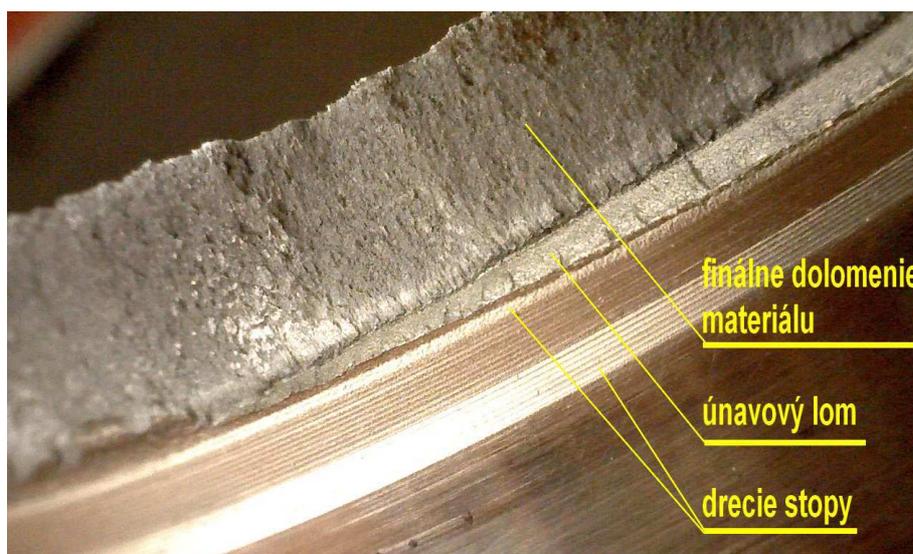
Fig. 4b Smaller opposite part of fatigue fracture and steep-incline area of final material rupture.

d) In the area of development of fatigue fracture abrasion marks were found on the peripheral wall of the axle (see fig. 4b). These marks represented certain continuous micro damage to the axle surface, which served as stress concentrators in the upper layer of the axle within the triggering mechanism of fatigue process of material damage.

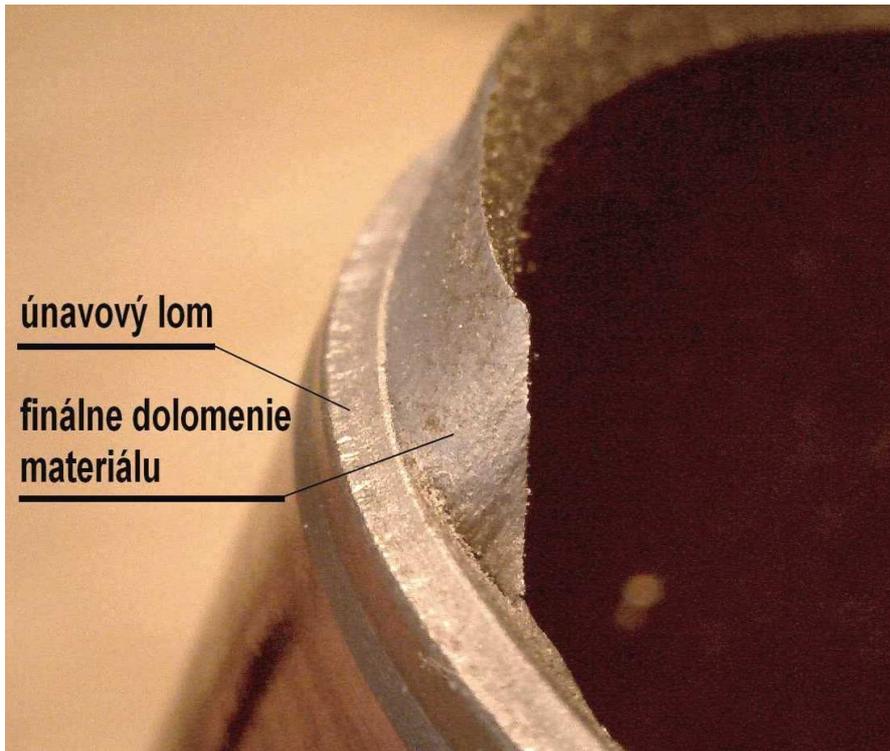
Fig. 4c Side view of the area of final material rupture with visible steep inclination of fracture surface

g) Steep gradients of fracture surfaces in the area of final material rupture are not caused by occurrence of a material anomaly in these areas. They were formed in this shape due to damage caused to the material in the final phase by shear mechanism at so-called bending pressure.

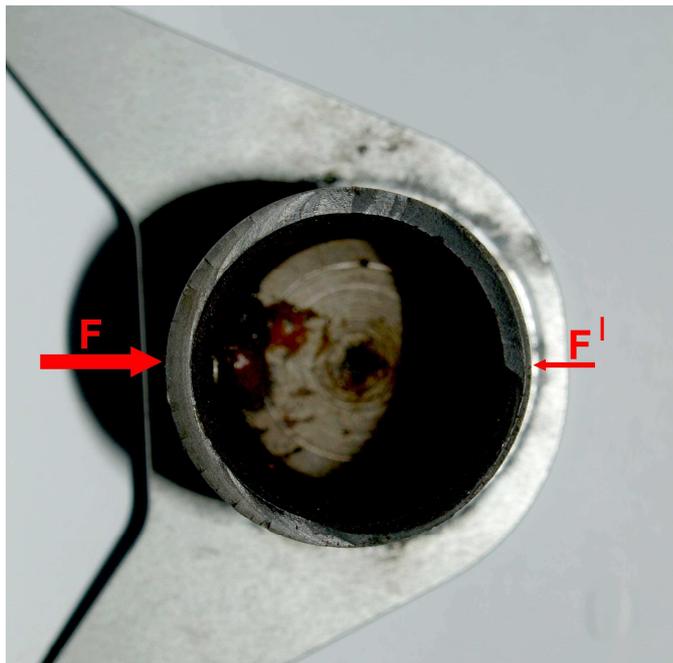
e) the existence of two opposite sections of fatigue fracture with different size proves that the axle was exposed to alternate variable stress, where amplitudes of stress in one direction were much larger and probably more numerous than amplitudes of stress in the opposite direction ($F \gg F^I$ - fig. 5),

Fig. 5 Direction of forces loading the axle upon formation and development of fatigue fracture

- if forces F and F_I (fig. 5) acted in the horizontal plane or the force F slantly upwards, this loading stems from impacts of the wheel to obstacles and bumps of natural landing surfaces (large clumps on grass surfaces of airports, etc.).
- if contemplated forces F and F_I acted in the vertical plane, damage to the axle would be triggered by impacts of the wheel on the solid subbase during landing of aircraft on the runway.

From the fact that a large part of the fatigue fracture is practically smooth without visible progress bands it results that the fracture occurred at a large number of loading cycles (so-called high-cycle fatigue) and relatively low normal load. From this perspective the variant a) is much more probable than variant b). A much larger number of impacts of the wheel to bumps on natural runways (at start or landing of aircraft) as compared with vertical dynamic forces during aircraft landing can be namely expected.

To implement its own measure to enhance regular checks and to keep records beyond the scope of the binding decision of EASA AD 2009-0016 and in accordance with the procedure of the binding bulletin of DAI MSB40-046/3 (DAI MSB D4-046/3)

in cases where the aircraft operation is implemented prevalingly from a non-reinforced grass RWY, where a larger number of impacts of the front wheel to bumps of natural RWY may cause fatigue fracture and subsequent rupture of the front landing-gear axle of aircraft.
