FINAL REPORT

on investigation of air accident

of aircraft **3Xtrim 450**

Registration No. **SP-YPL**

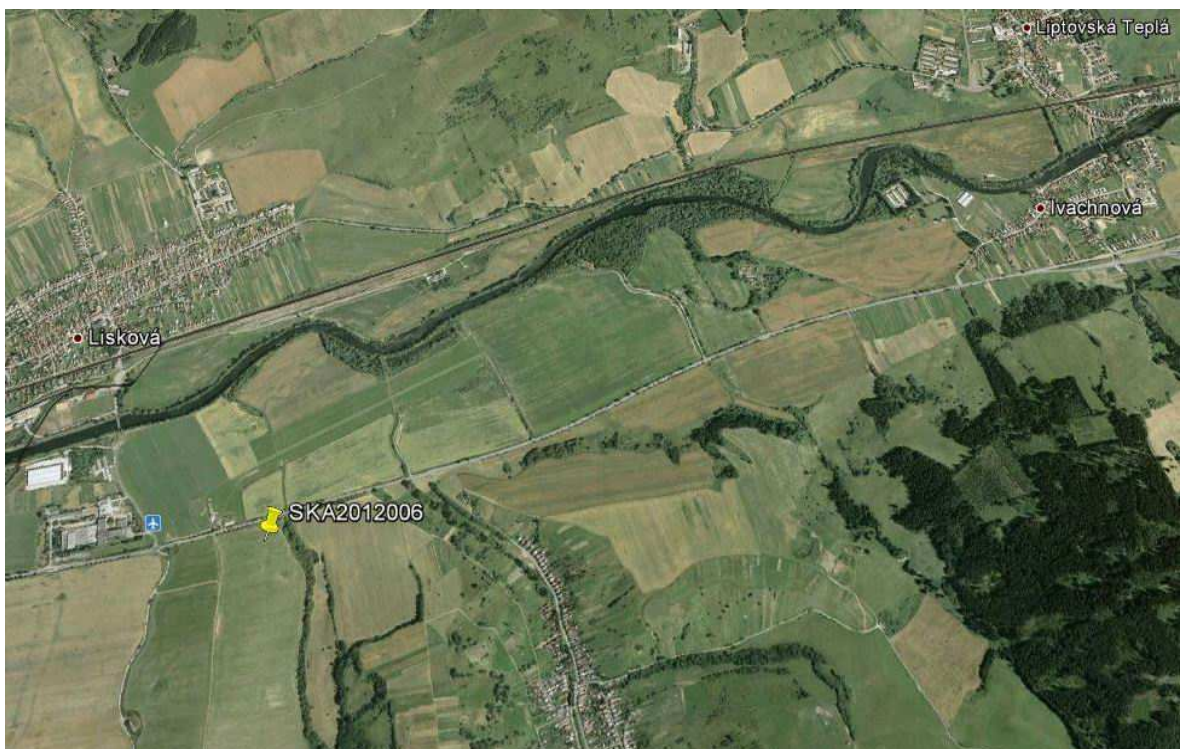
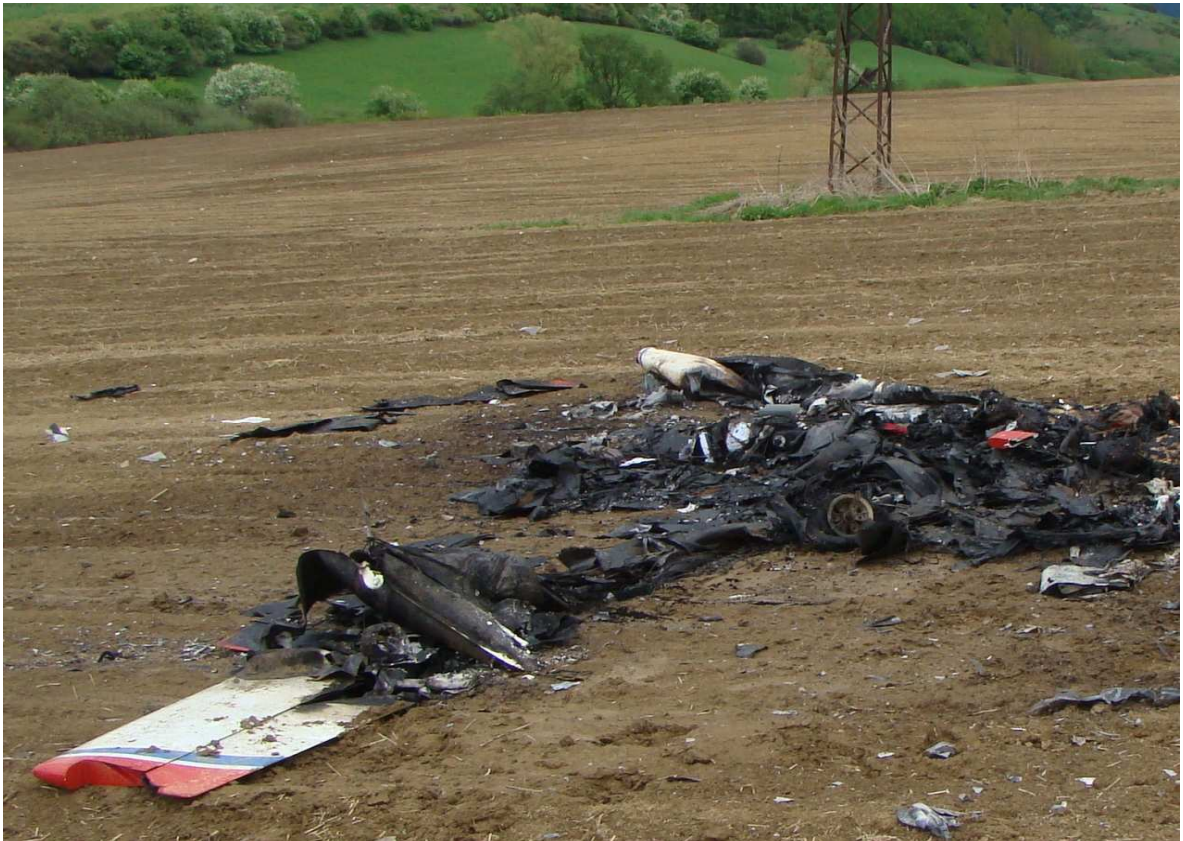
After impact to the ground the aircraft came to a standstill in the tilted-forward position, caught fire and burnt down completely.

The final position of the aircraft after the air accident was documented, including the photo documentation.
