FINAL REPORT

on investigation of air accident
of aircraft **Standard Cirrus**
registration No. **OK-8918**

Date: 20.05.2012

Place: 0.6 km east of the community Istebné

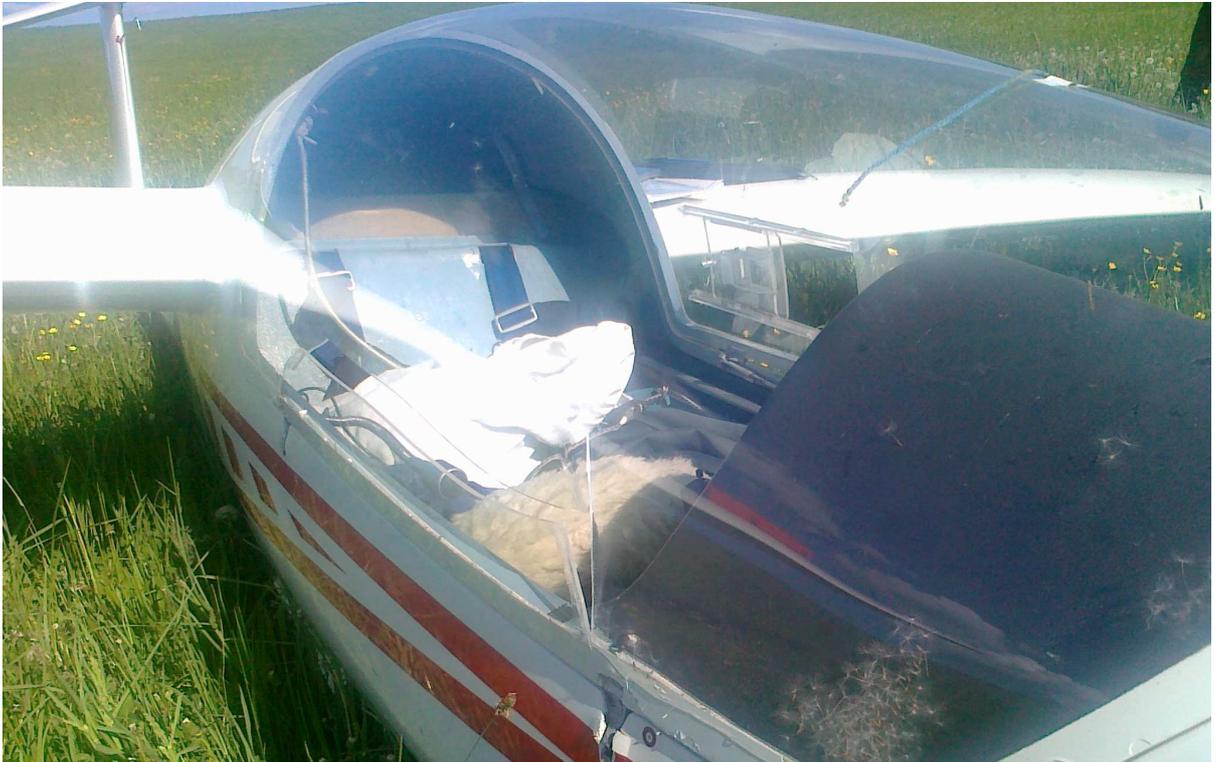
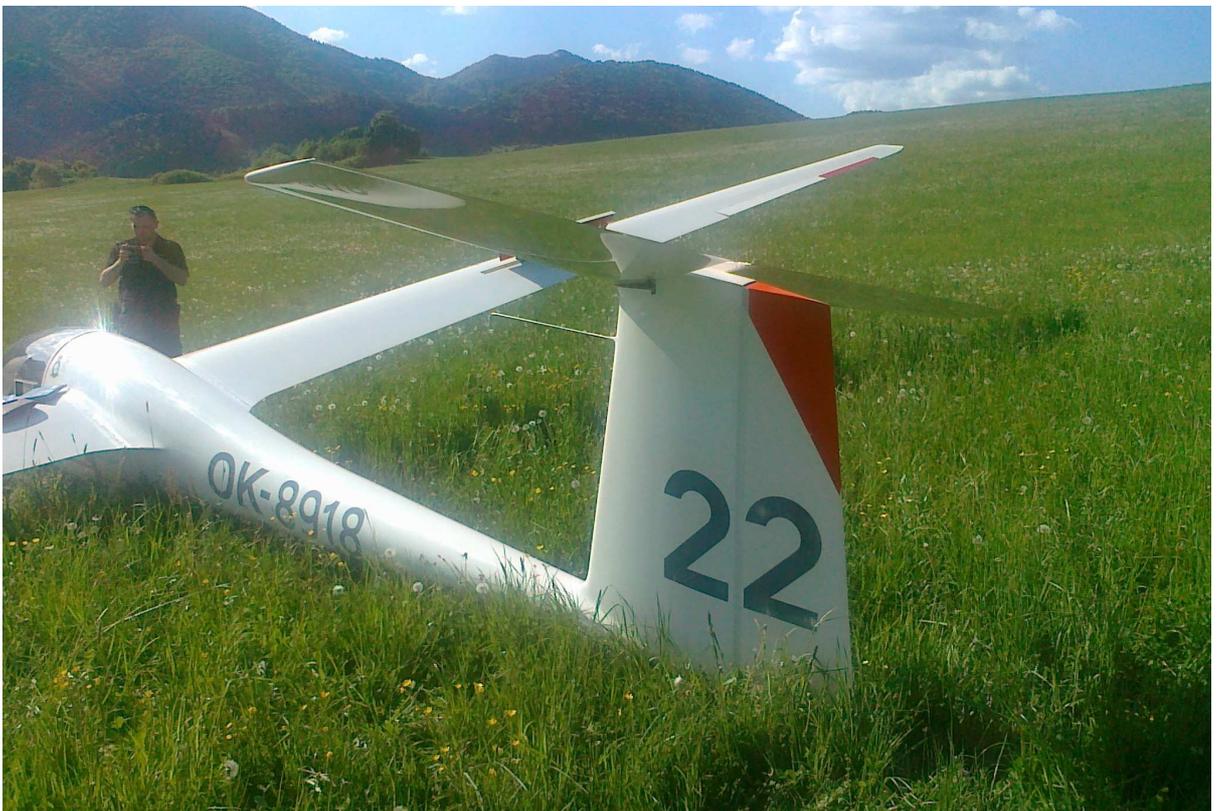
When the aircraft bounced off the uneven ground and touched the ground, its wing came into contact with the ground and the aircraft turned around. Due to this movement and hard contact with the ground, the cockpit got damaged and snapped open, and the tail wheel and horizontal rudder got damaged.

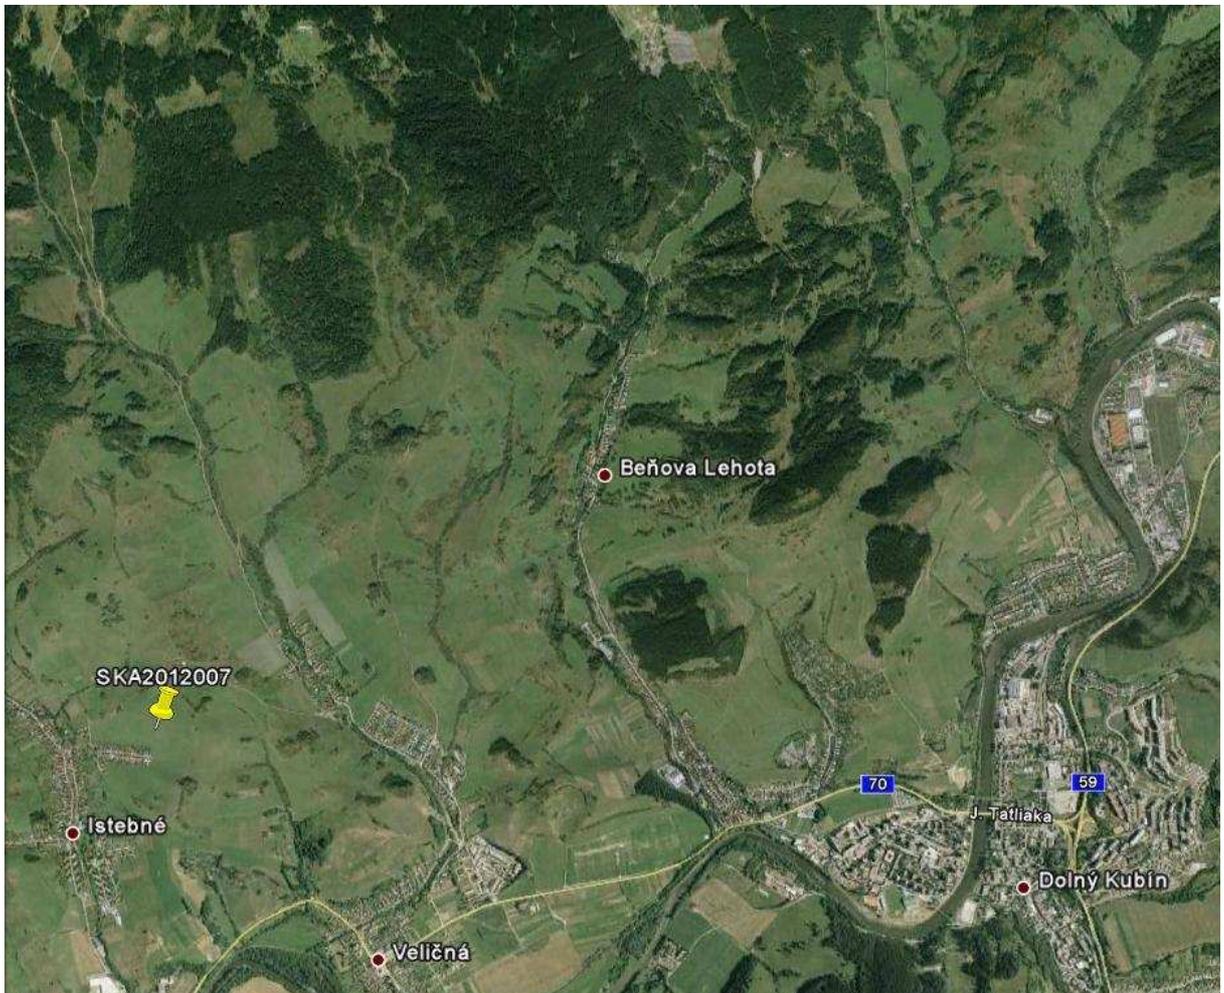
The place of accident is an area with size of 600x150 m, situated 0.6 km east of the community of Istebné, oriented to an easy slope with slightly undulated ground. The surface of the area is formed by a meadow covered by 20-30 cm high grass.

The final position of the aircraft after the accident was documented and photodocumentation was made.

The place of accident is delimited by coordinates: 49°13'01,53''N 19°13'40,88''.

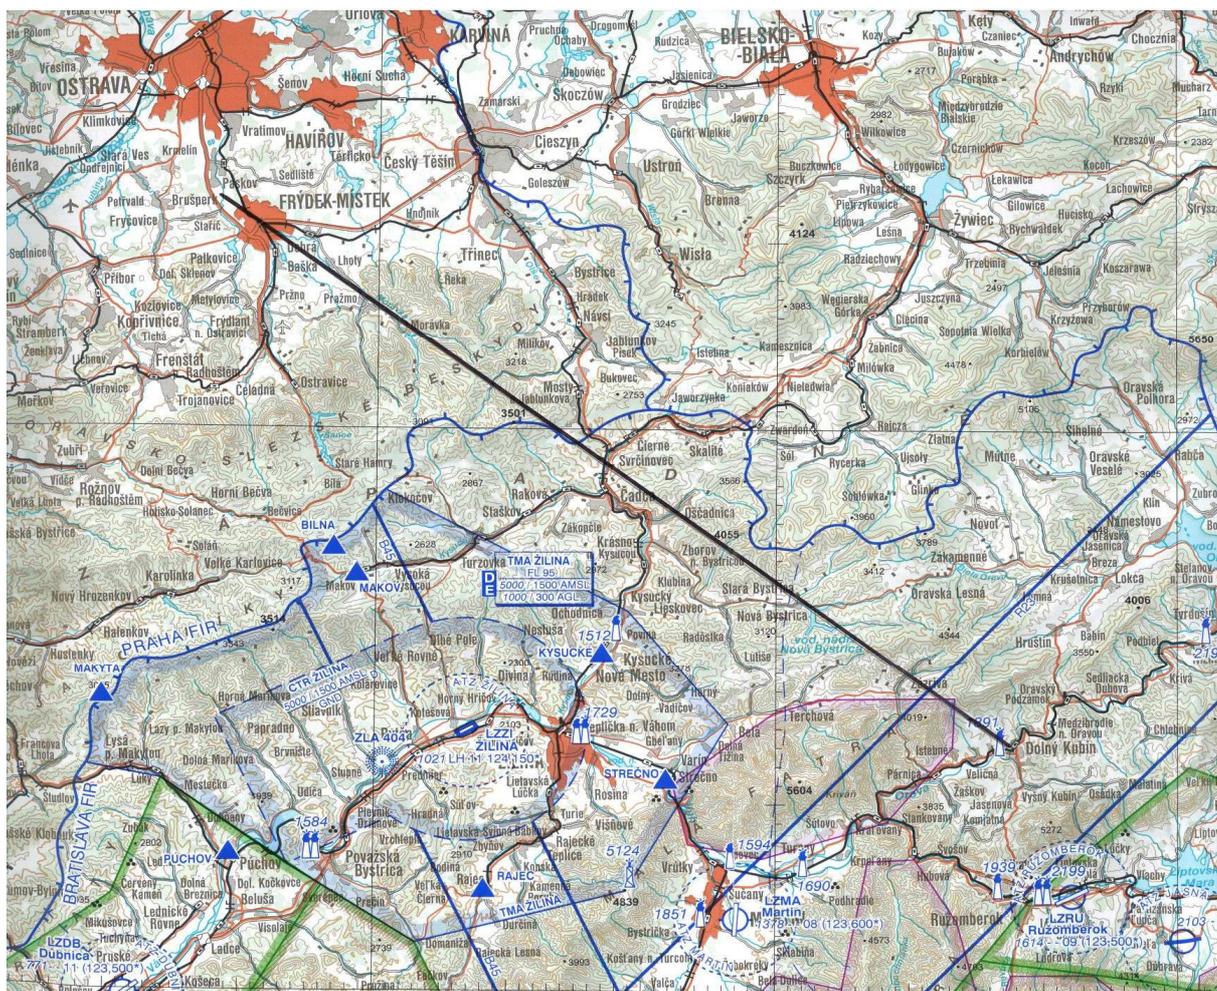
Planned flight route above high ground.
