FINAL REPORT

on investigation of parachute accident

Date: 07.07.2012

Place: Airport Dubnica nad Váhom-Slávica / LZDB

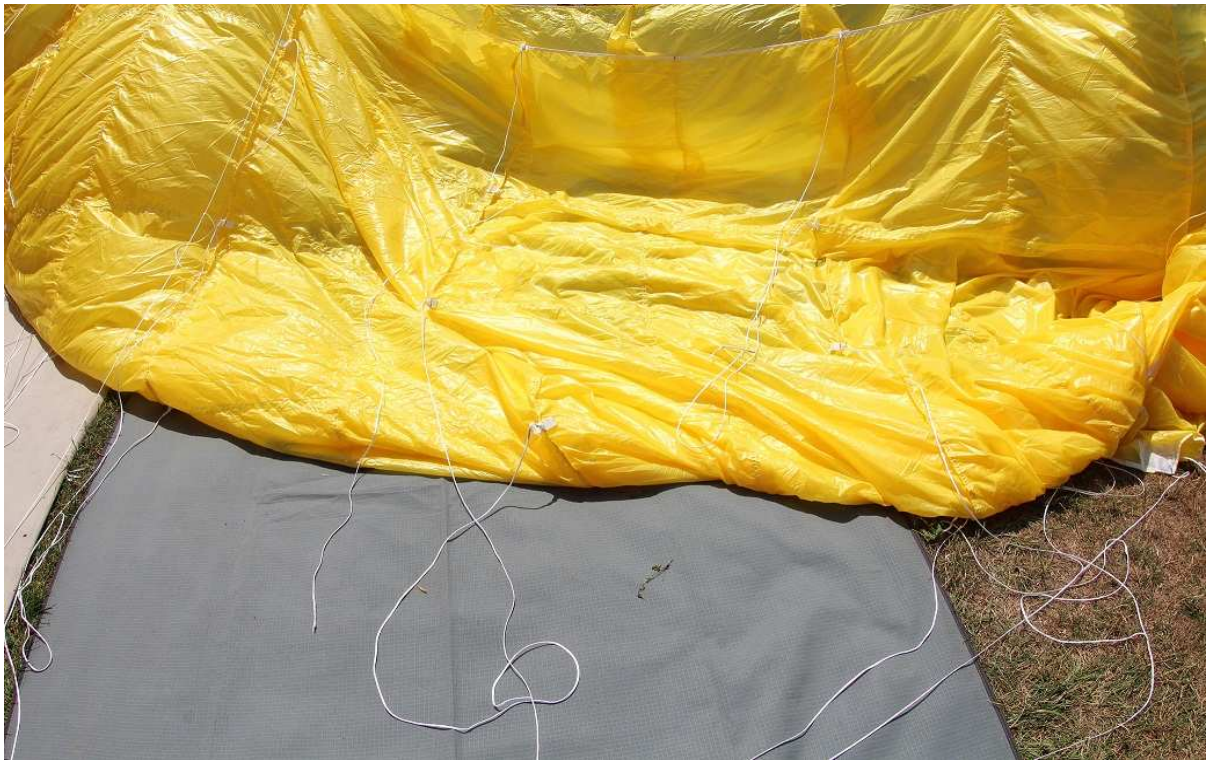
1.3 Damage to parachute

The extracting parachute and the container with canopy of the reserve parachute flew off left of the parachutist. After or during opening of the canopy of the reserve parachute, four rigging cords of the left front strap and left control cord got broken.

The breaking of cords caused partial deformation of the canopy of the reserve parachute, followed by rotation.

Four cords of left front strap, the left control cord and a part of canopy of the reserve parachute got broken.

The exact cause of rupture of the cords of reserve parachute canopy was not unambiguously determined by the day of issue of the final report. For the exact determination of the cause it will be necessary to obtain the opinion of the reserve parachute canopy manufacturer Performande Designs Inc., established in USA. One of possible causes of damage and rupture of the cords of the reserve parachute canopy could be their locking or friction on the parachutist harness in the process of opening in the unstable position on the back.

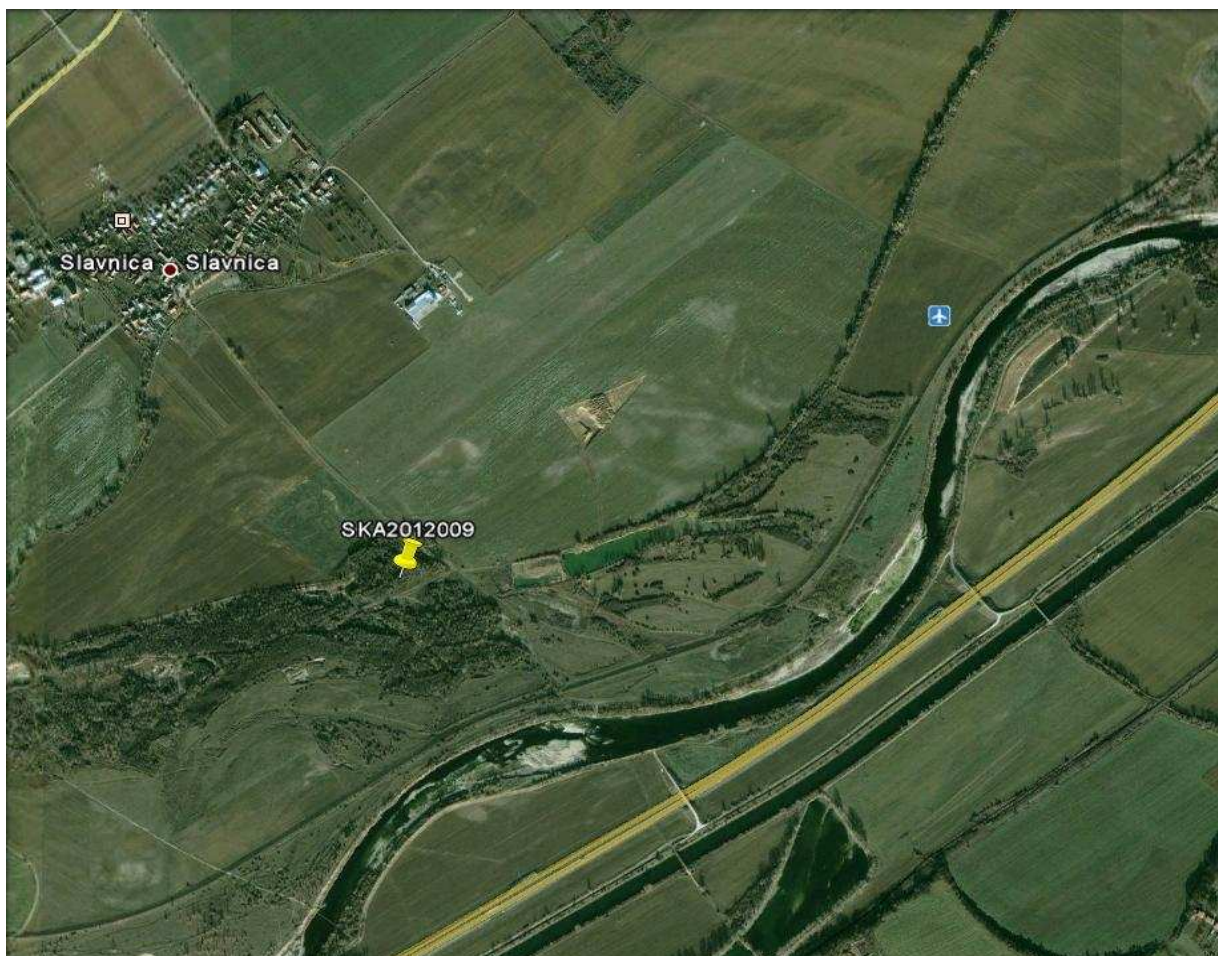
1.12 Wreckage and impact information

The place of accident is delimited by the geographic coordinates:

N 48°59'28,68'', E 18°11'14,54''

It is situated in trees and shrubs south-west of the airport.
