FINAL REPORT

on investigation of accident
of helicopter type **Mi-8T**
Registration No. **OM-TMT**

Date: 03.08.2012

Place: Airport Poprad / LZTT

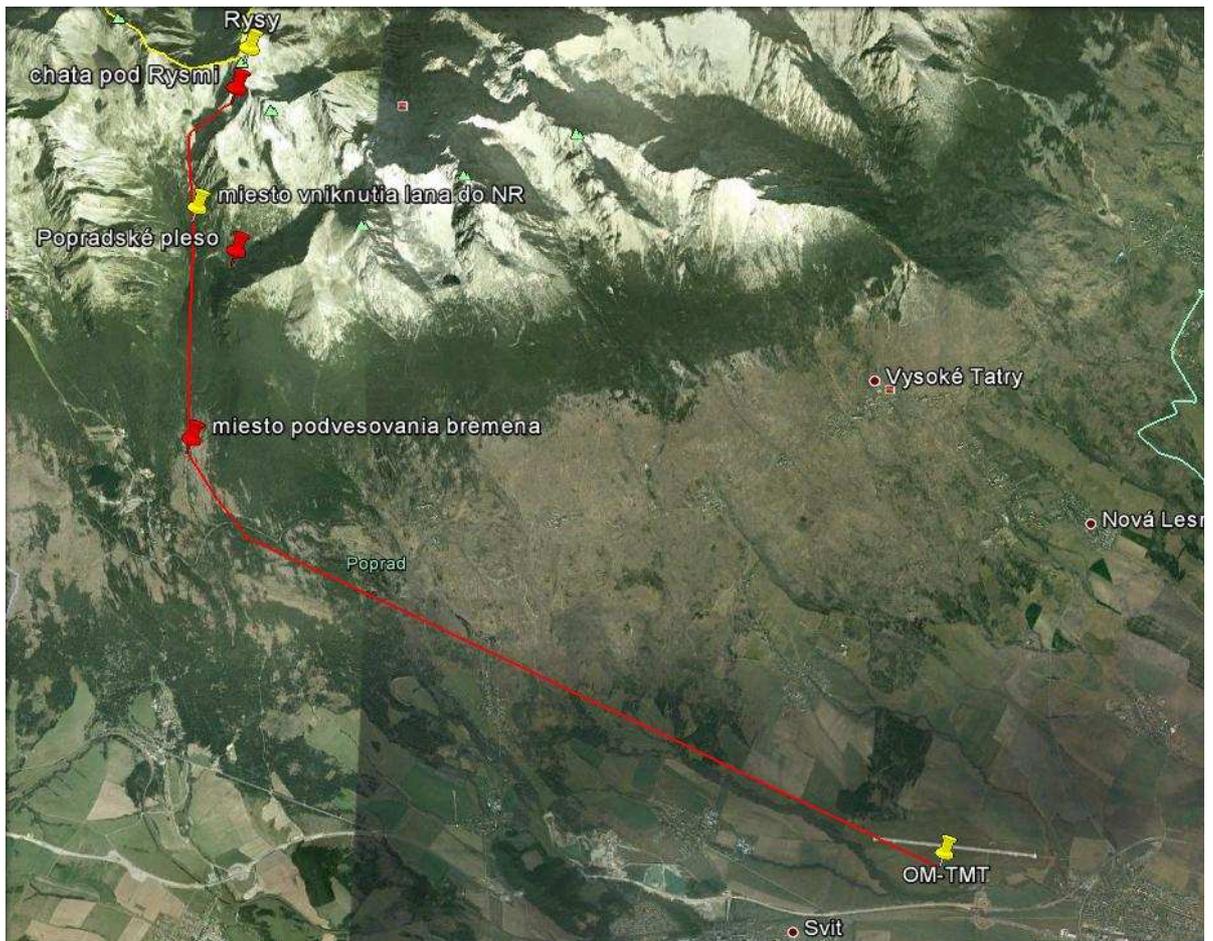
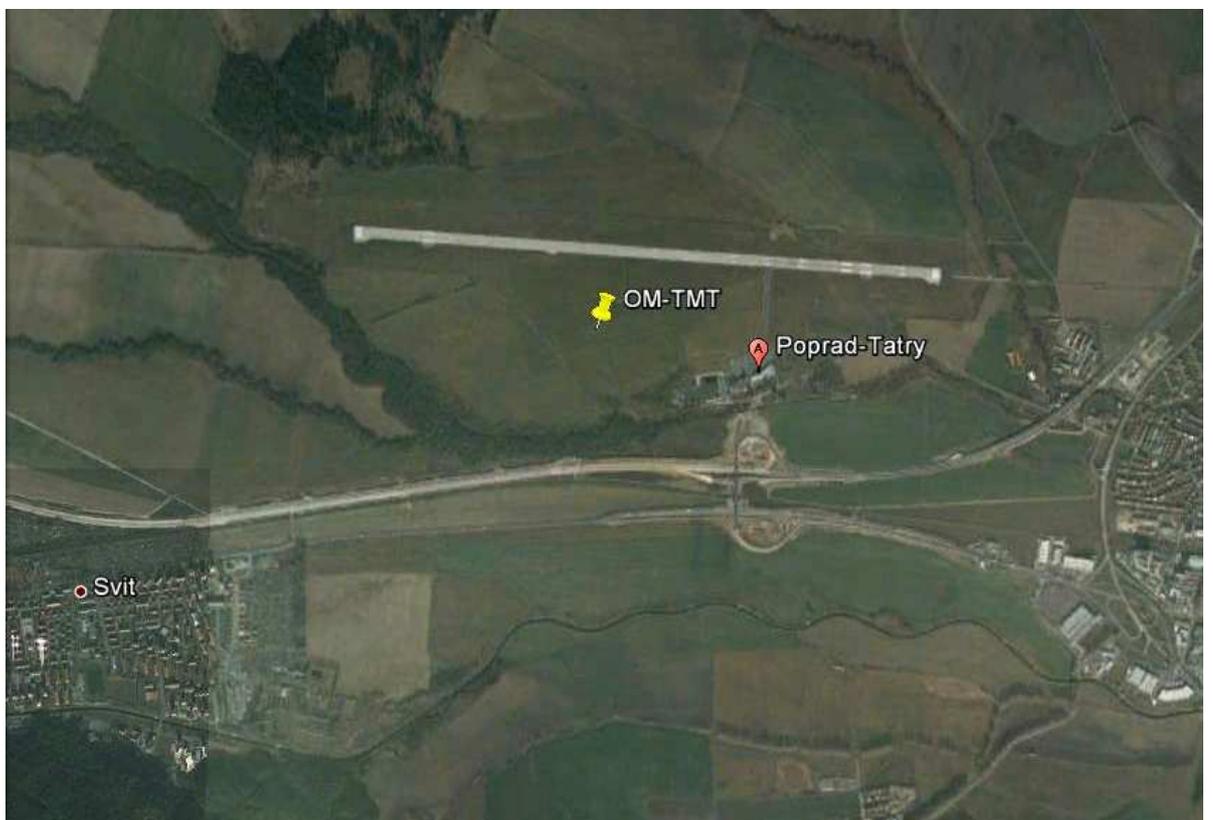
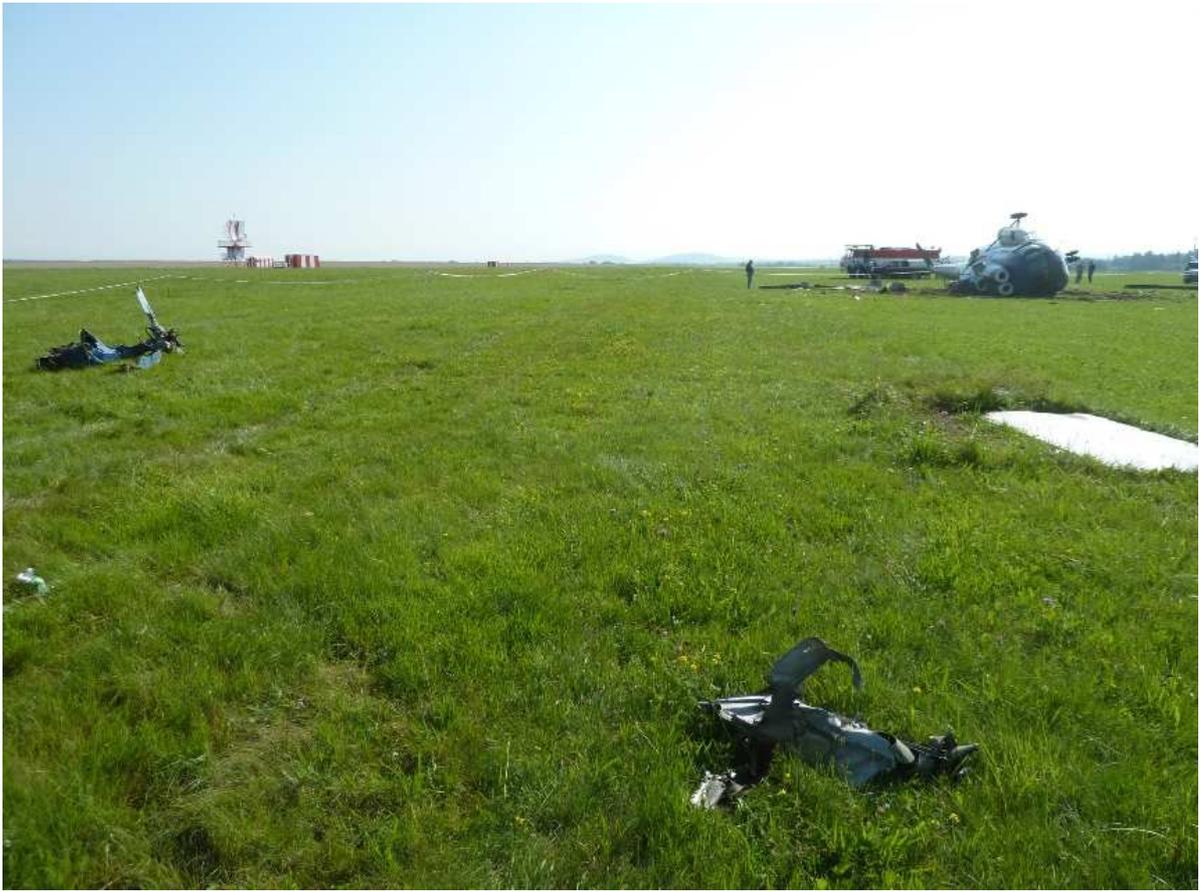
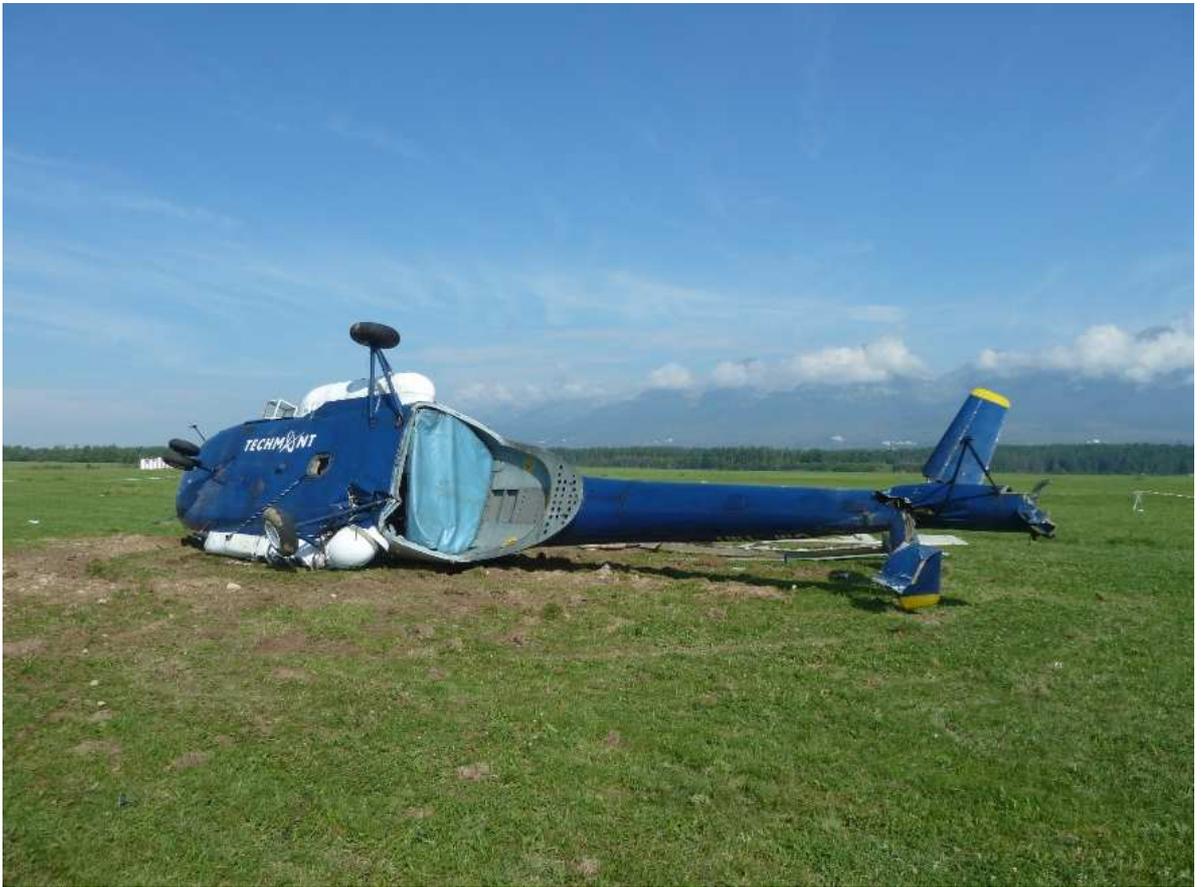
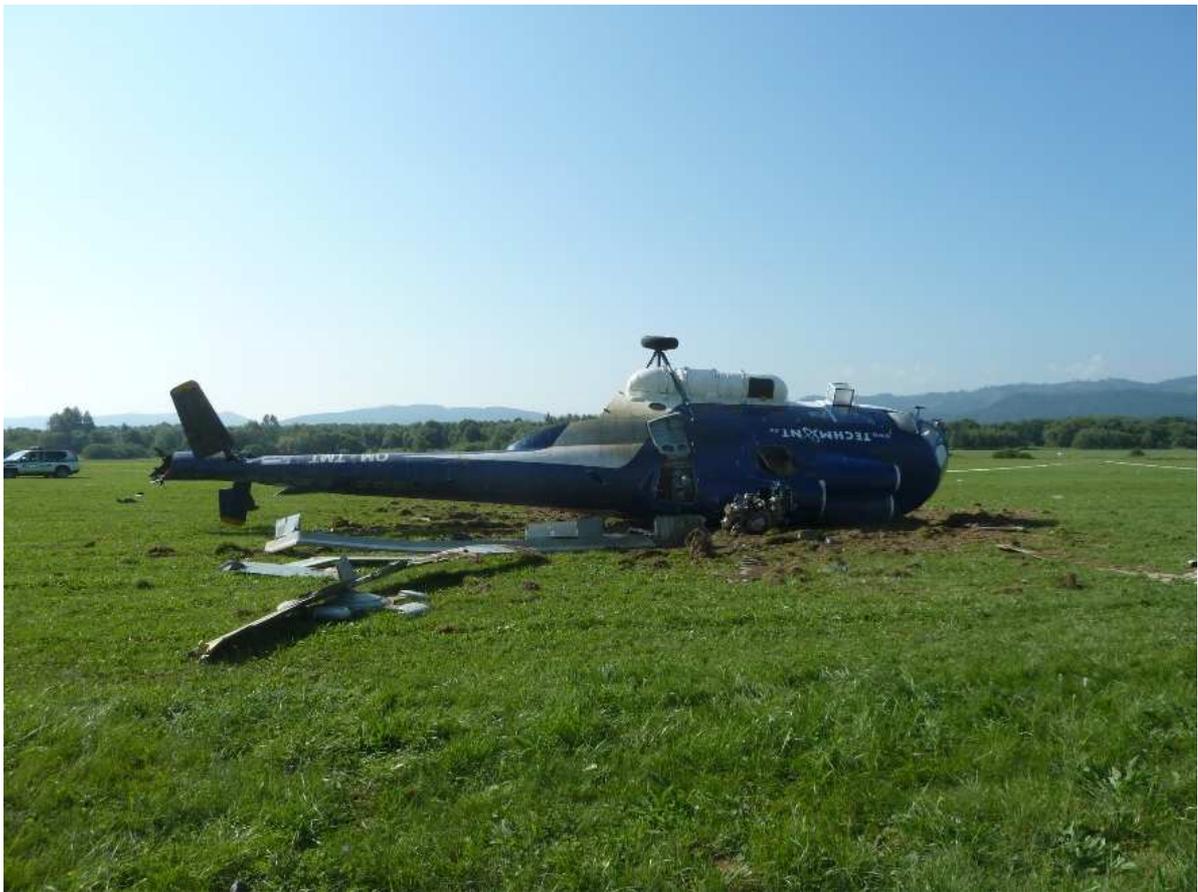
The place of accident is situated on RWY 07 of airport LZTT and is described by the coordinates N 49°04' 13.9'', E 020°14' 17.6''

Due to the contact of rotating MR blades with the ground the helicopter got destroyed. Besides total destruction of the helicopter, after the contact of already damaged blades of the anti-torque rotor with the ground the end part of tail boom with anti-torque rotor came apart from the helicopter body.

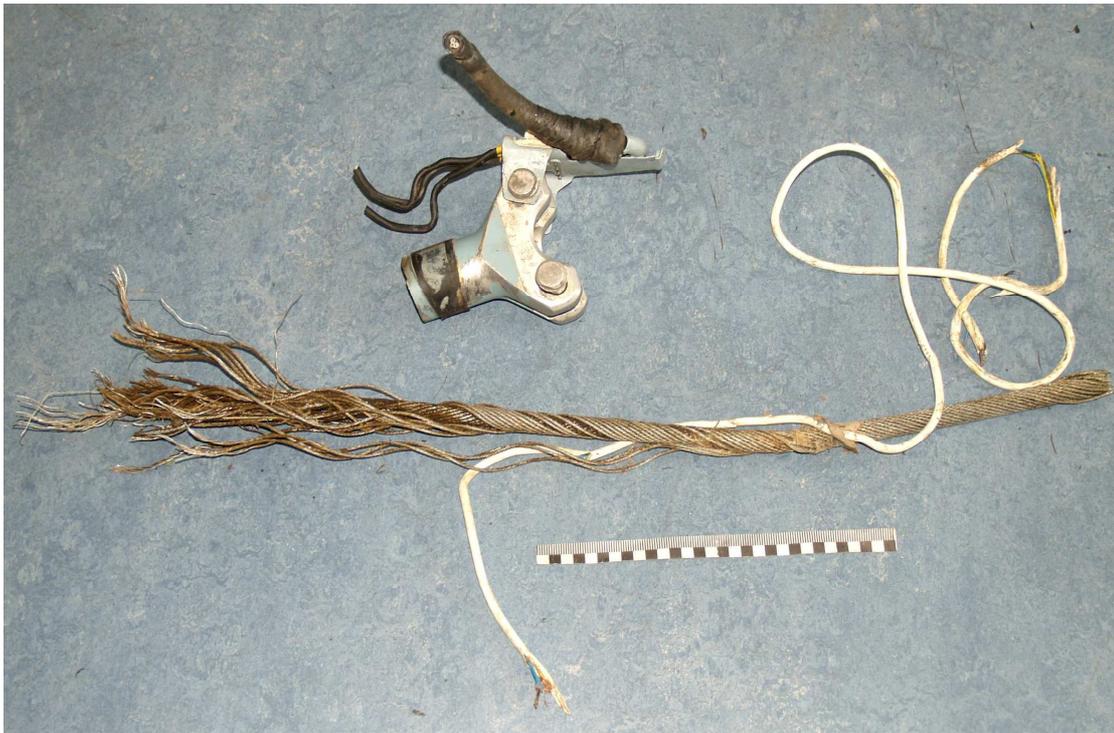
The examination detected that the submitted steel cable was damaged by unauthorized or improper transverse loading (contact with foreign body). The design of cable (regular lay (and diameter of wires) corresponded with grooves and imprints on the surface of submitted part of the anti-torque propeller blade hinge.

In view of the character of examined grooves and imprints and damage to the cable, and practical impossibility of contact of the compensating propeller with other steel cable it can be assumed that the traces (surface grooves) on the submitted part of the anti-torque propeller blade hinge were left by the examined cable.

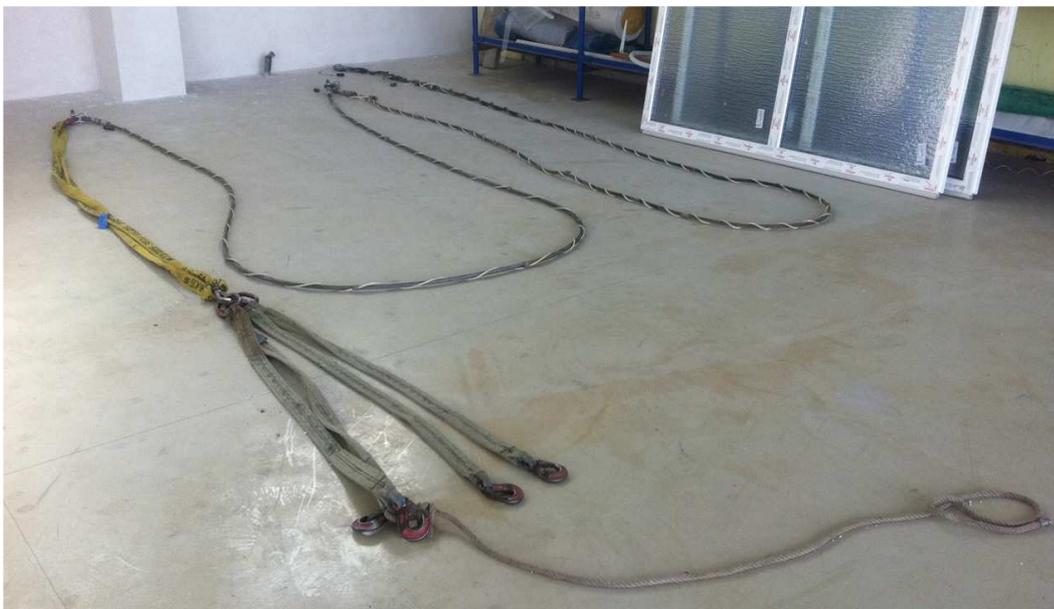
The flight was made with free underslung transport cable with total length of 28 m in the following configuration:

- steel cable Hercules 18 mm with length of 20 m;
- two nylon strips, each with length of 4 m;
- two canvas strips ended by steel suspension hooks, each with length of 2 m;
- hemp cable for guidance of load to the place with length of 2 m.

- to consider the replacement of very flexible, 4 m long nylon end part of the suspension device,
3. to supplement the operating manual by recommendations set out in paragraph 2 for performance of aerial work for specific types of aeronautical appliances,

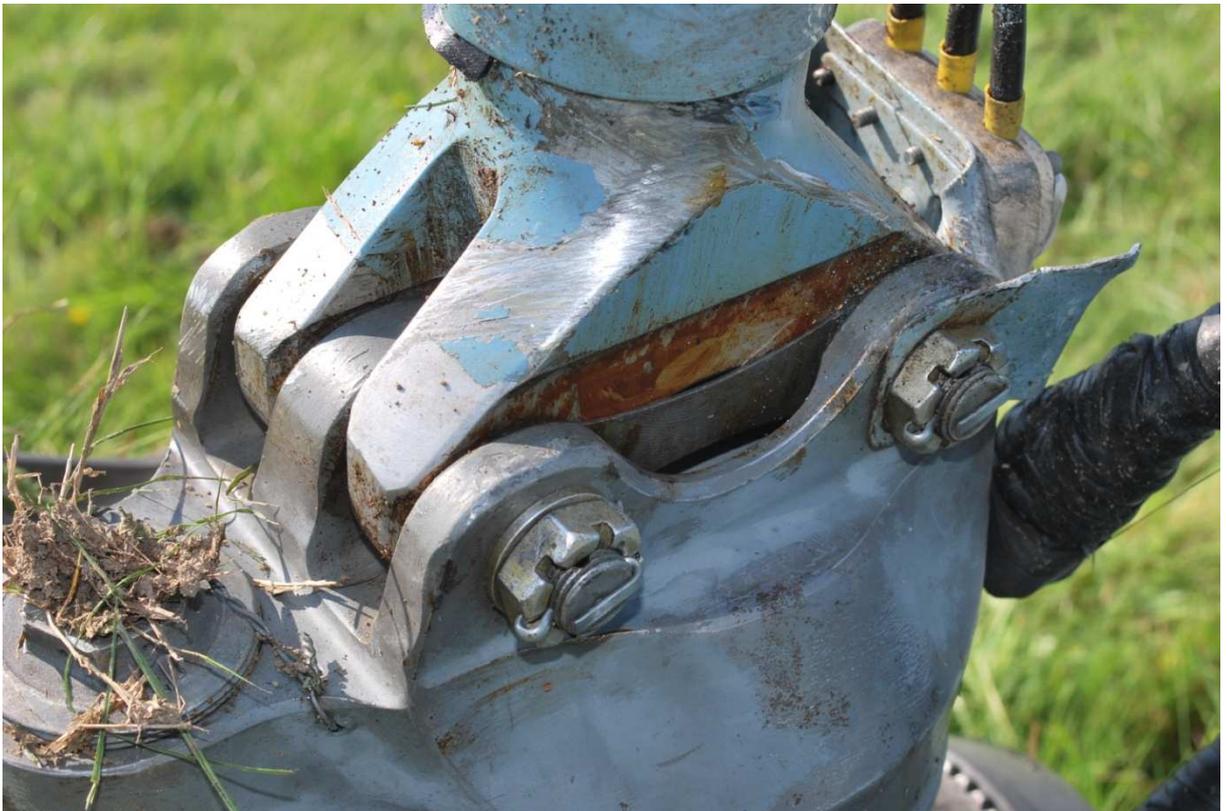
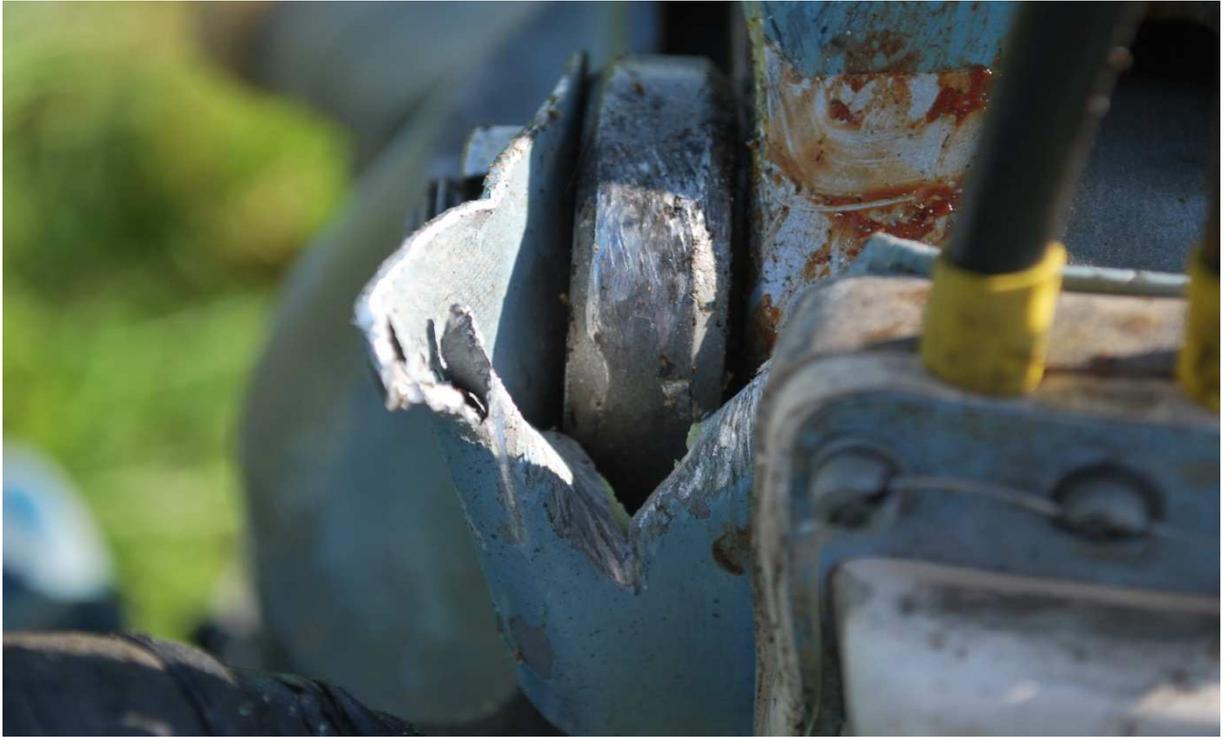
In nominal operating regime of the power unit the anti-torque rotor has rotation speed of 1124 rpm^{-1} , which is 18.73 revolutions per second. After the contact of the end flexible hemp section of the transport cable with the plane of rotation of the anti-torque rotor the cable started to quickly wind on the anti-torque rotor head. At rotor speed of 18.73 revolutions per second, the winding of the cable section exceeding the length of helicopter (15.3 m) on the anti-torque rotor head with diameter $\varnothing 280 \text{ mm}$, until stretching of the remaining cable section (12.7 m) attached to the suspension device in the helicopter body, took only 0.9 s! At that moment the steel cable dynamically stretched up to the ultimate tensile strength broke at the bending point (tension concentrator), at the point of contact with the anti-torque rotor blade hinge.

After breakage a part of the loose end of broken cable, attached in the helicopter body, sprang back flexibly and wound on the right half of stabilizer, causing a severe damage to it.

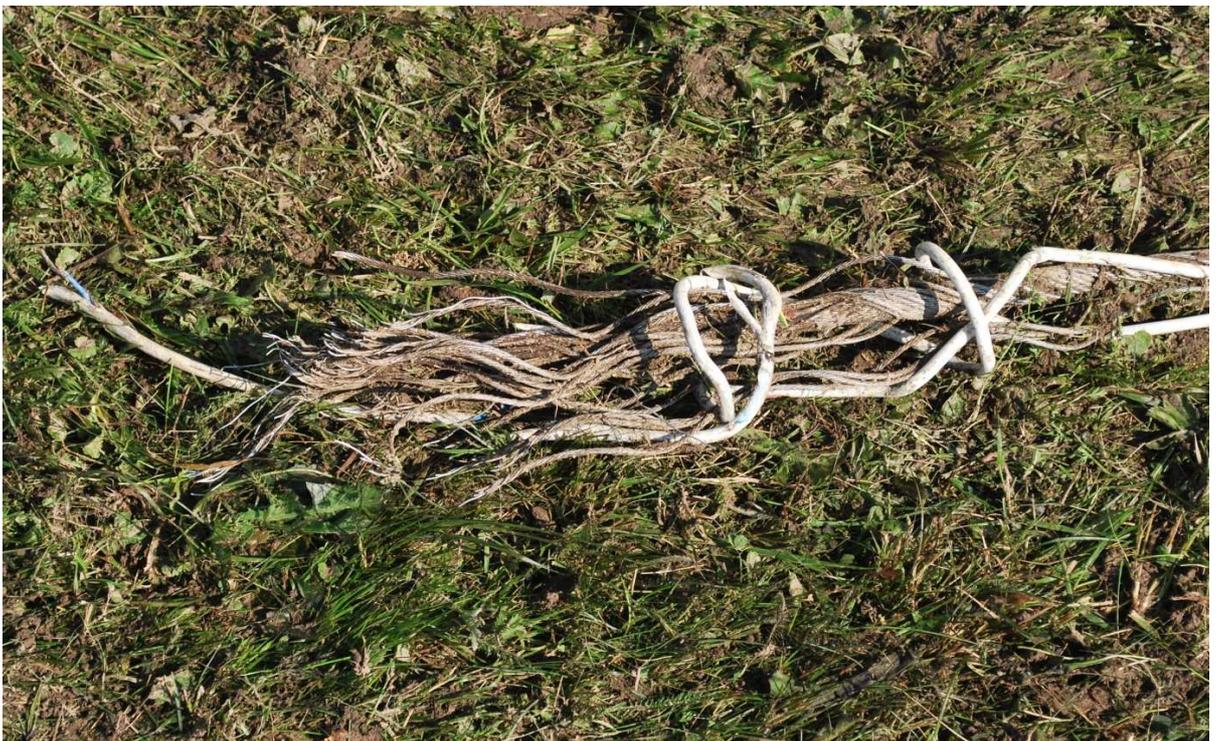
The separated section of the cable (cca 15.3 m), wound on the anti-torque rotor head, started to unwind (against the direction of rotation of the rotor, but slower than in case of its winding on the rotor head) by application of progressively growing centrifugal force. By gradual unwinding of the cable the mass imbalance of anti-torque rotor increased and manifested itself by **intensive** oscillation of the helicopter in the longitudinal direction. (Mass imbalance of rotating body means a state when the main central inertia axis is not identical with the axis of its rotation – static imbalance).
