FINAL REPORT

on investigation of air accident
of glider **Standard Cirrus**
registration No. **OM - 7274**

Date: 07.08.2012

Place: community of Zázrivá

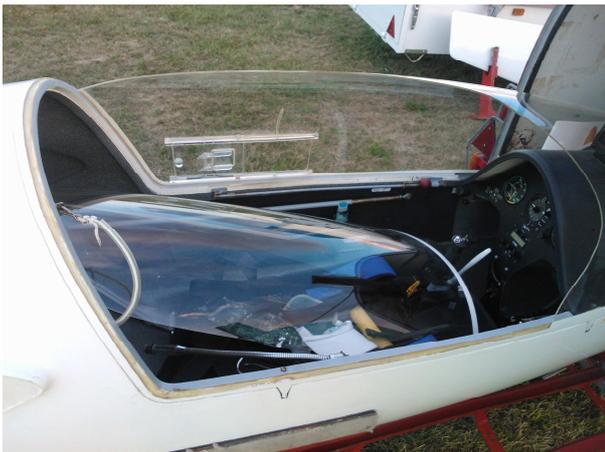
fig. 1

Glider Standard Cirrus – After the forced landing the Plexiglass tilting canopy of the cockpit was broken (fig.1), the tail skid shoe (fig. 2) and dashboard hinges (fig. 3) came off and the dashboard was bent (fig. 4). The rear lower pipe of the rodding in the rear suspension of the landing gear was bent (fig. 5) and the front knuckle bearing on the left side of fuselage was broken (fig. 6). The windtip skid on the right wing came off (fig. 7), the lower left wing cover, about 1 m away from the wing end, was scratched (fig. 9) and the horizontal rudder fairing showed cracks (fig. 8).

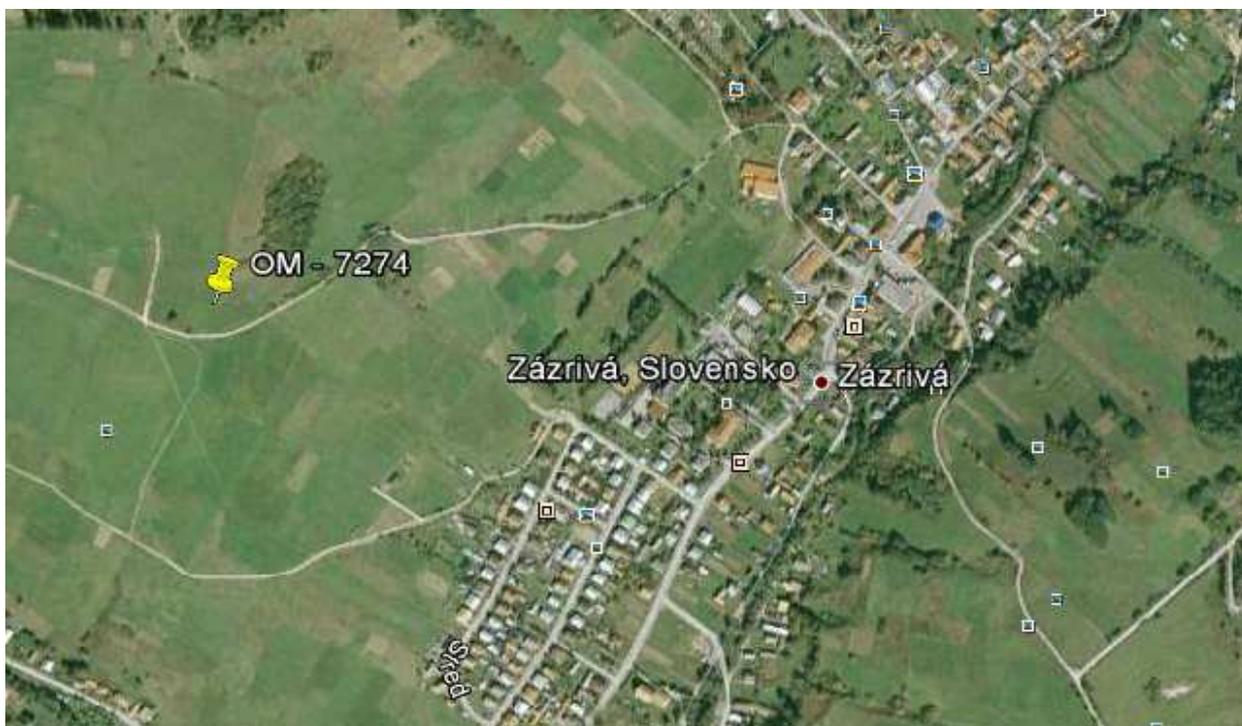
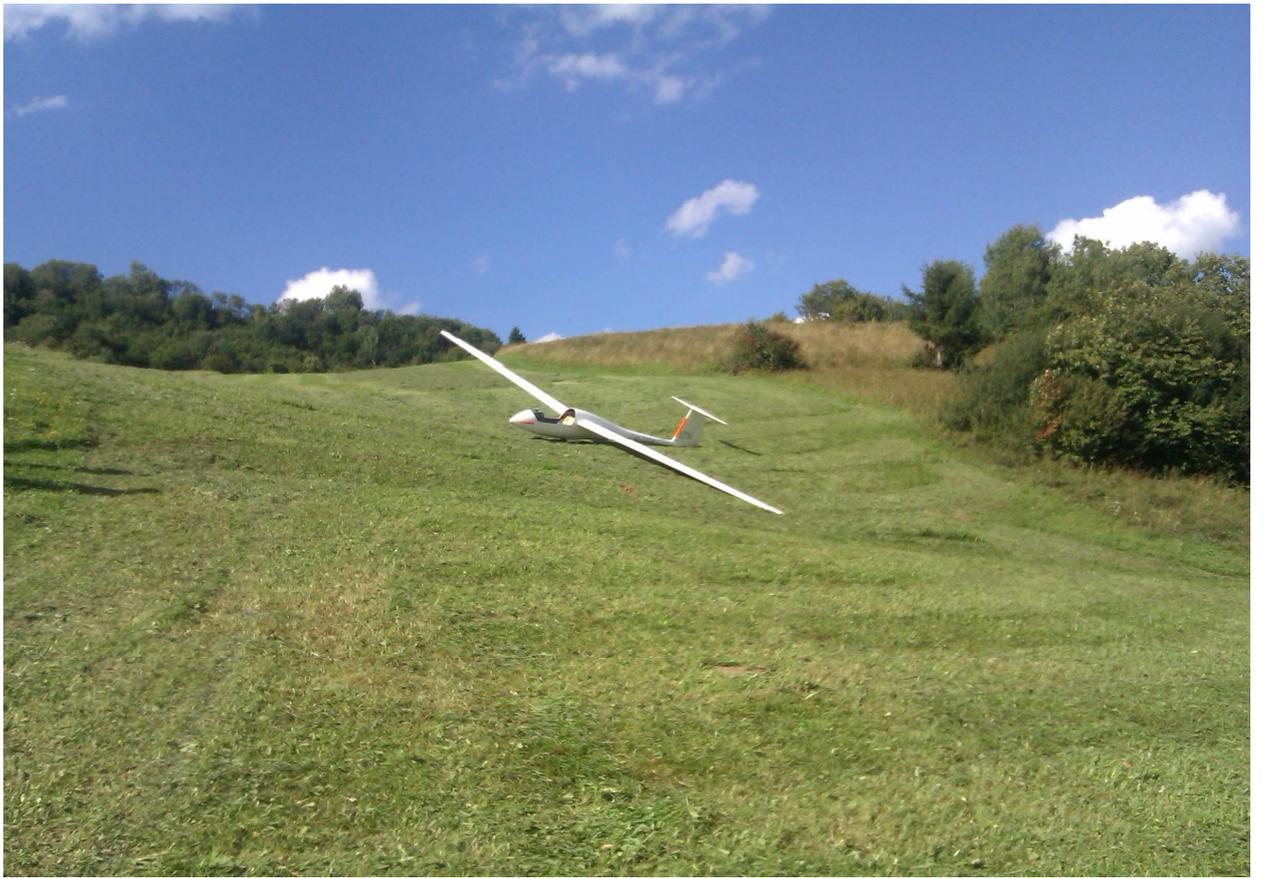
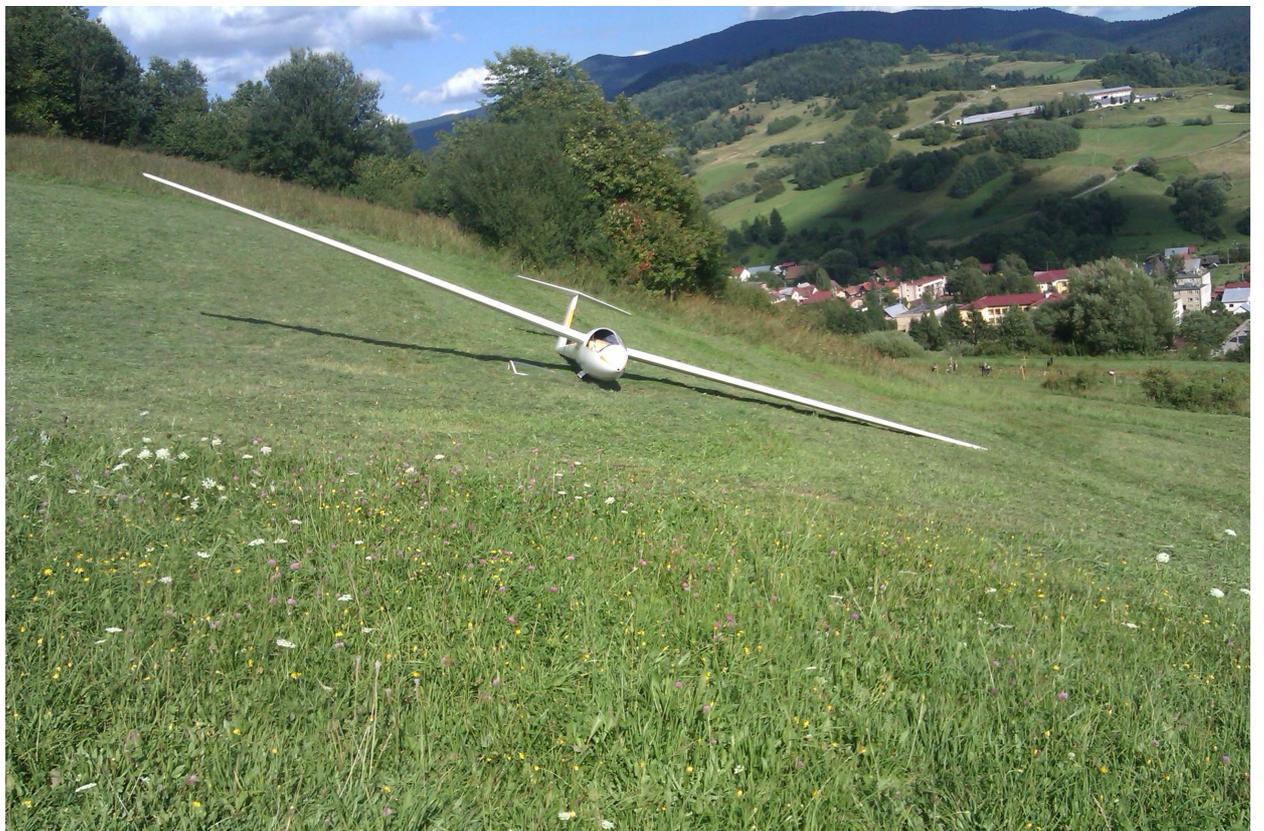
The place of accident is described by the coordinates N 49°16'35''; E 019°08'43''.

The glider remained in one piece and was damaged after the air accident.
