FINAL REPORT

on investigation of accident
of ultra-light aircraft type **TL 2000 STING**
Registration No. **OK- MUA 93**

Date: 19.08.2012

Location: Airport Prievidza / LZPE

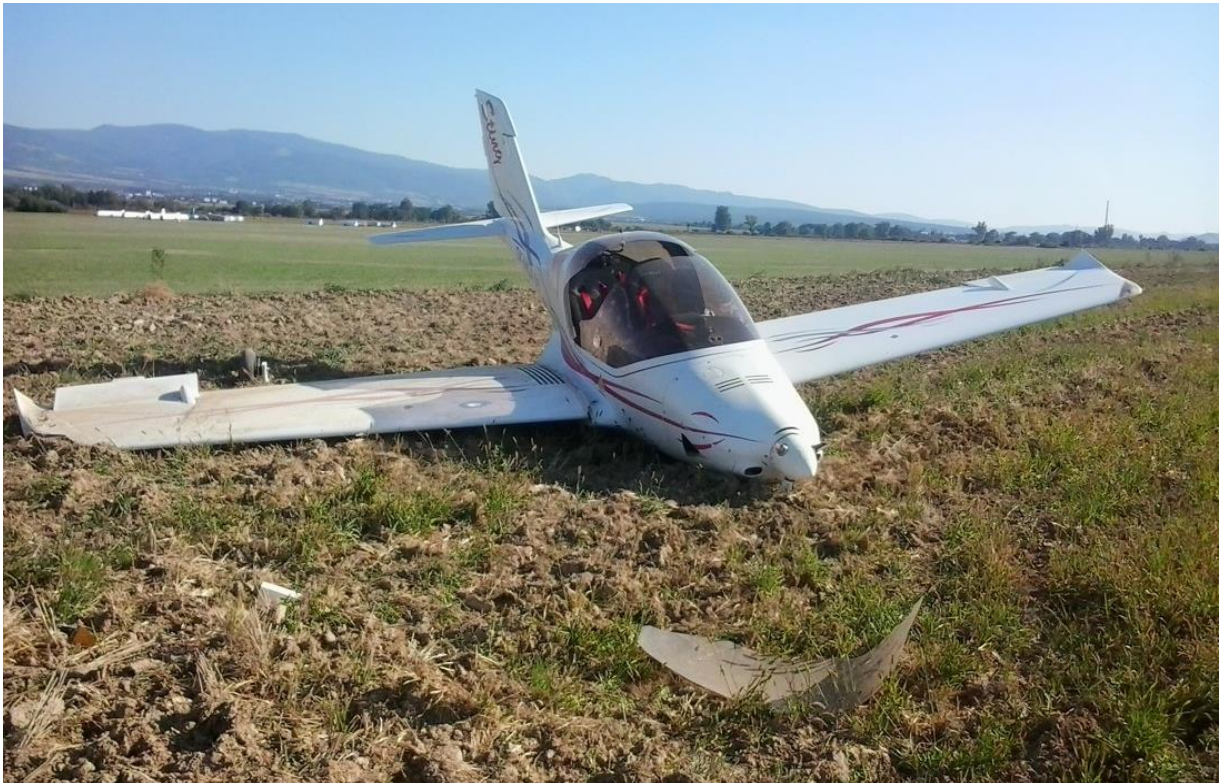
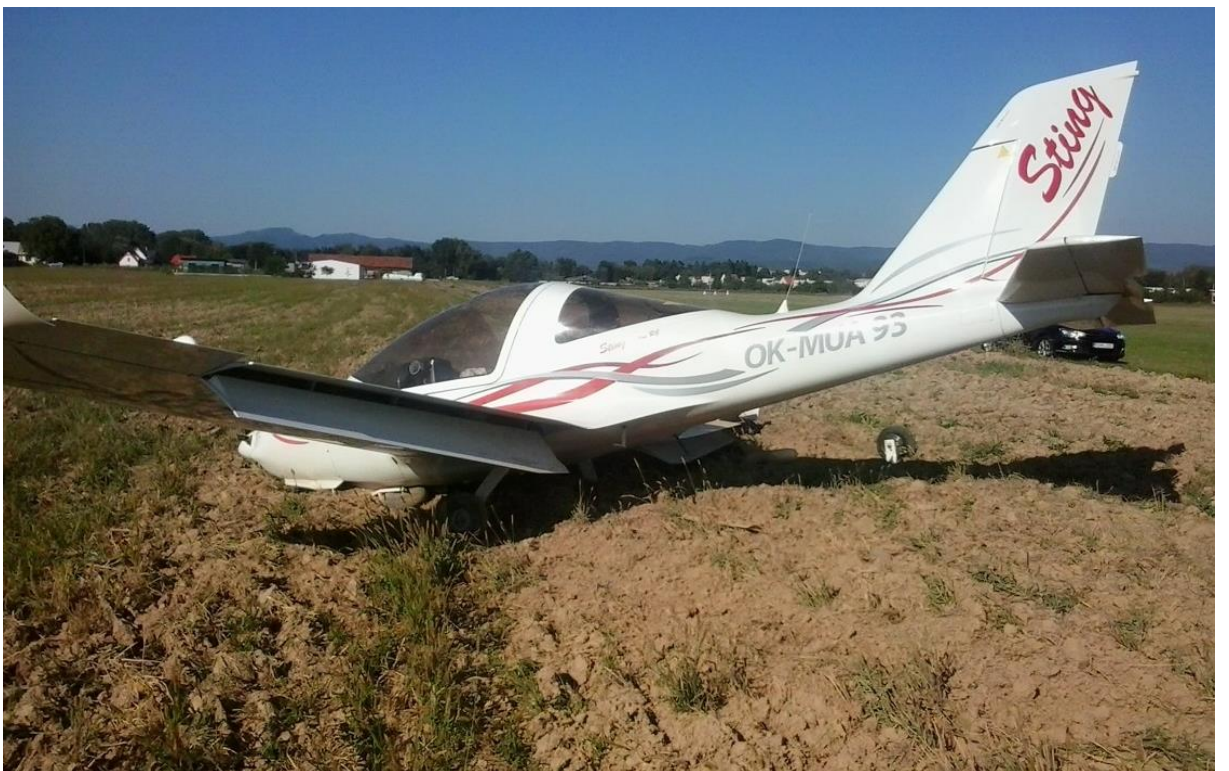
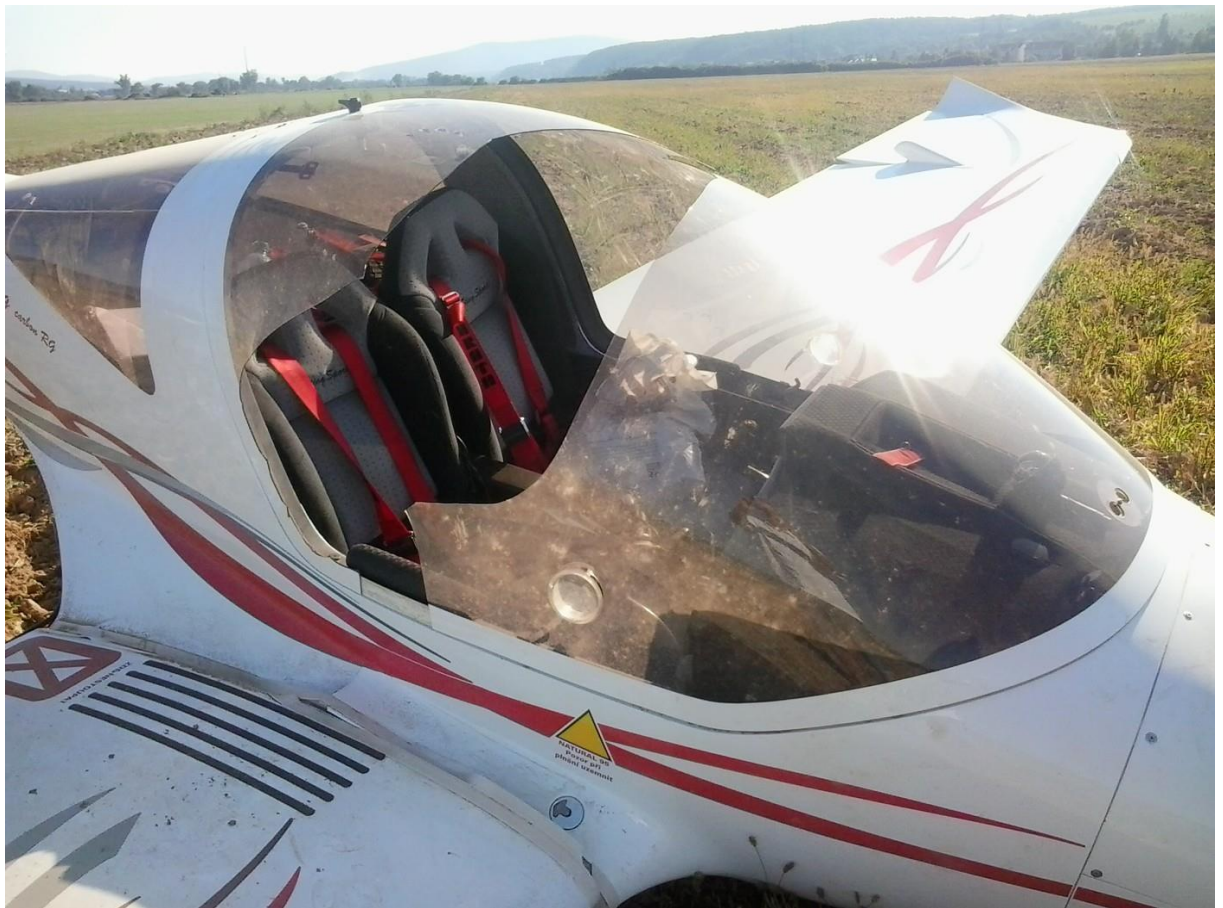
During the landing manoeuvre on RWY 04 of the airport LZPE, the aircraft landed quite hard, ballooned off and inclined to the left. The pilot handled the situation by opening the throttle. After touchdown the aircraft started turning left and ran out of RWY 04 to rough ground – ploughed field, where it came to standstill. By movement on this rough ground the aircraft suffered serious damage.

Damaged landing gear, right wing and propeller, engine stopped by force, broken cockpit hood.
