MINISTRY OF TRANSPORT CONSTRUCTION AND REGIONAL DEVELOPMENT OF THE SLOVAK REPUBLIC

FINAL REPORT

on investigation of air accident
of powered paraglider type **ORBIT 3 28 / MINIPLANE TOP80**
without registration number

Date: 17.09.2012

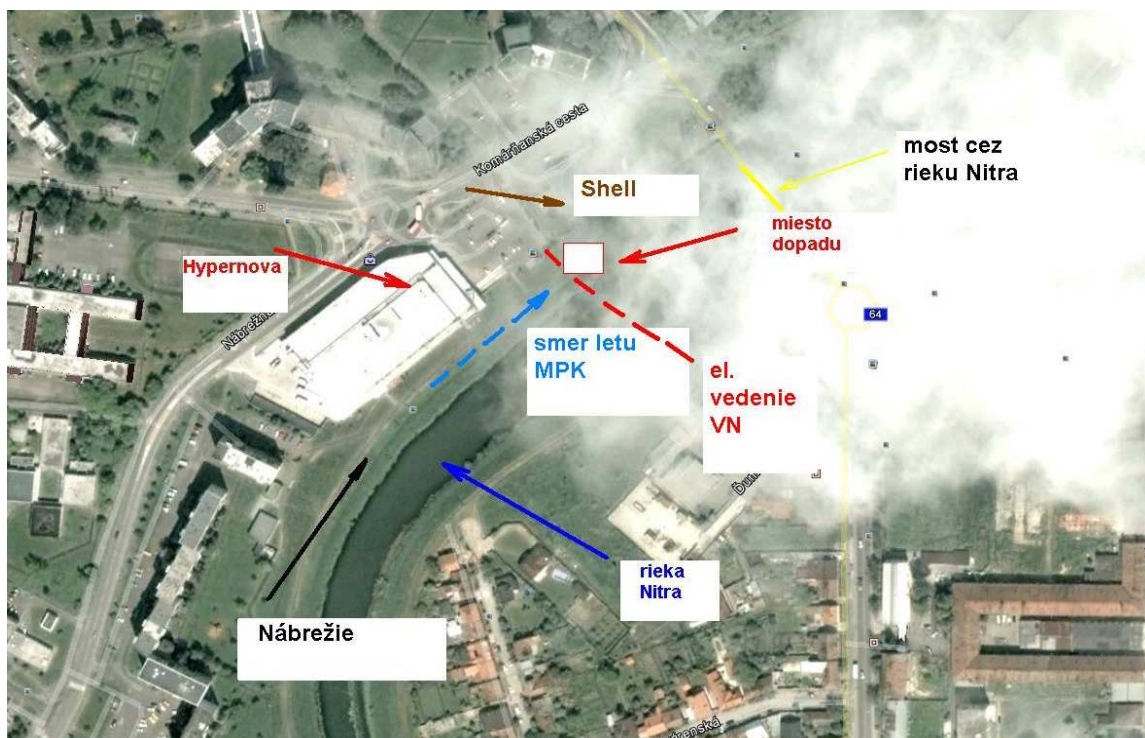
The site of air accident is situated on the bank of the river Nitra in the built-up area of Nové Zámky.
