FINAL REPORT

on investigation of air accident
of aircraft type **PULSAR**
registration No. **OM-AYF**

Date: 03.10.2012

Place: Airport Nitra / LZNI

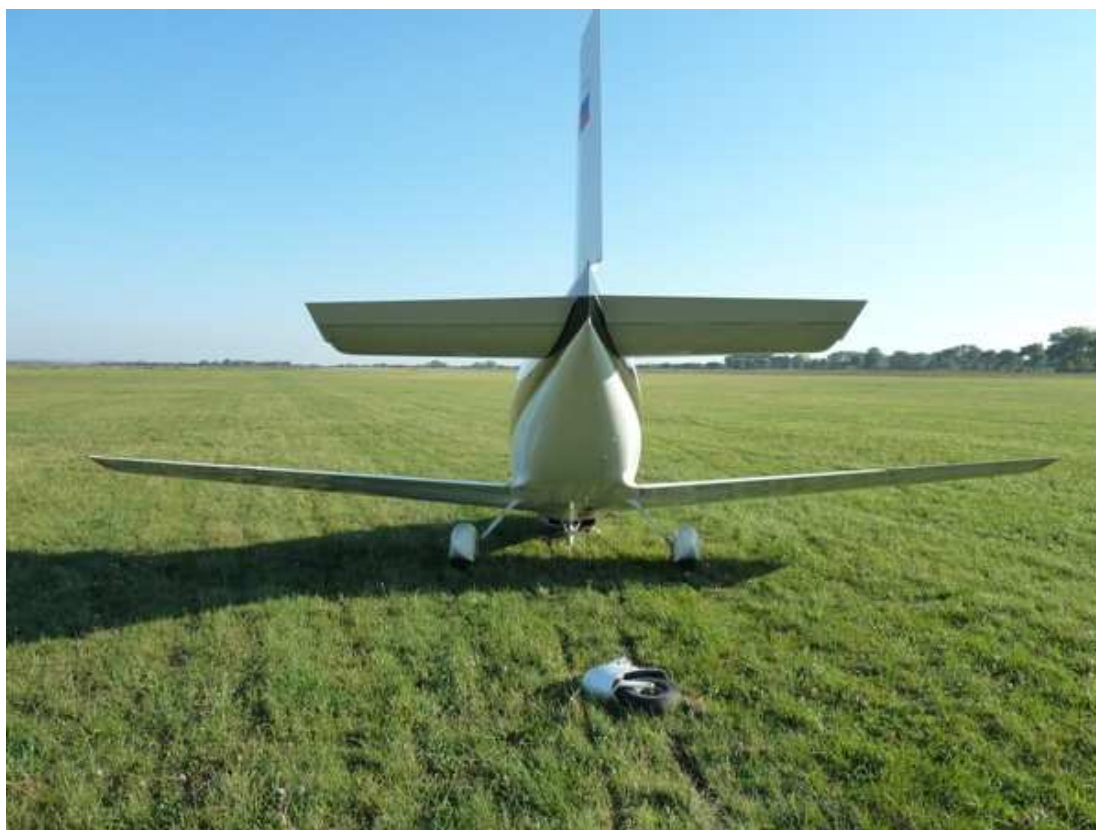
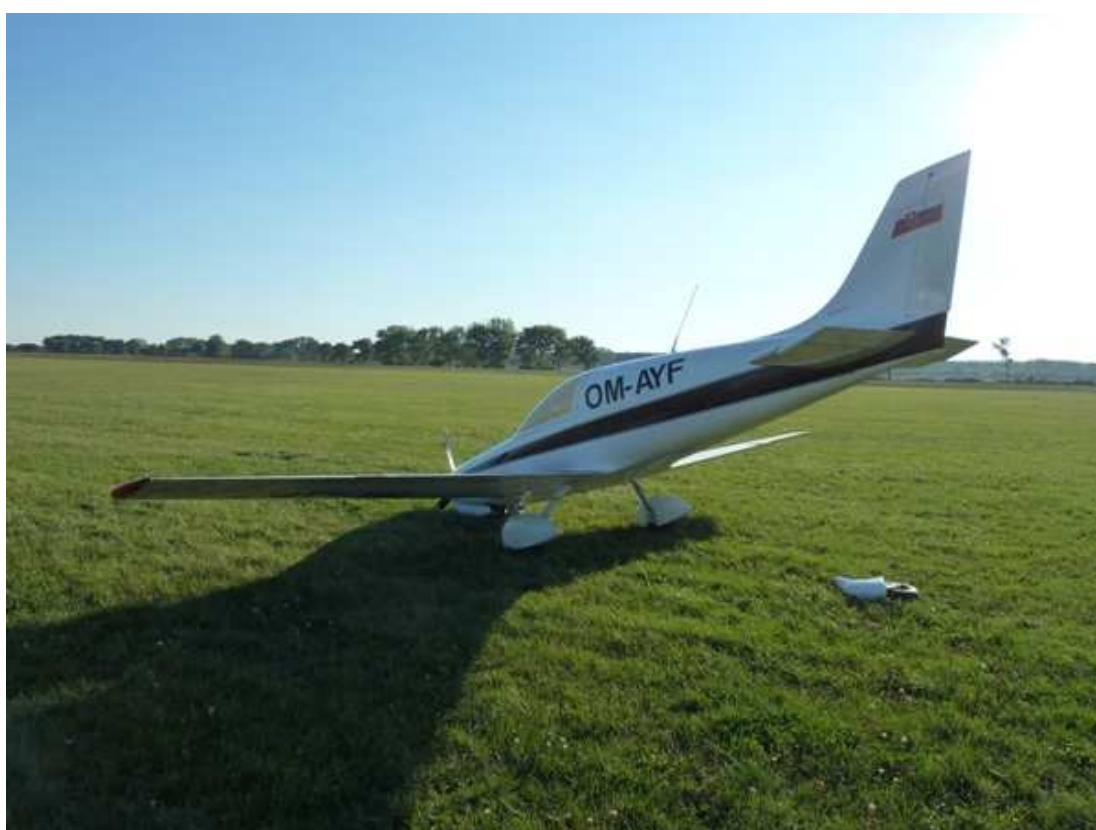
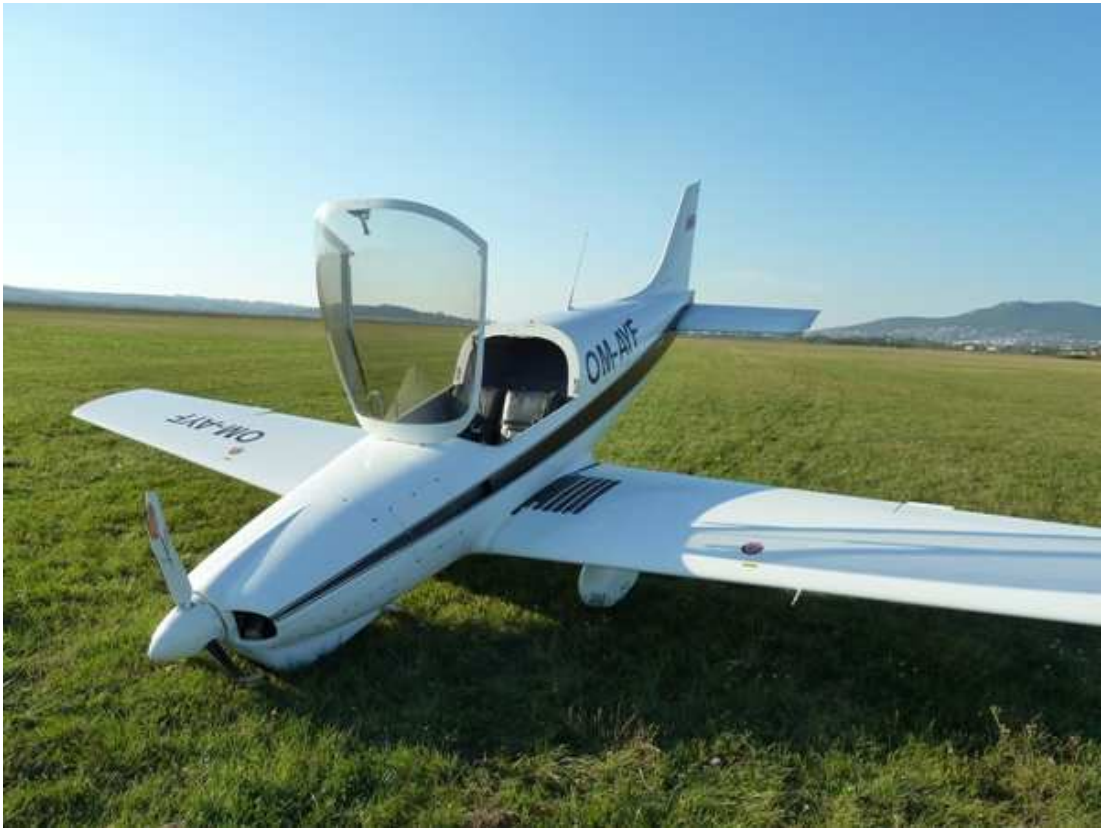
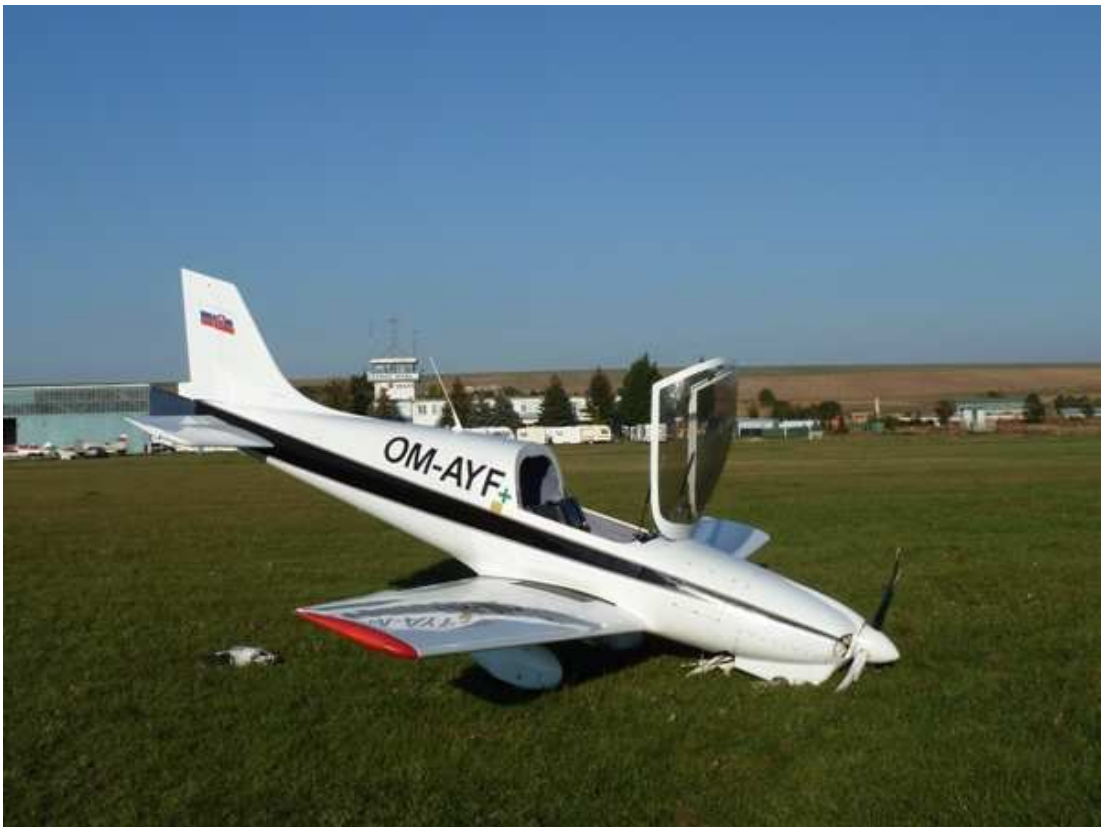
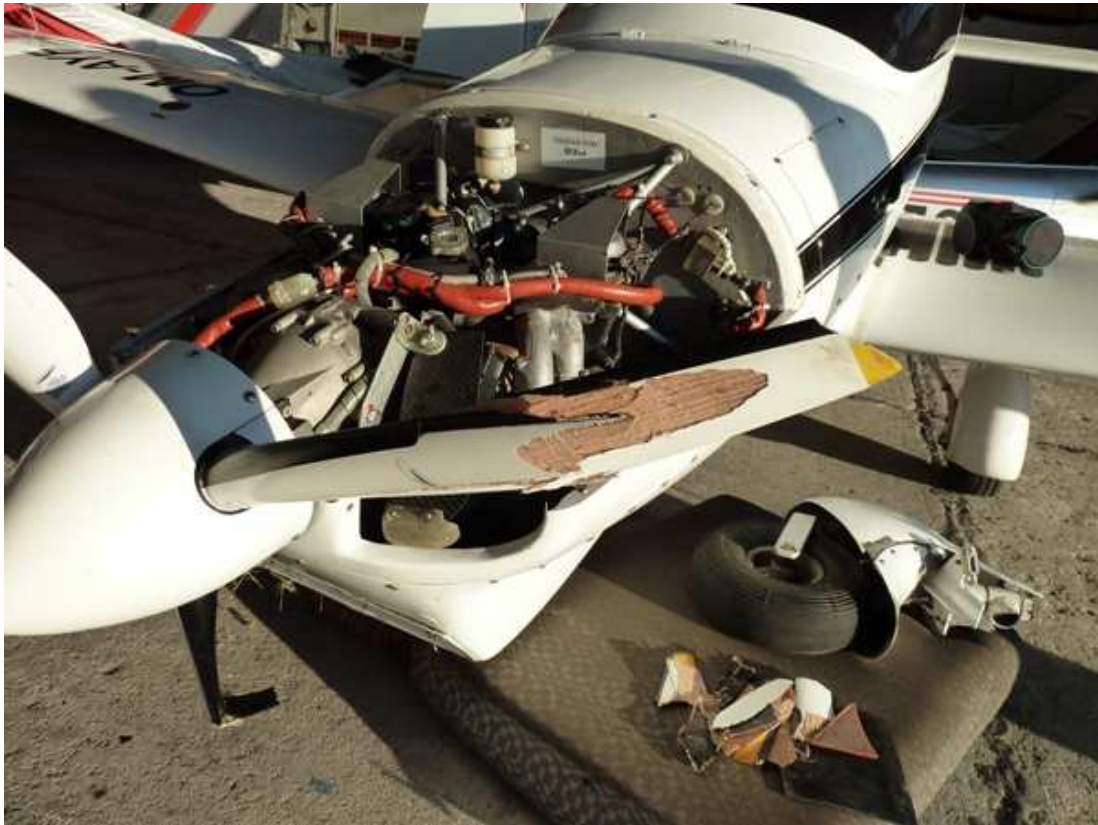
Broken front landing-gear leg, destroyed propeller.

The aircraft landed on RWY of airport LZNI.

After the last fourth bounce the front landing-gear leg broke off and the aircraft stopped on RWY. When the nose of aircraft inclined to RWY the working propeller got damaged.
