## Lateral runway excursion during landing roll, nose landing gear collapse

<b>Aircraft</b>	Airbus A300-B4 registered EI-EAC
<b>Date and time</b>	16 November 2012 at 4 h 25 UTC <sup>(1)</sup>
<b>Operator</b>	Air Contractors
<b>Place</b>	Bratislava Airport (Slovakia)
<b>Type of flight</b>	International public cargo transport
<b>Persons on board</b>	Captain (PF) ; Copilot (PNF) ; Flight Engineer
<b>Consequences and damage</b>	Aeroplane severely damaged

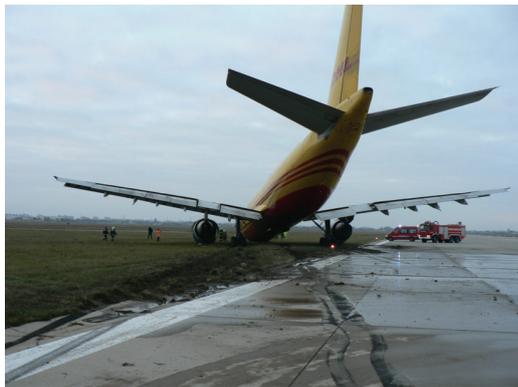
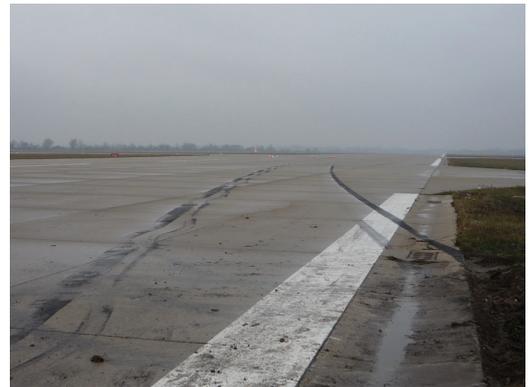
On the runway, a continuous line of rubber from the nose gear tyres was observed. It began on the runway centreline (point 04 on the illustration below) then veered towards the left as far as the edge of the runway. On the last part of the path, another tyre mark from the left rear tyre (tyre n°5) on the left main landing gear was also observed.

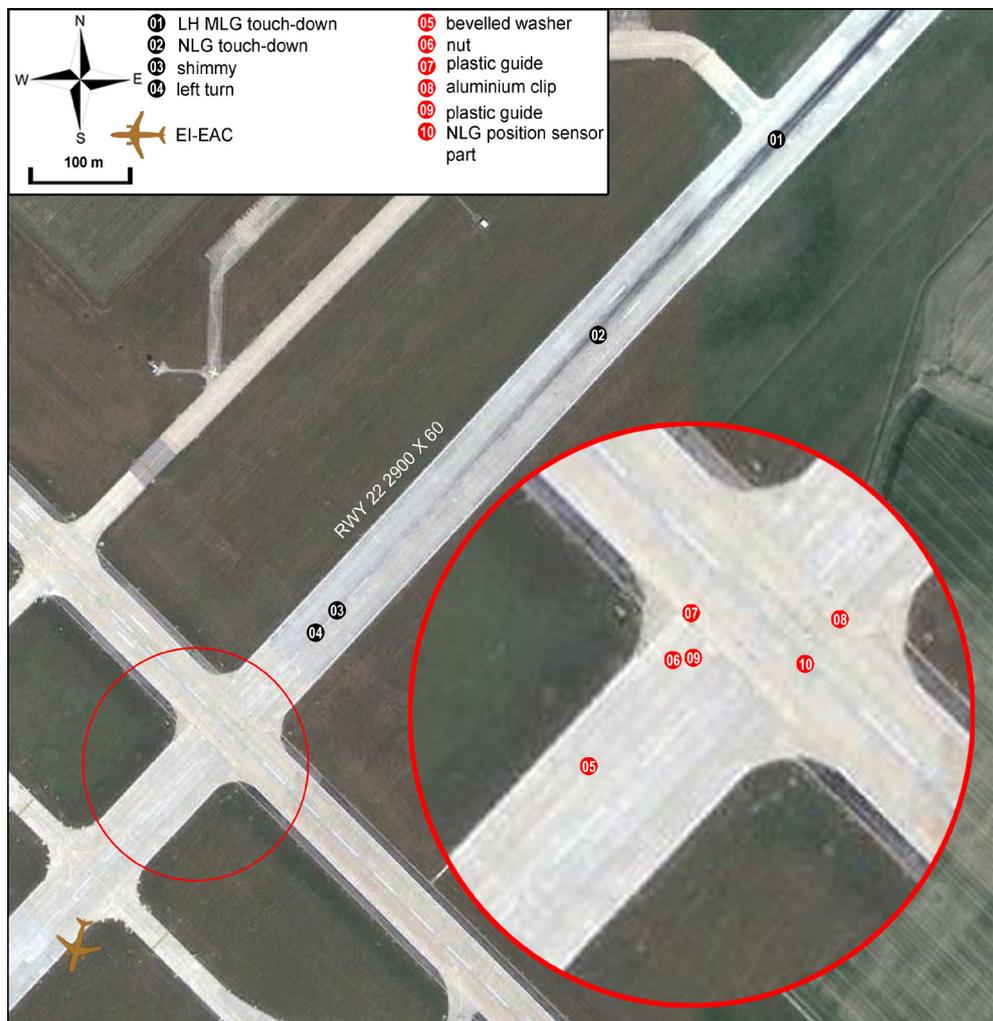
On the runway, parts of the nose gear were found at the beginning of the marks made by the nose gear tyres. Among them was the shock strut apex pin (see list of parts referenced in red on the illustration below).

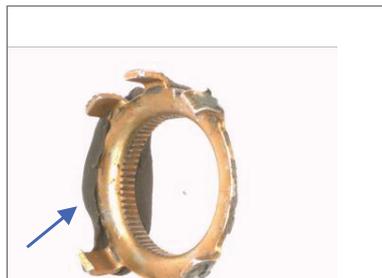
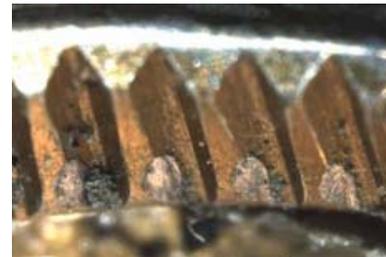
At the accident site, the grooved washer (in blue on the above diagram and part n°5 on the diagram of the central shaft in paragraph 2.2) was not found. The other parts making up the nose gear shock strut assembly were examined at the BEA. The observations and examinations of the shaft showed:

- ❑ Contamination (grease and dust) on the inner side of the shaft head. This seemed to indicate that it was not in contact with the grooved side of the washer (red);
- ❑ Circular marks around the fillet. This seemed to indicate the presence of a washer blocked against the fillet;

- ❑ The shaft thread in good condition. This seemed to indicate that the nut was not torn off but unscrewed in service. At the end of the last grooves on the shaft, damage was observed;
- ❑ The damage to the inner extremities of all of the grooves on the washer lock (n°7).

The examinations showed that the washer lock was not completely engaged on the last series of grooves on the shaft.

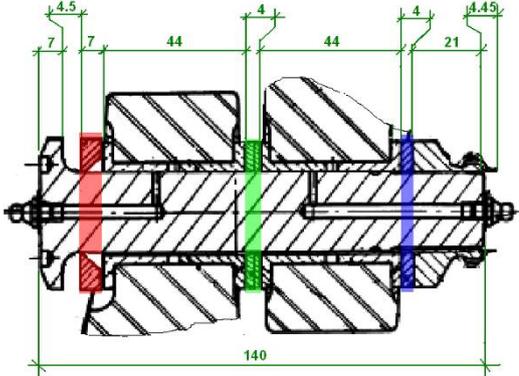
<p style="text-align: center;"><b>Dimensional diagram 1</b></p>
<p><b>2<sup>nd</sup> incorrect assembly:</b></p> <p>In case of inversion of the red and green washers, play is also visible between the shaft head and the badly positioned washer, also because of the fillet.</p>

<p><b>1<sup>st</sup> incorrect assembly:</b></p> <p>The bevelled washer in red in the diagram is installed the wrong way round. In this position, the washer is no longer in direct contact with the shaft head because of the presence of the fillet between the shaft and the shaft head.</p>

In both cases, play of 4.5 mm appears between the shaft head and the first washer installed. This gap makes complete engagement of the key washer on the grooves impossible at the other end of the shaft. The grooves on the washer lock are engaged over less than 1 mm on the shaft grooves, instead of the nominal 4.45 mm.

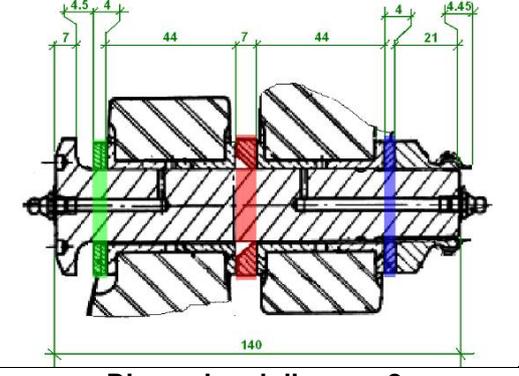
<p style="text-align: center;"><b>Dimensional diagram 2</b></p>

In the case of the second assembly, the greater thickness of the n°1 washer (7 mm instead of 4.2 or 4.4 mm) introduces an additional difficulty during insertion of the centre hinge. Abnormally high effort is necessary to align the bearings of the two arms of the torque links and insert the hinge completely. The second assembly scenario is consequently more difficult to perform than the first.

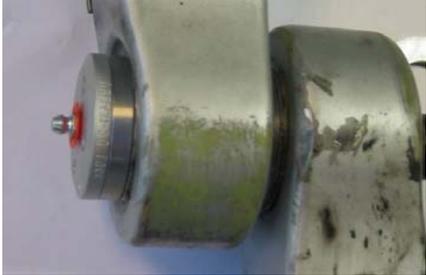
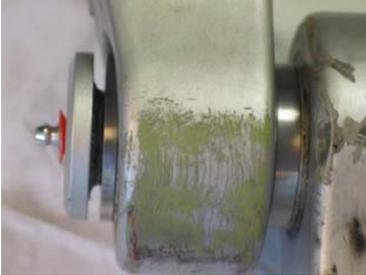
<b>Step 1</b>	
<b>Correct assembly</b>	<b>Incorrect assembly</b>

<p>Installation of the bevelled washer with its bevelled side in contact with the shaft head leaves no play.</p>	<p>A 4.5 mm space is visible between the shaft head and the badly positioned washer.</p>
<b>Step 2</b>

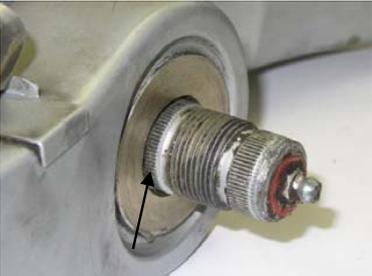
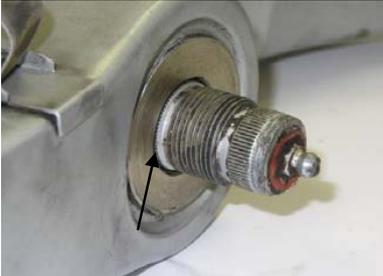
<p>The shaft grooves appear. The grooved washer engages in the first grooves. Once in place this washer is prevented from rotating.</p>	<p>The shaft grooves no longer appear. The grooved washer can no longer engage in the shaft grooves. This washer can then rotate freely.</p>
<b>Step 3</b>

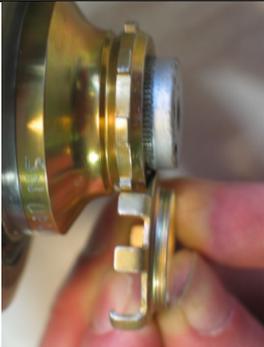
<p>About 0.5 mm of shaft grooves is visible after installation of the washer lock.</p>	<p>The key washer cannot completely engage on the shaft grooves. The grooves go past the washer lock.</p>

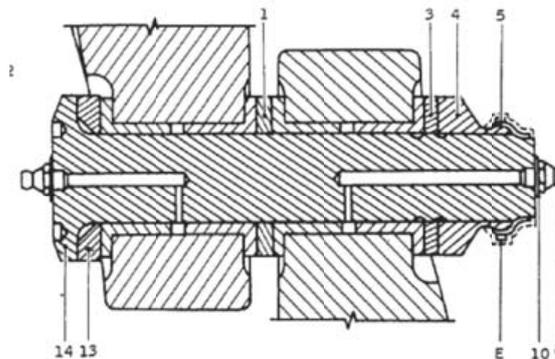
Extract from AMM 32-21-15 p. Block 401

The assembly diagram used in the AMM 32-21-15 p. Block 401 « Nose gear torque Links– Removal/Installation » gives exact details of the position and the shape of each washer. However the text associated with the diagram does not specify the order for installation and does not inform the operator of the need to install the first washer with its bevelled side in contact with the shaft head. It states:

- During disassembly, keep the washers (3), (1) and (13) (diagram below).
- During re-assembly, re-install the washers and refer to the AMM 32-21-15 p. Block 801« Nose gear torque Links – Approved repairs» in order to measure the play between the two torque link arms :

Despite the presence of a detailed diagram, the absence of clear and detailed instructions in the text of the manufacturer's AMM, allowing the operator to ensure that the assembly was correct, contributed to the incorrect assembly.

Following the accident, Airbus provided all Airbus A300/A300-600/A310/AST customers with recommendations on the maintenance of nose gear steering torque link assembly (Operators Information Transmission - OIT ref 999.0014/13 dated 3 April 2013). This publication draws operators' attention to the importance of correct assembly of the washers on the nose gear torque link centre hinge. It was stated that a warning would be added to the AMM 32-21-15 p. Block 401 « Nose gear torque Links – Removal/Installation » during its next revision.
