FINAL REPORT

on the safety investigation of an air accident
of a helicopter type **Guimbal Cabri G2**
registration mark **OK-BRI**

Reg. No: **SKA2018001**

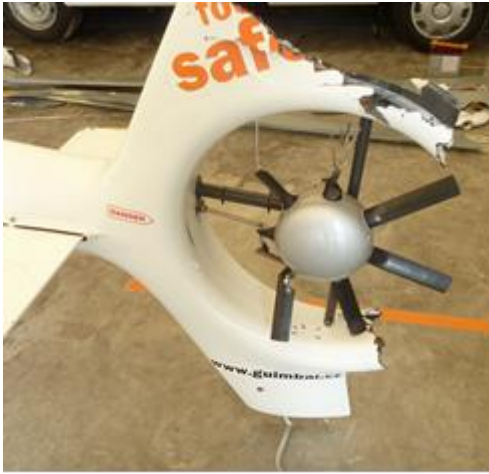
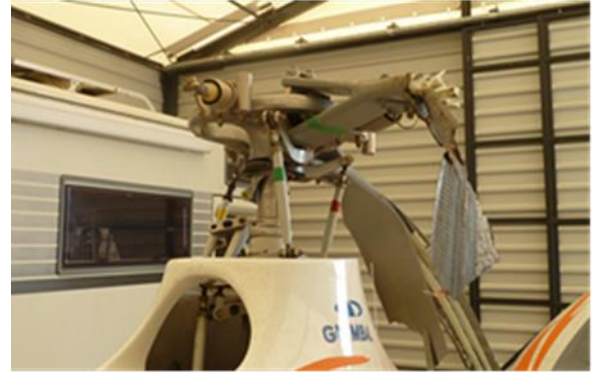
Pictures 1, 2. When the helicopter fell down, the fenestron and consequently the MR and the engine were stopped by force

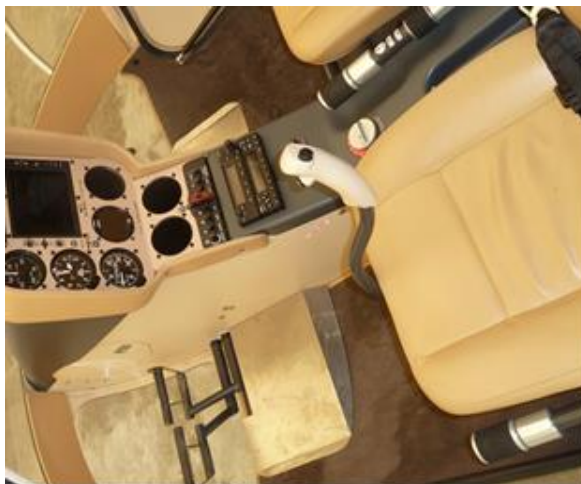
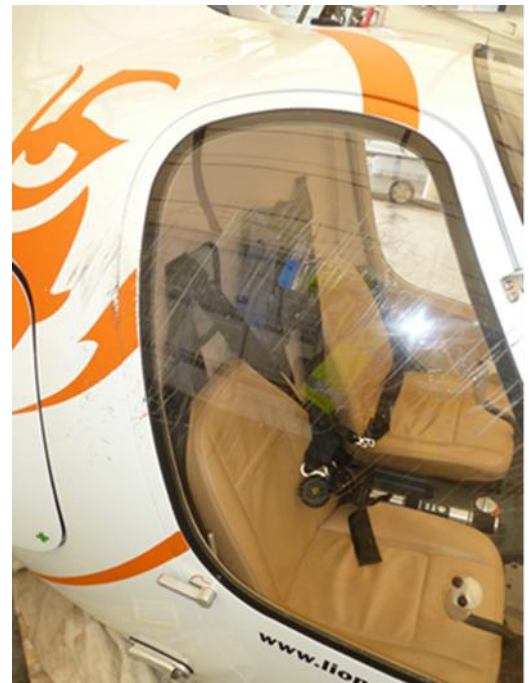
Picture 3. From inside, the pilot cabin did not show any signs of damage; the cabin was slightly damaged on its right side

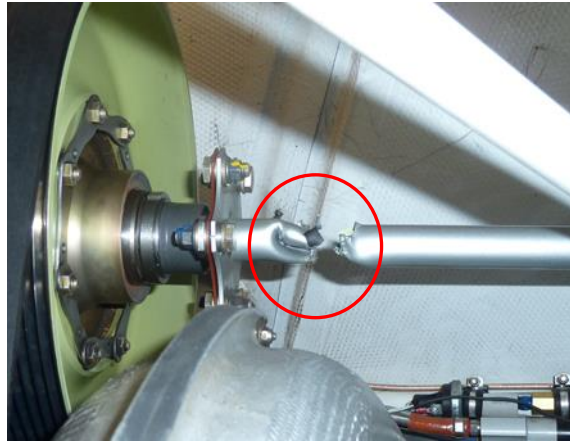
During a detailed inspection of the crashed helicopter, in particular of the functionality of the pedal control and of the functionality and integrity of the fenestron transmission, it was found that such elements were and remained functional even after the accident, except for the transmission which was disrupted as a result of the violent stoppage of the fenestron during the accident as a consequence of the engine torque.

Picture 4. Disrupted transmission

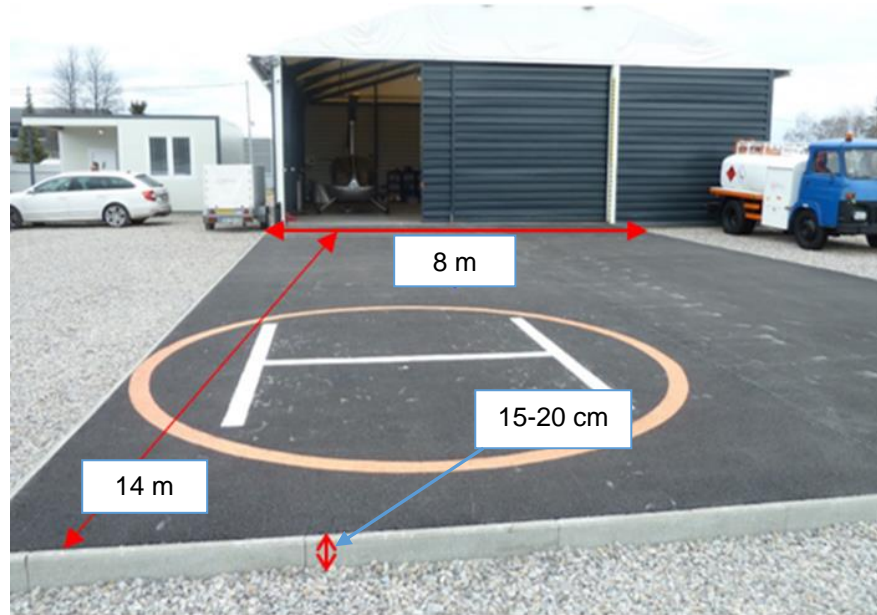
The heliport is located on an aircraft stand sized 14x8 m, eccentrically in the left corner (when looking at the hangar) of the more remote part (i.e. with its centre approximately 12 m from the hangar).

Picture 5. Heliport location and size

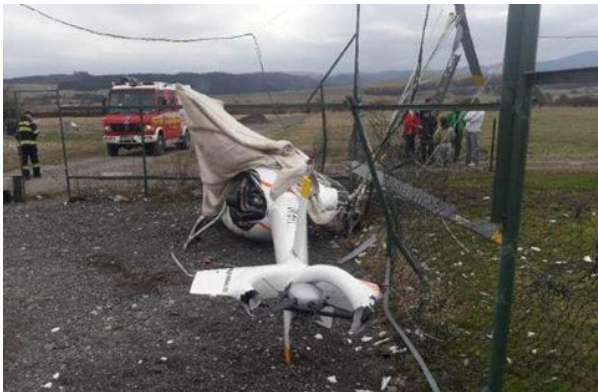
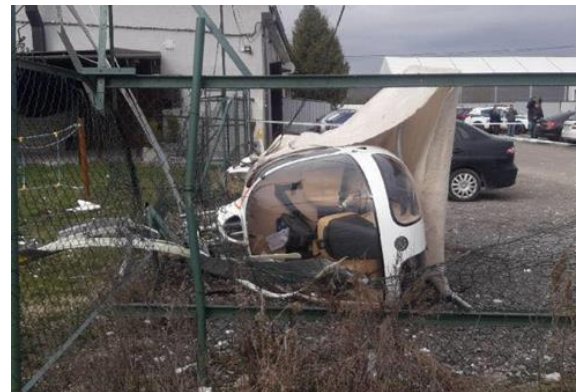
The helicopter fell on a hardened local road bordered with wire fencing at a distance of 30 m from the take-off site.

Pictures 6, 7. Air-crash site

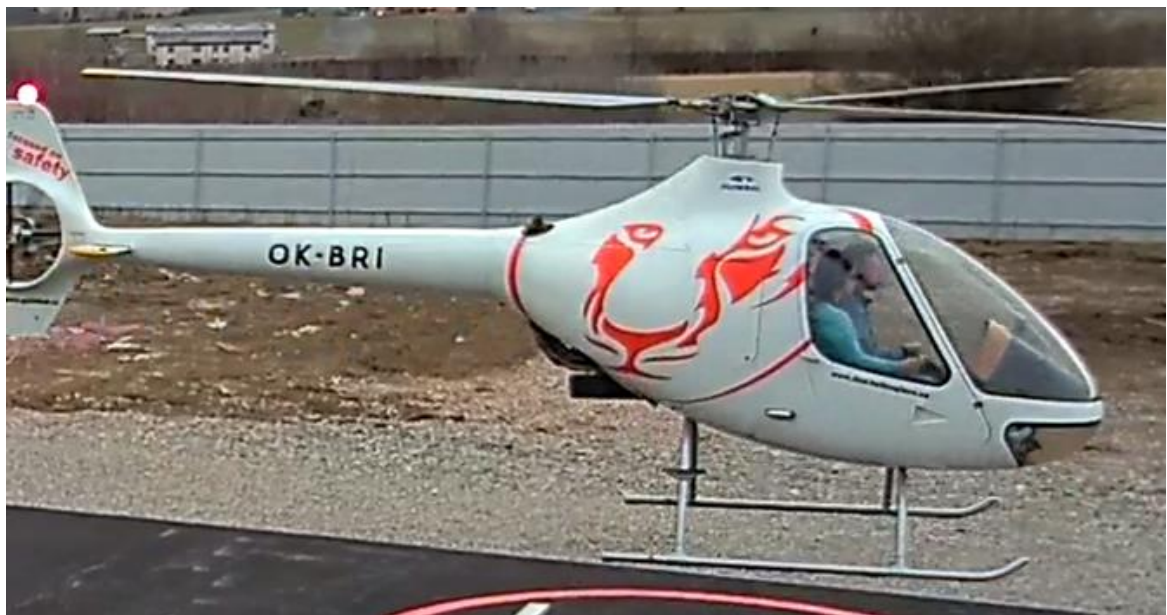
The committee had a video recording from a camera located on the hangar. The recording shows the take-off part from the moment the helicopter took off from the heliport until the start of the third 360° turn. The recording also shows that both crew members have their hands and feet on the helicopter's control elements and also the right deflection of the instructor's control pedal.

Picture 8. Position of the student's feet on the control pedals
