FINAL REPORT

on safety investigation of an aviation accident

of gliders type **LS8-18**

Reg. No: **SKA2018002**

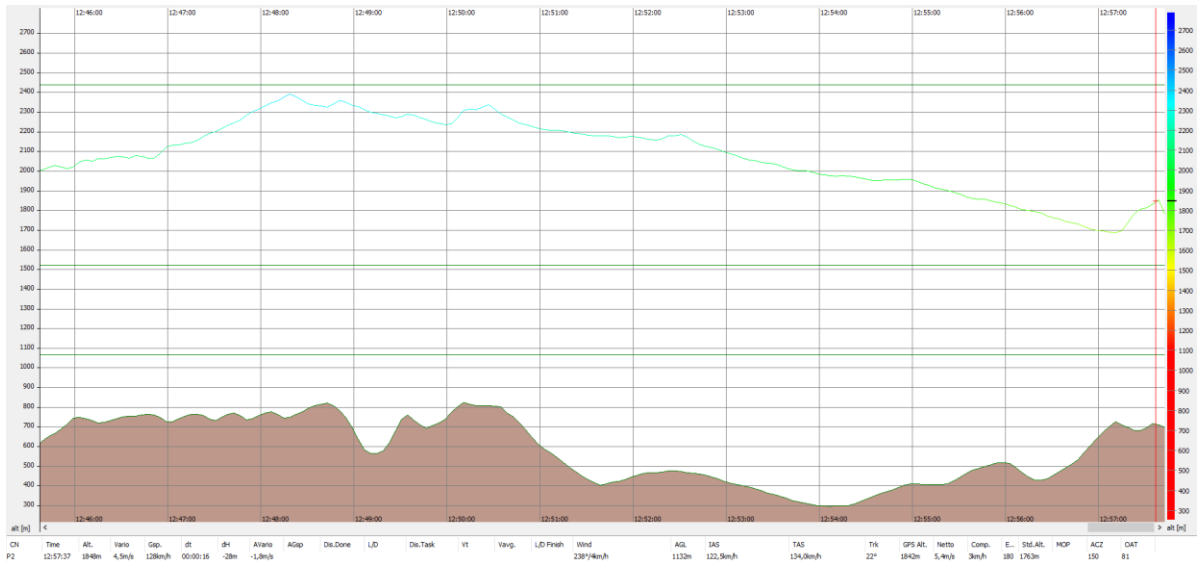
Being 4 m above the "P2" glider, the "A" glider's left wing hit the left wing of the "P2" glider at an altitude of 1,850 m; 710 m above the terrain.

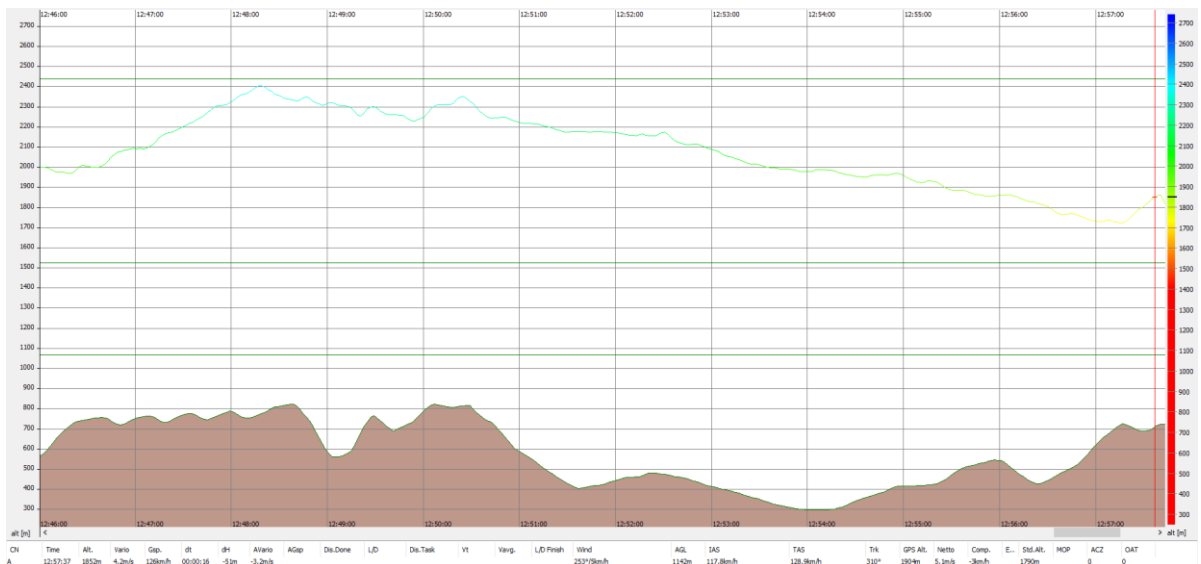
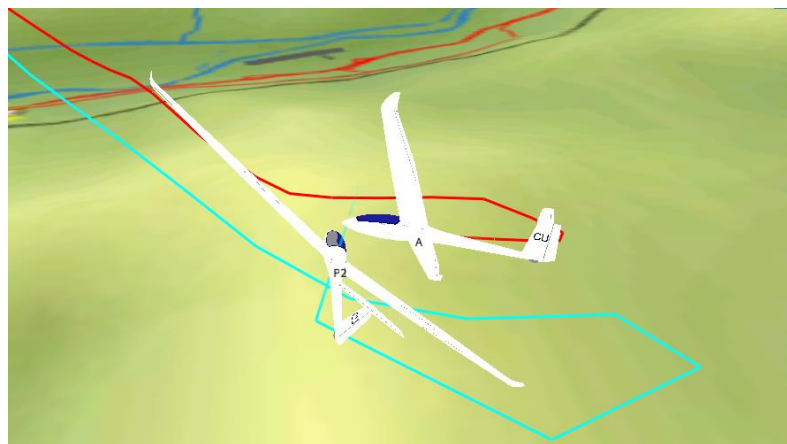
The "A" glider pilot was the second one to start turning right with a horizontal separation of 350 m behind the "P2" glider, with the probable intention of overtaking him. During the right turn he got above the "P2" glider in an upward flow; he subsequently lost visual contact with the "P2" glider as a result of covering it with a lower part of the "A" glider cabin.

to make a detailed analysis of the air accident with aircrew during regular winter training, emphasizing the importance of following all procedures and rules with regard to giving way when lining up, circling, leaving upward flows and avoidance during the flight.

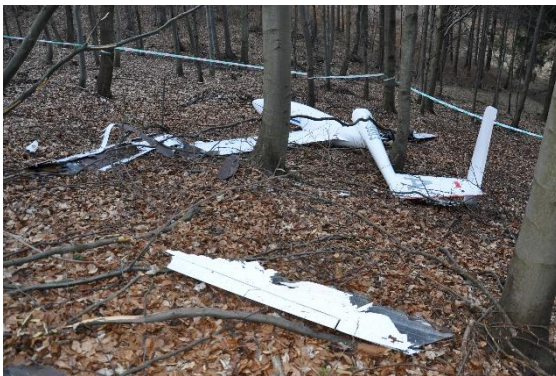
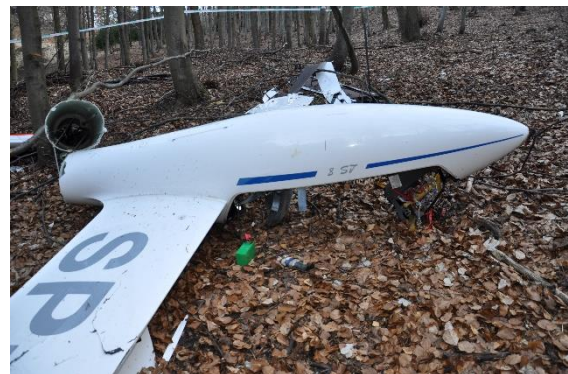
The "A" glider was destroyed in the aviation accident.

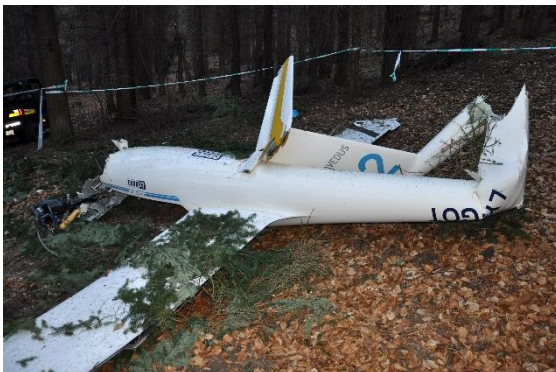
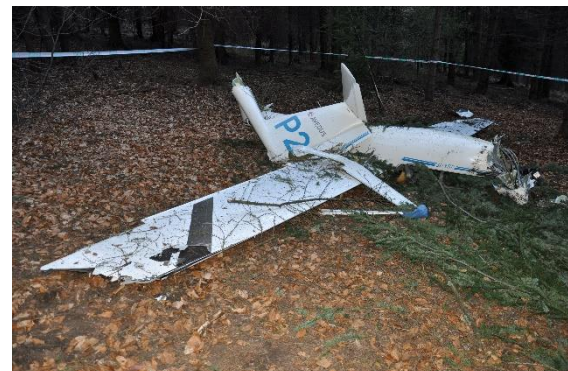
The "P2" glider was destroyed in the aviation accident.

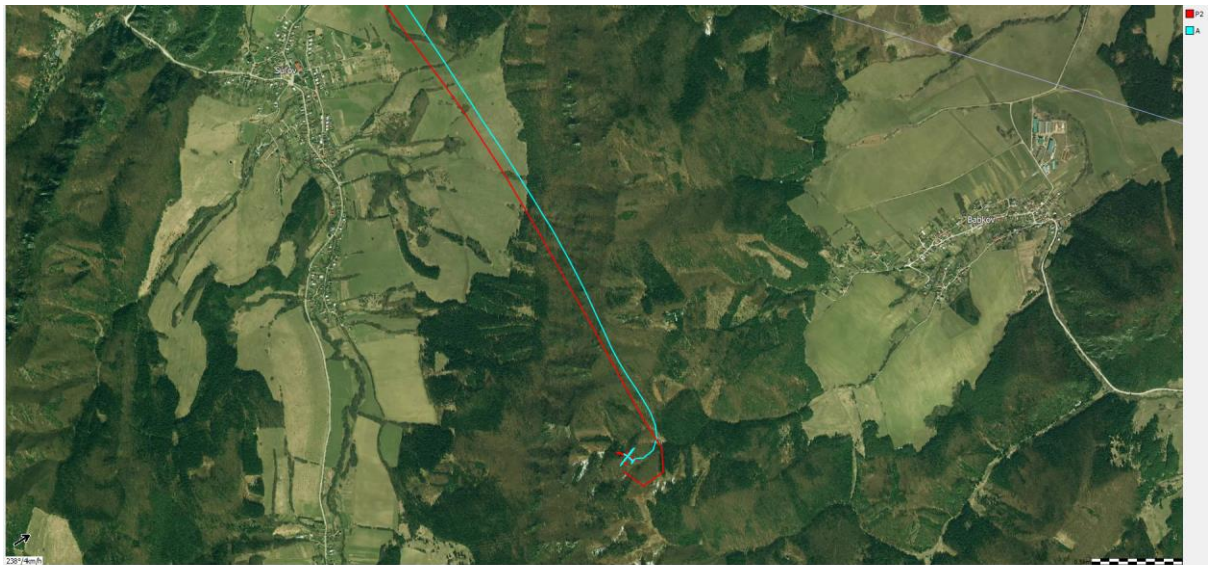
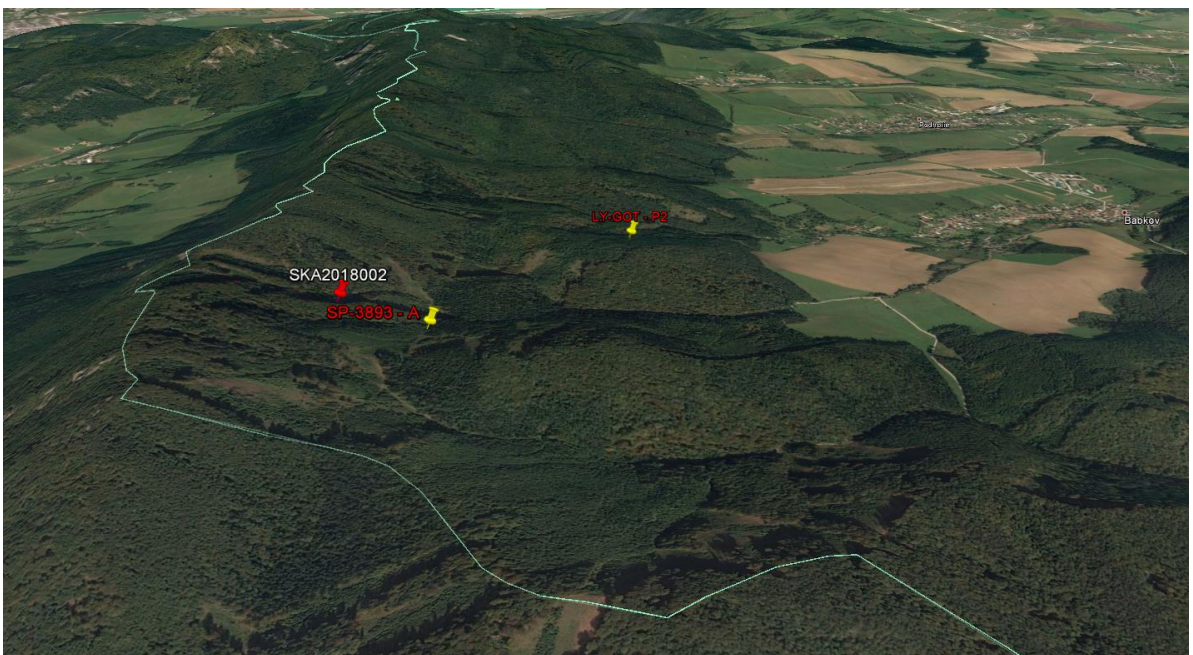
"P2" glider crash site: N 49°09'60"; E 018°37'21"

"A" glider crash site: N 49°08'45"; E 018°36'58"
