AVIATION AND MARITIME INVESTIGATION AUTHORITY
Námestie slobody 6, P.O.BOX 100
810 05 Bratislava

FINAL REPORT

on the safety investigation of an air accident
of a glider type **Ventus bT**
registration mark **D-KEYX**

Reg. No: SKA2018003

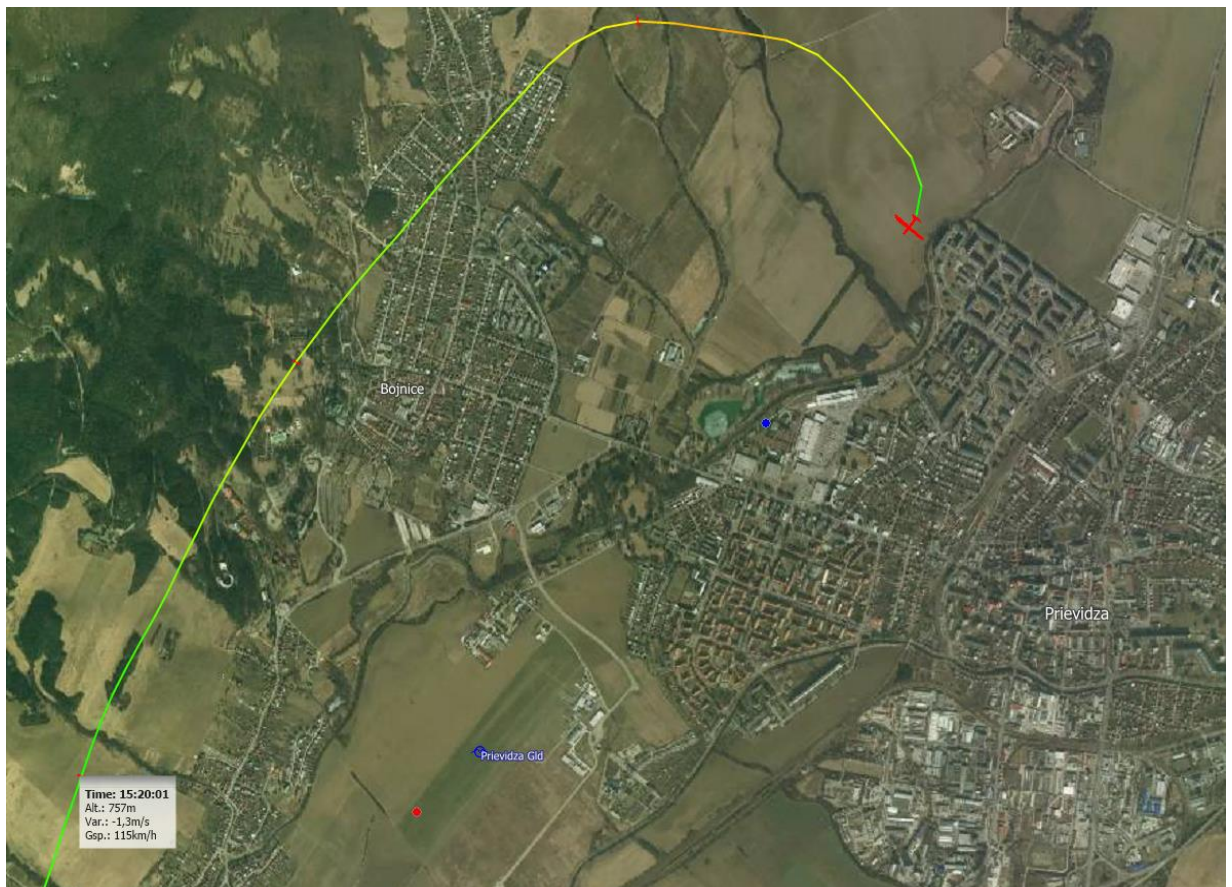
At 15:22:47, at an altitude of 273 m AGL, 2.6 km from the threshold of VPD22, after levelling out the turn for the final approach, the pilot started increasing his landing speed.

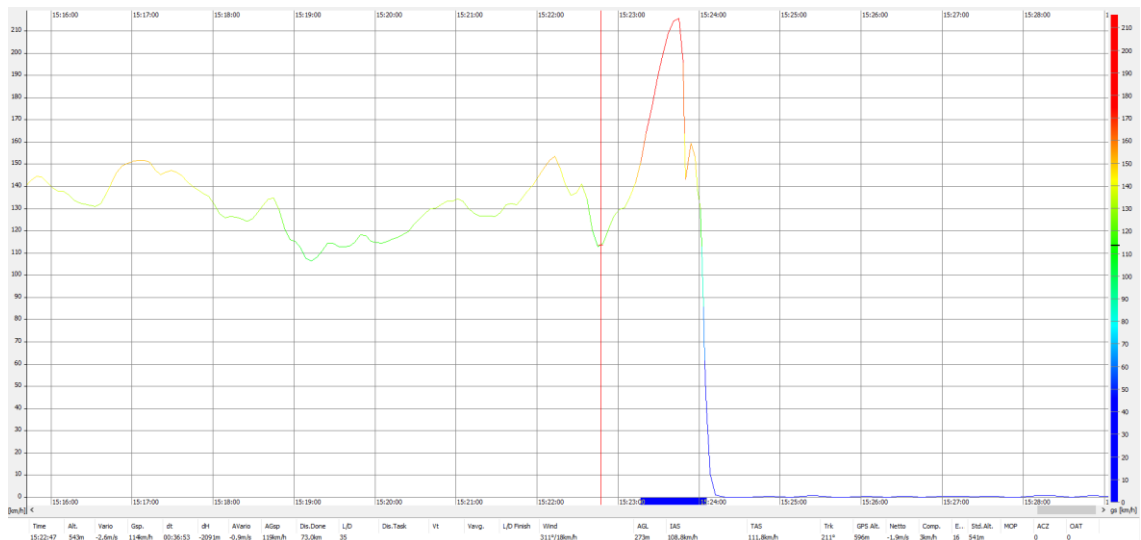
In his testimony the pilot states that 1 km from the threshold of VPD22 he saw a parachutist above LZPE at an altitude of 150 m AGL and decided to land at the above-stated airport as soon as possible and with the shortest possible track in order to avoid collision with the parachutist by increasing his landing speed again.

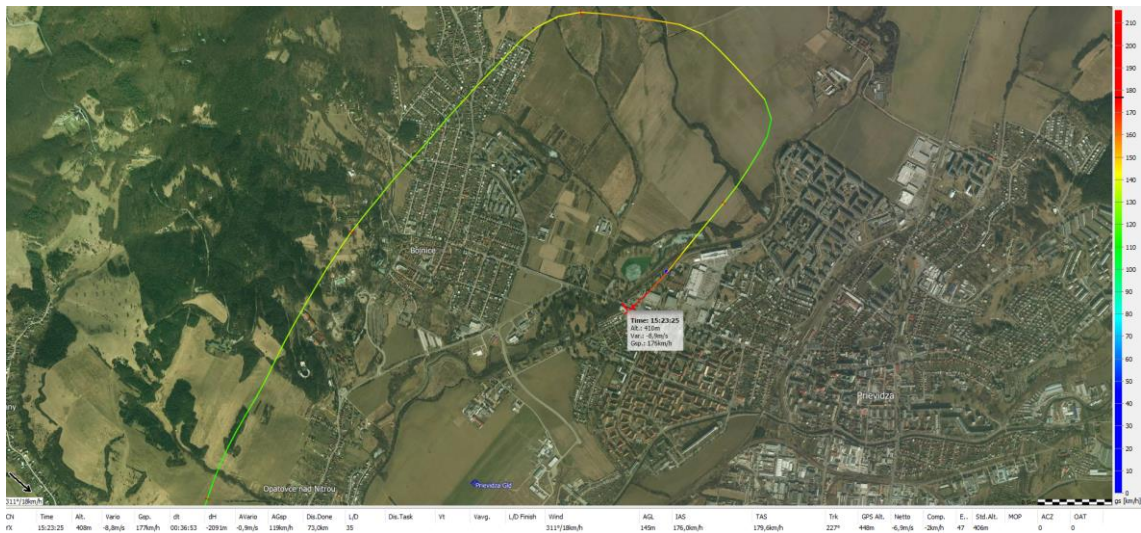
Approximately 50 m before the threshold of VPD22, at an altitude of 20 m, the pilot's landing speed was 214 km/h.

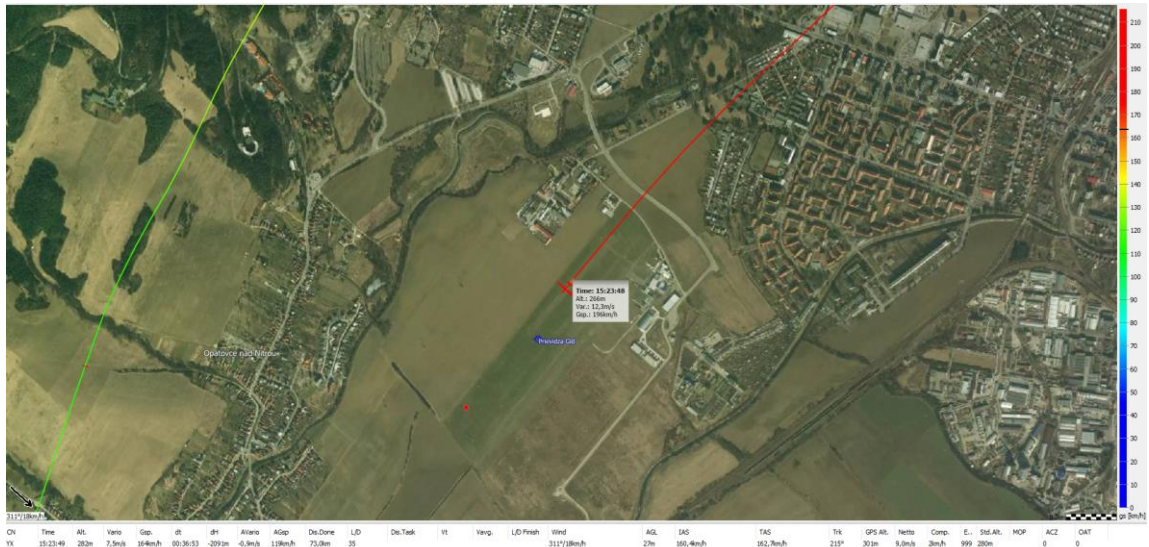
Then the glider made a hard touchdown on VPD22 at high speed without its speed brakes extended.

Its first contact with VPD22 was at the speed of 196 km/h and it was followed by a 20-metre-high bounce.

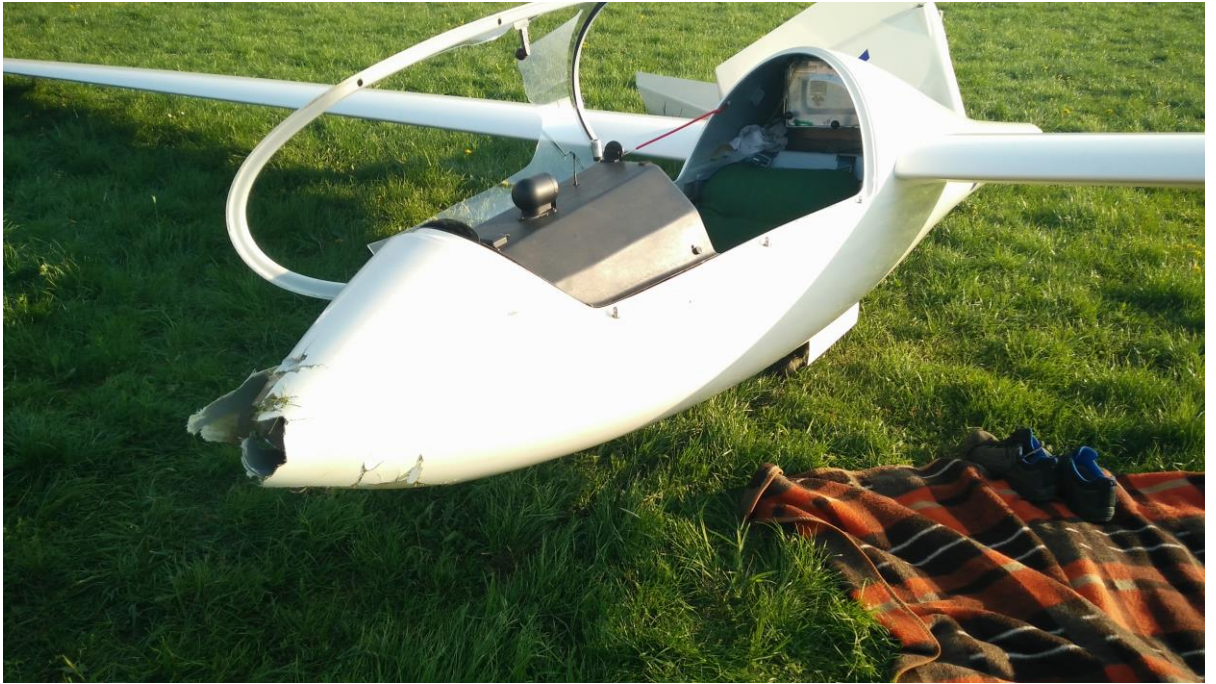
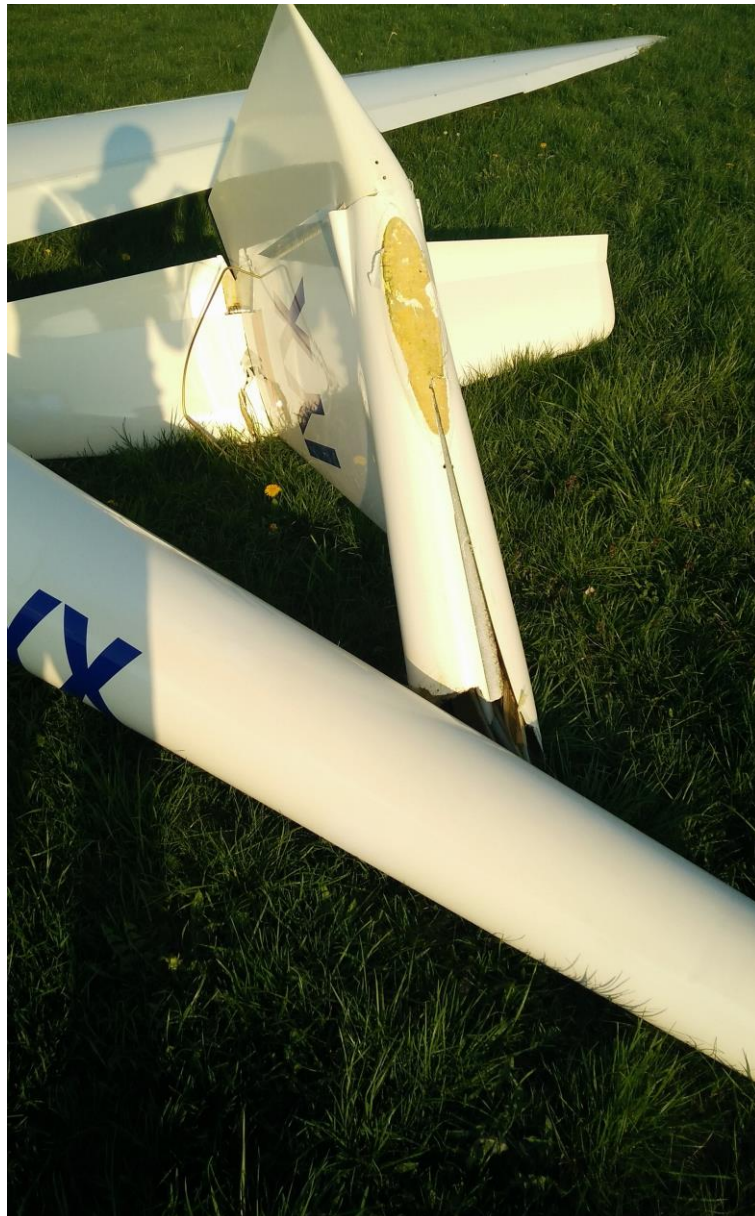
After the last bounce of the glider which was approximately 5 metres high and its subsequent touchdown on VPD22 with wings overswung, the right wing tip got caught on the ground with such force that the glider started rotating around its vertical axis, made a 360° turn, overturned to the front and hit the ground with its front part. As a result of the impact and rotation, the front part was destroyed, the fuselage broke approximately 70 cm before the keel and the winglets were damaged.

The glider was destroyed in the accident:

- the fuselage was broken;
- the entire wing was damaged;
- the cabin part was destroyed.

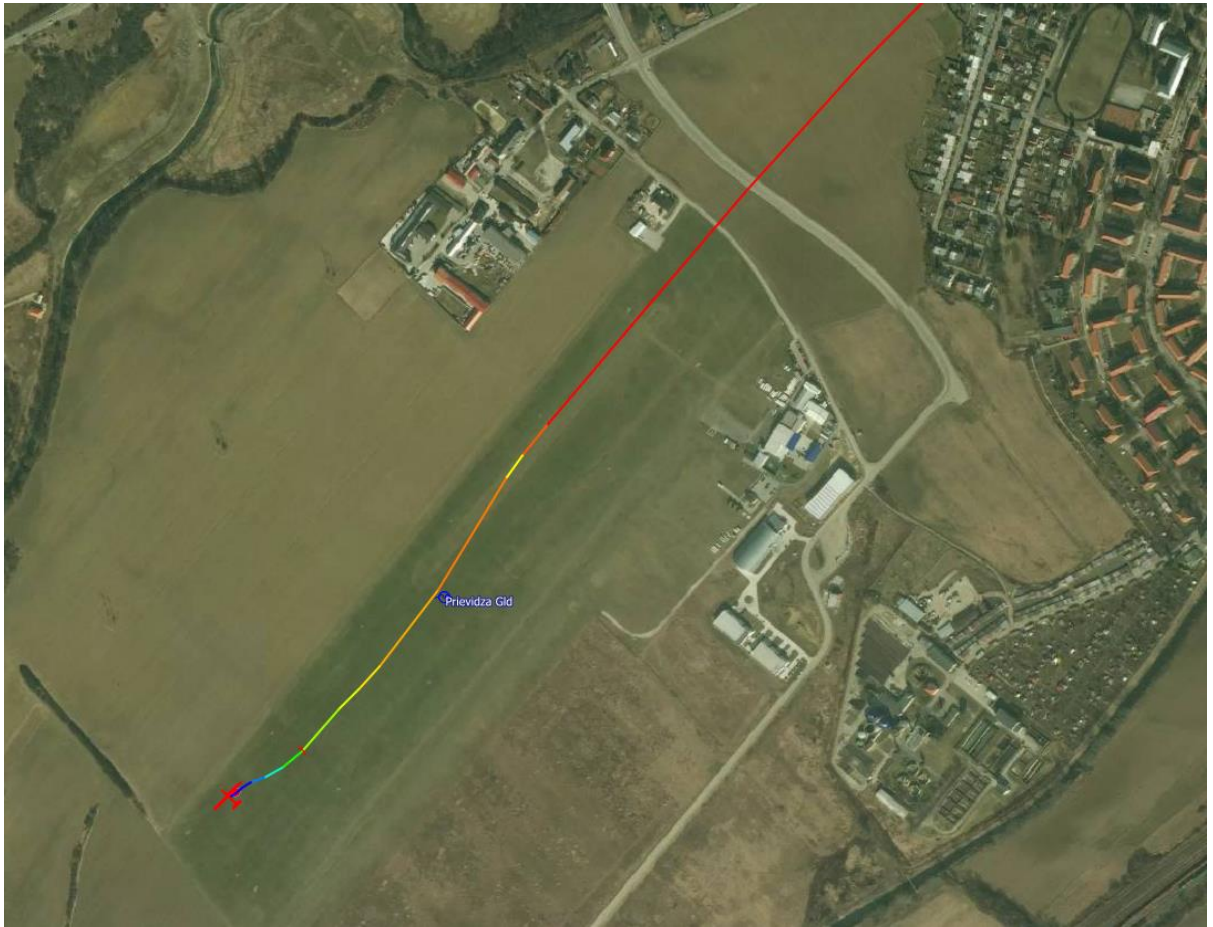
Coordinates of the accident site: N 48° 45' 49'', E 18° 34' 58''
