# FINAL REPORT

on the safety investigation of an air accident  
of a glider type **Standard Cirrus**  
with registration mark **OM - 7274**

Reg. No: **SKA2018004**

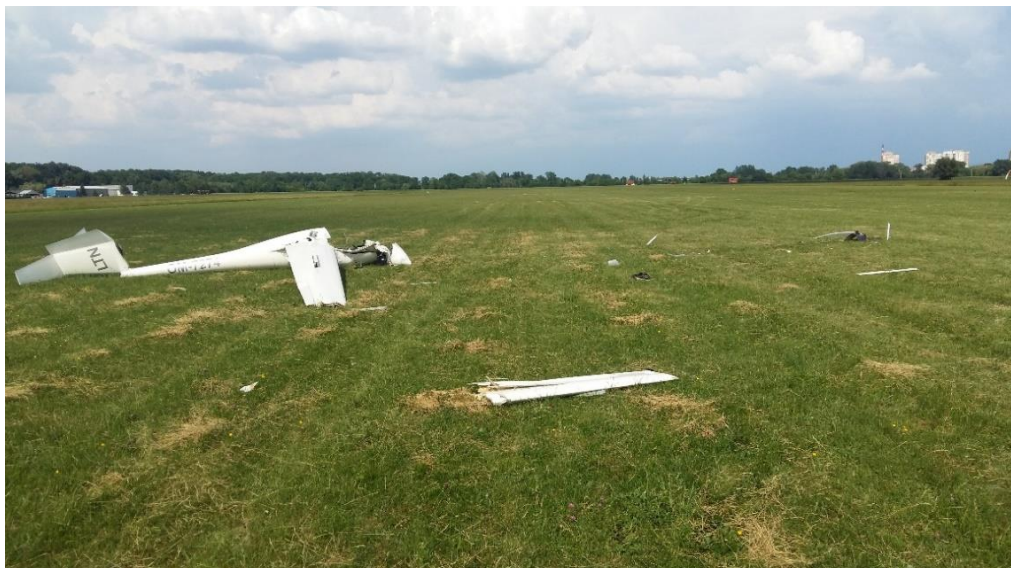
The glider was destroyed in the accident.

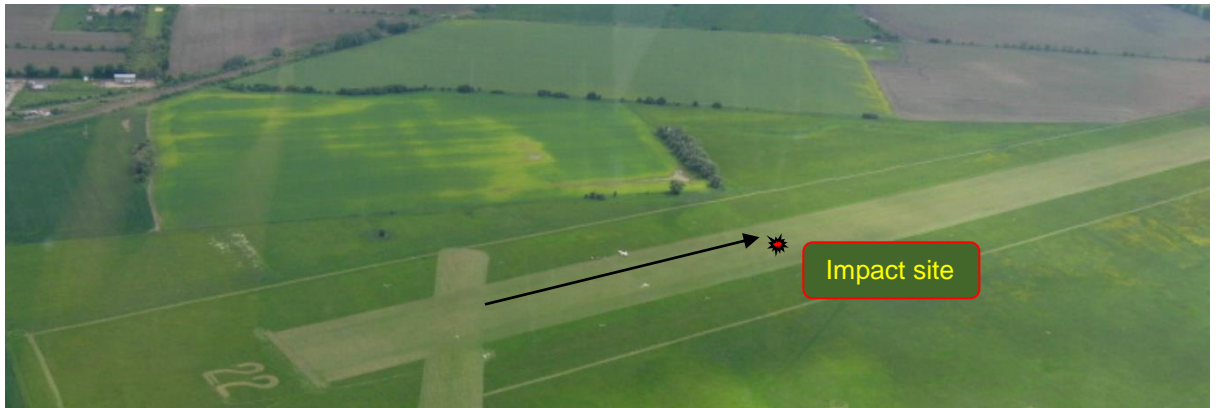
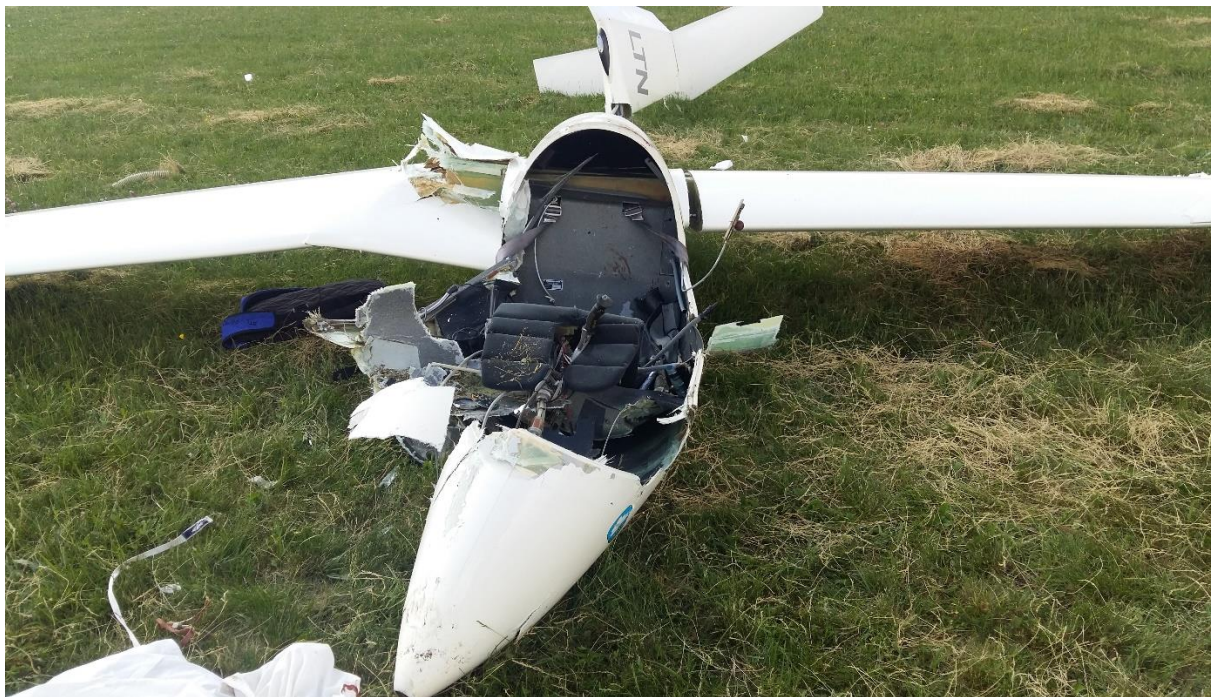
Coordinates of the accident site: N 48°48'40", E 017°08'08".

After take-off, the glider started climbing steeply, which led to loss of control of the glider and its subsequent fall on VPD22 with its right wing.

1. **Standard Cirrus** gliders cannot perform winch-assisted take-offs.
2. Every year before the start of the season or before a winch-assisted solo flight in a single seat glider, pilots must perform 4 winch-assisted launches with an instructor.
