FINAL REPORT

on the safety investigation of an air accident
of a helicopter type **Robinson R44 Raven I**
registration mark **OM-TTM**

Reg. No: **SKA2018005**

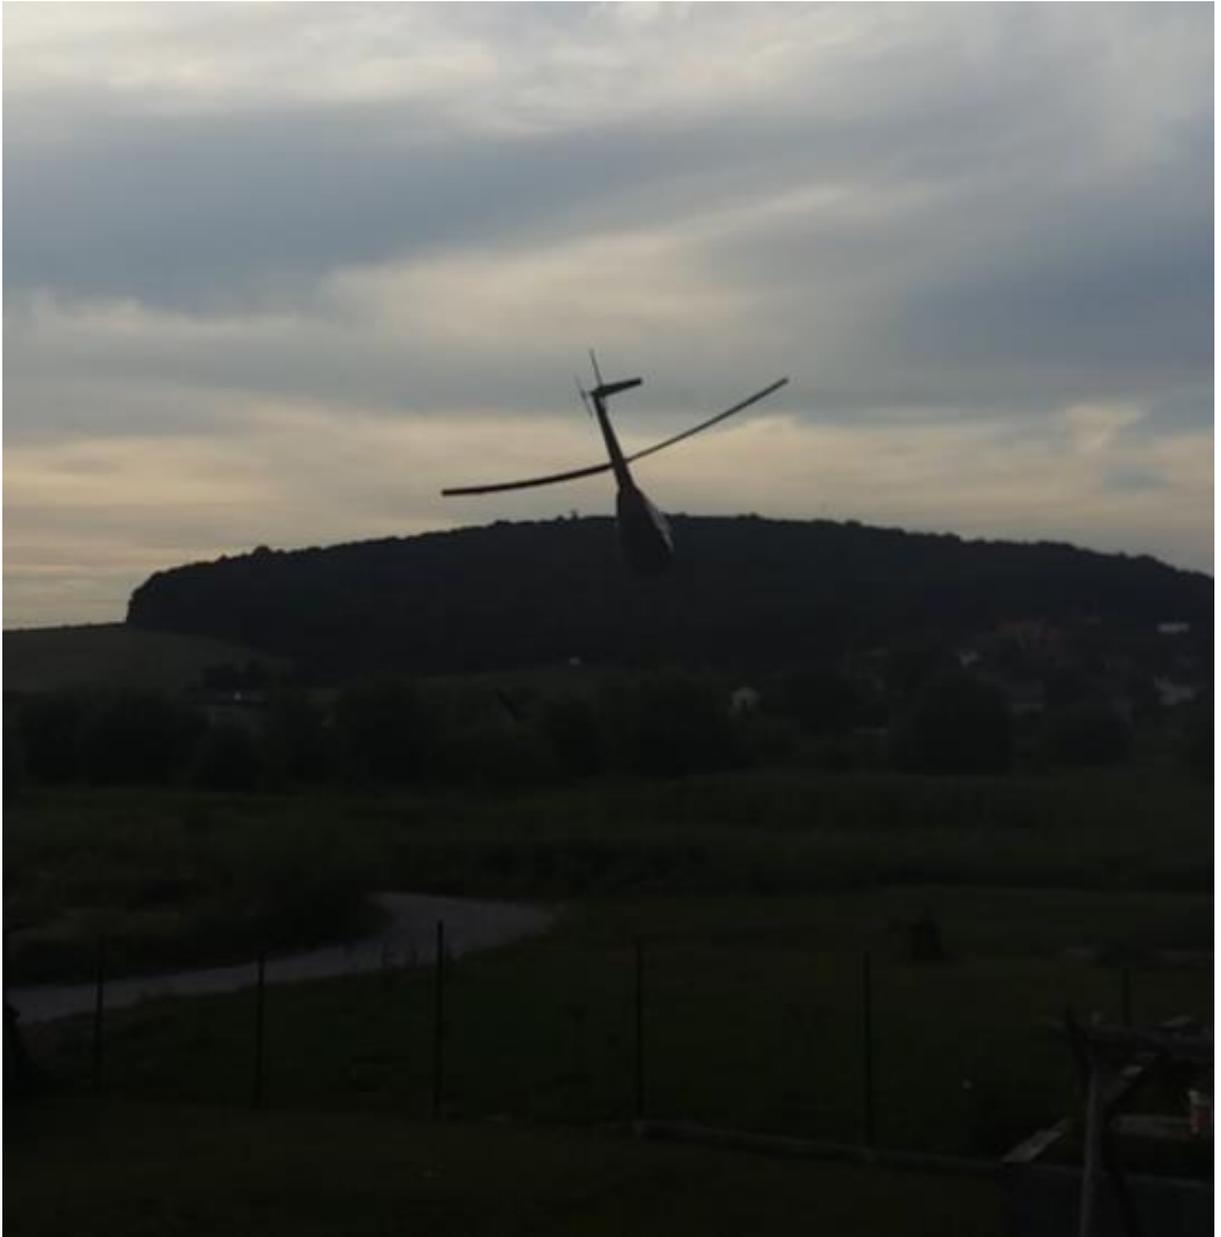
Then the pilot turned the R44 to the left in site. When turning, the pilot pushed the cyclic control stick and, while increasing the engine power, he departed with a descending flight, increasing the forward speed enormously with the heading 330°.

Ten seconds after departure, the R44 hit the HV lines which caused its destruction and subsequent fall. The R44 fell on a private field.

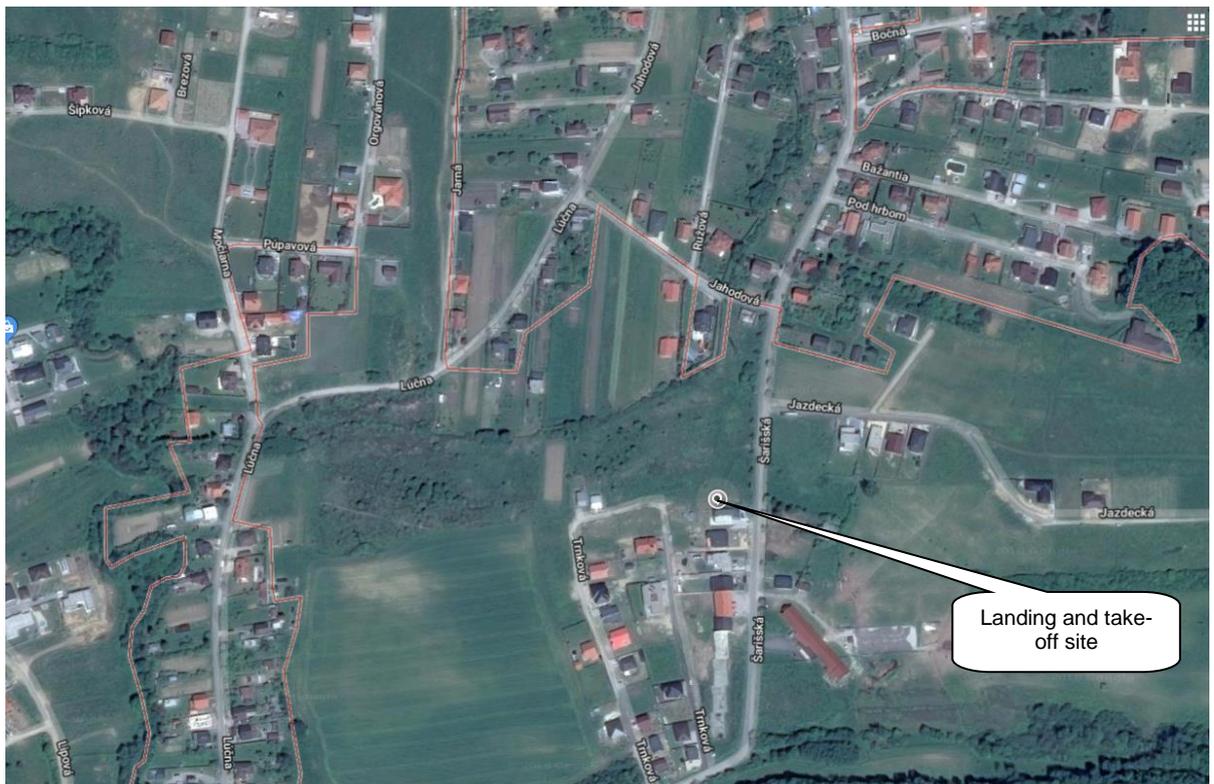
The landing and take-off site may be described as a 25x10 m area with a moderate incline, oriented in the direction 085°/265°, located near a family house with numerous obstacles in the surroundings. After landing, the R44 sat with its front part against the slope.

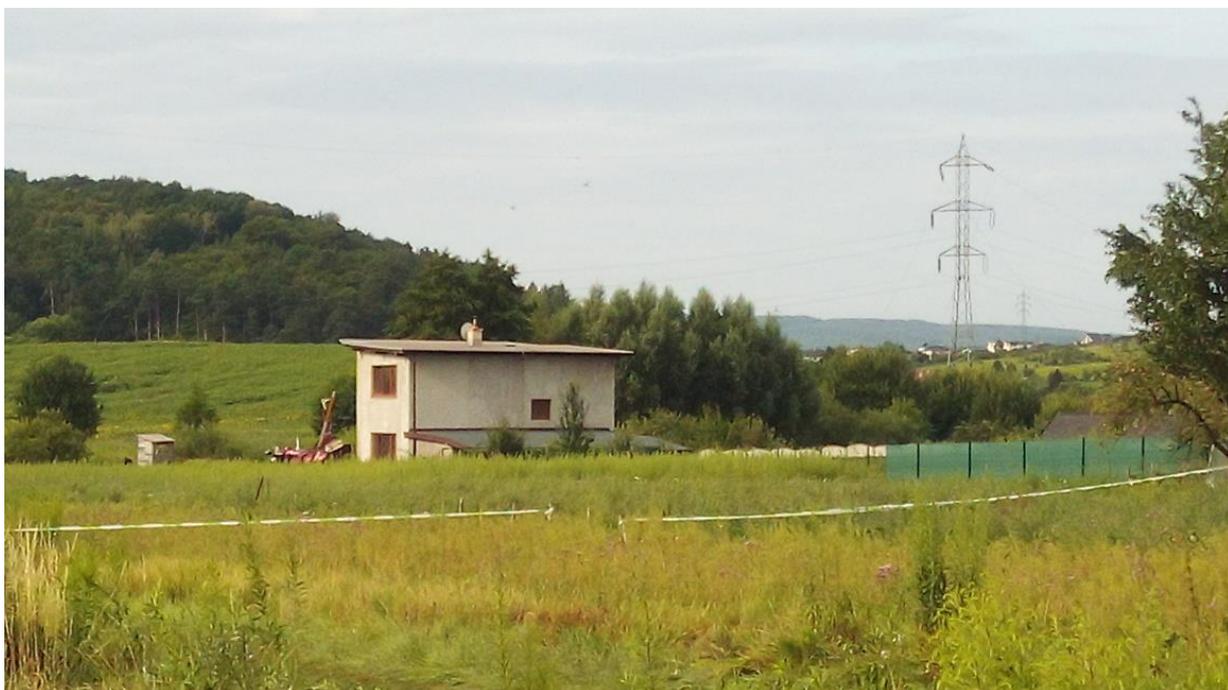
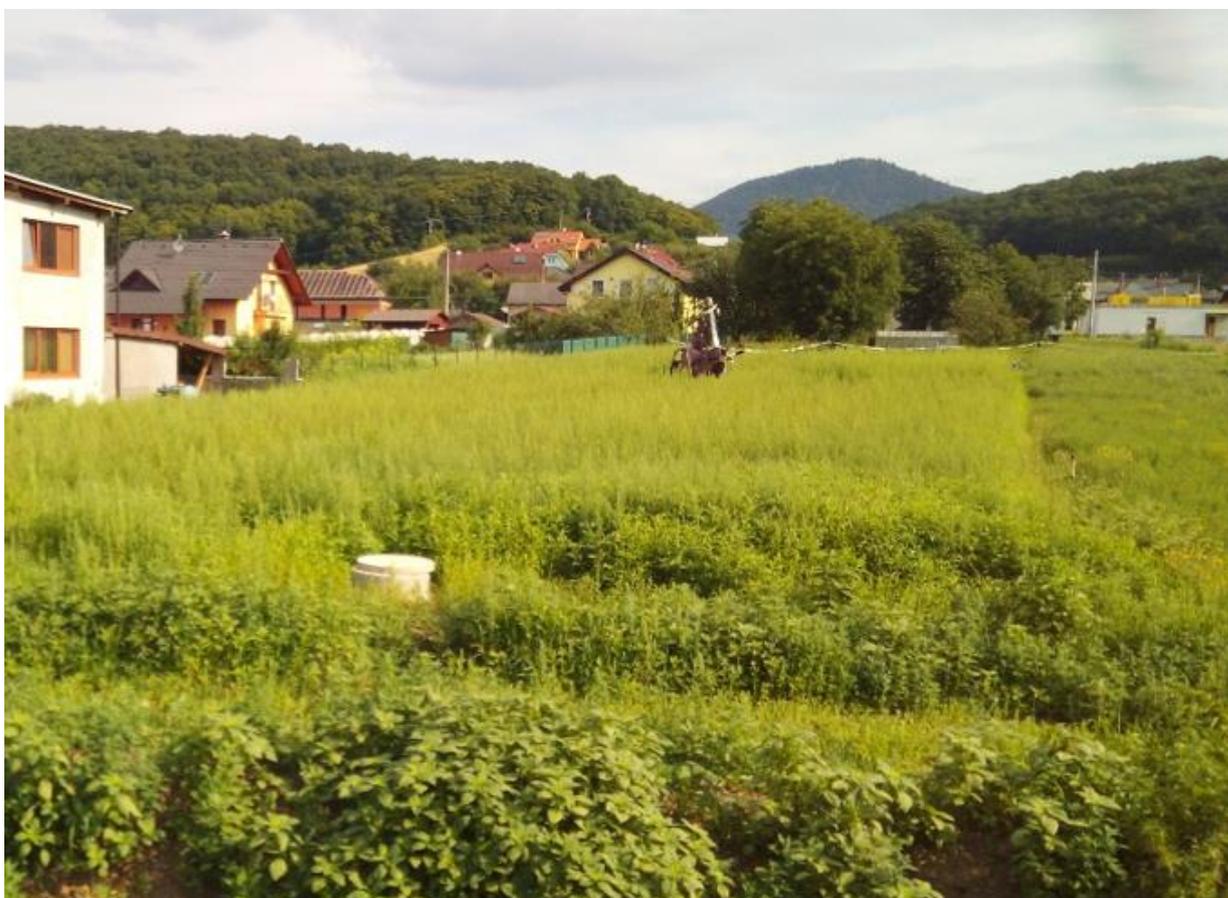
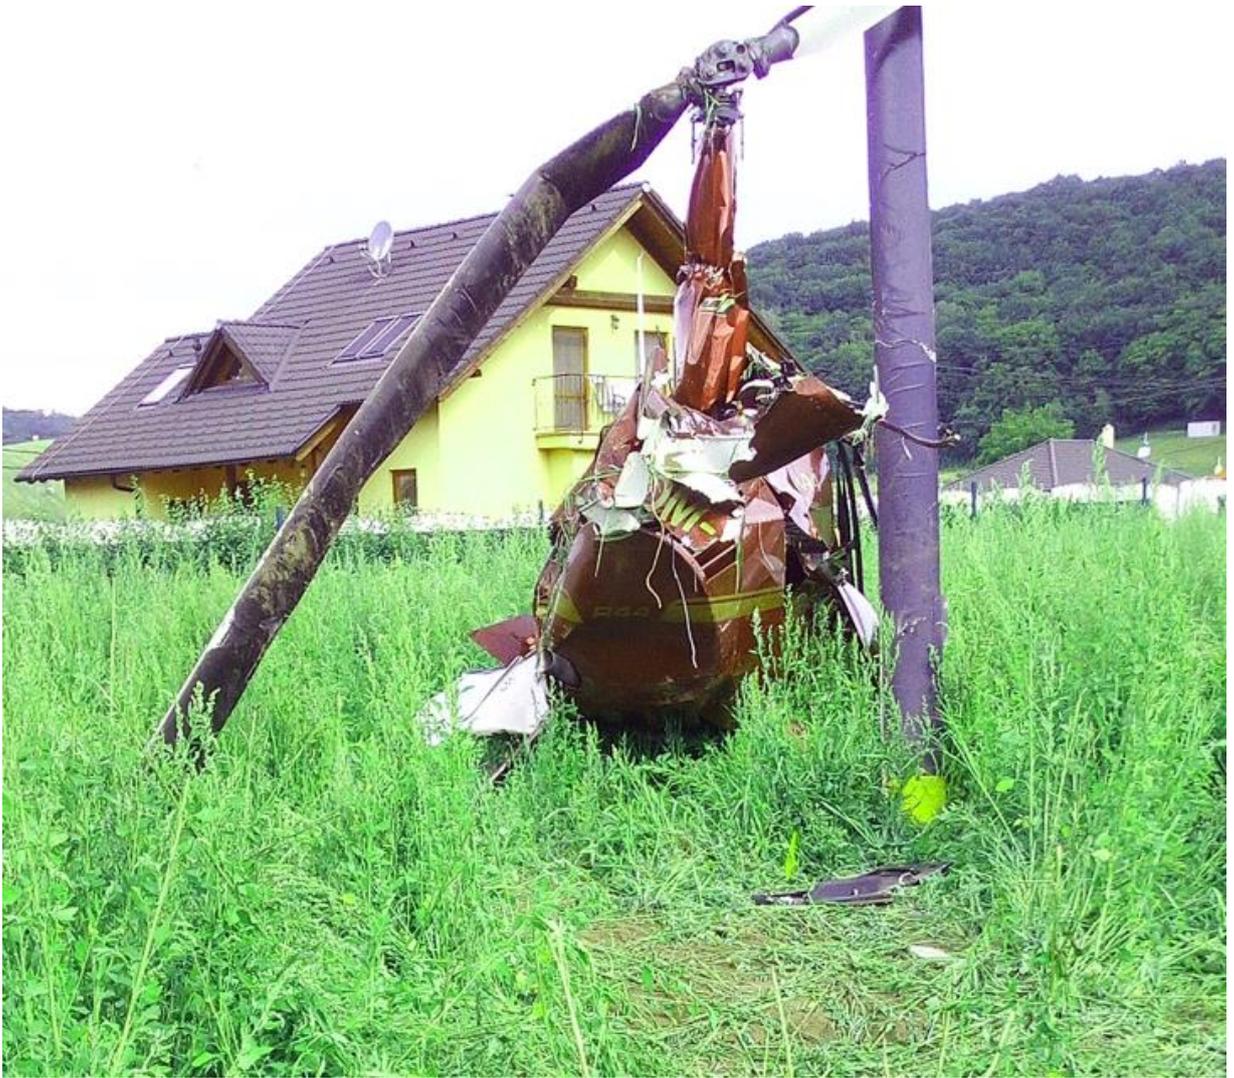
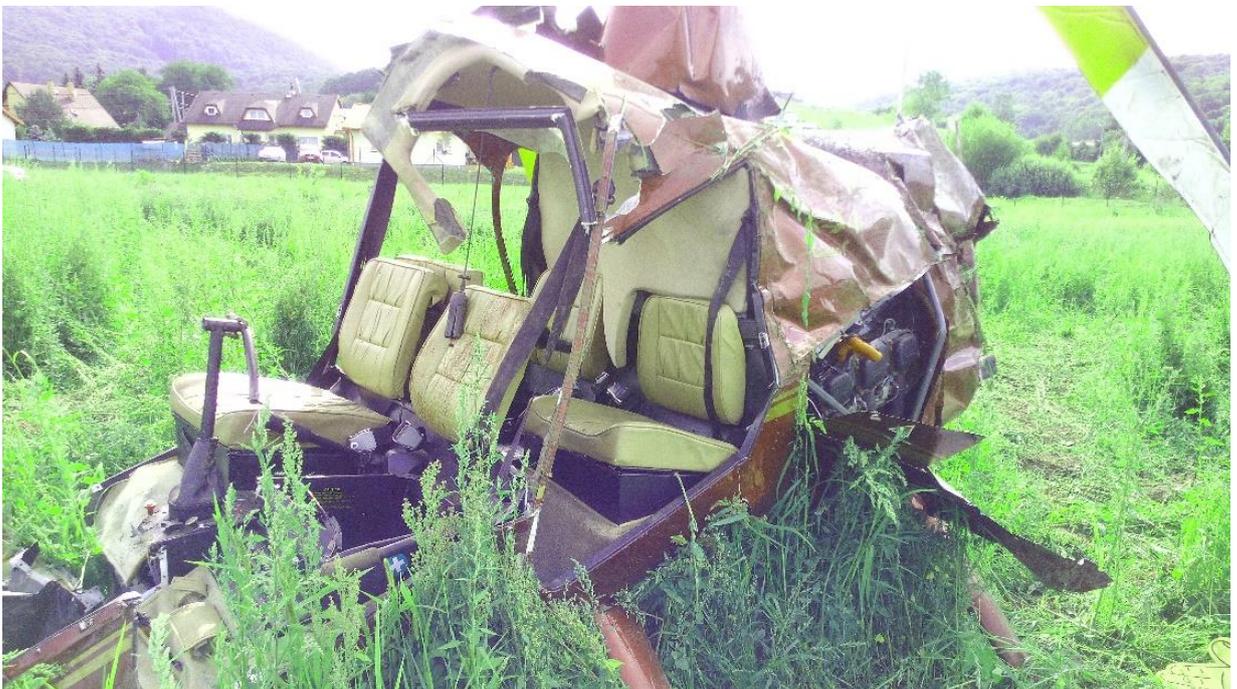
The fuselage was quite distorted and its front part was completely destroyed. Traces of earth were found on the wreckage of the fuselage, including the cylinder head of the main rotor and blades, so after the R44 hit the ground, it turned over on the front and the right side and the rotation was stopped by the skids.

The tail boom was separated and was found intact, 10 metres from the fuselage.

The control panel was thrown out of the fuselage and was found 2 metres from the fuselage; the cyclic control stick was damaged. The foot pedals of the pilot were torn off; the foot pedals in front of the seat of the other pilot were damaged.

The cover of the main rotor shaft was distorted and cut after the impact with the HV lines; the cyclic control rods were damaged. The cylinder head of the main rotor was damaged, both blades were broken at their roots and damaged along their entire length.

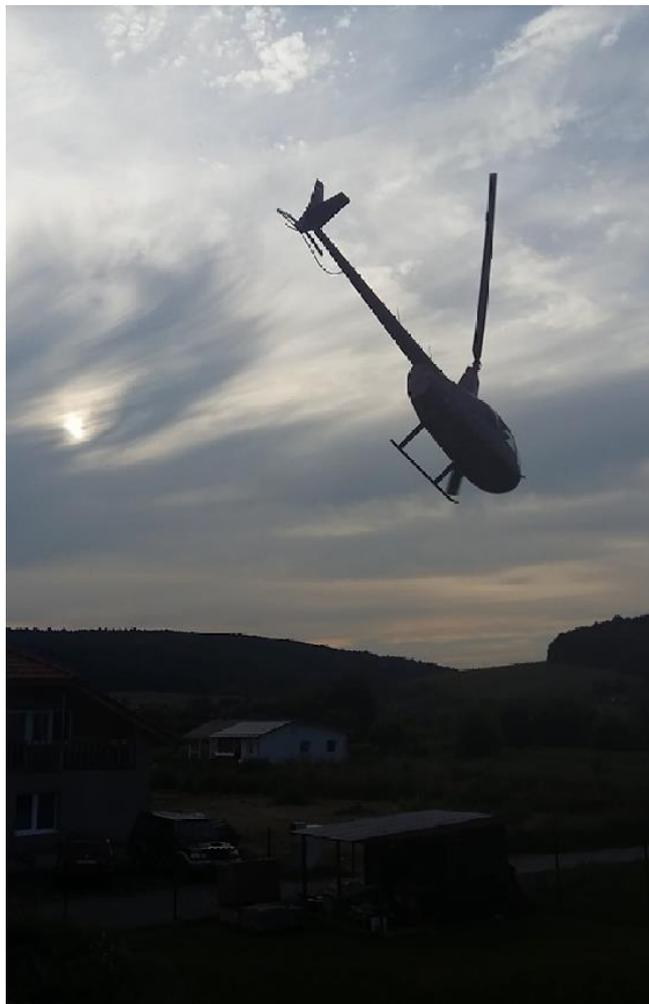
The R44 hit a HV line with the shaft of the main rotor and then another HV line with the cabin. The impact disabled the controls, damaged the main rotor blades and broke the pilot's cabin.

The R44 continued falling uncontrolled and fell 55 metres from the HV lines. After it hit the ground it turned over and the tail boom tore off. The rest of the fuselage turned over after the impact and ended up on the undercarriage skids.

If the R44 had departed along the HV lines in the direction towards Prešov with smooth gradual acceleration and climbed at the same time, the pilot would have avoided the biggest obstacle in the direction of the flight.
