FINAL REPORT

on investigation of incident
of aircraft type **An-2 TD**
registration No. **OM- RST**

Date: 07.10.2012

Location: Airport Prešov / LZPW

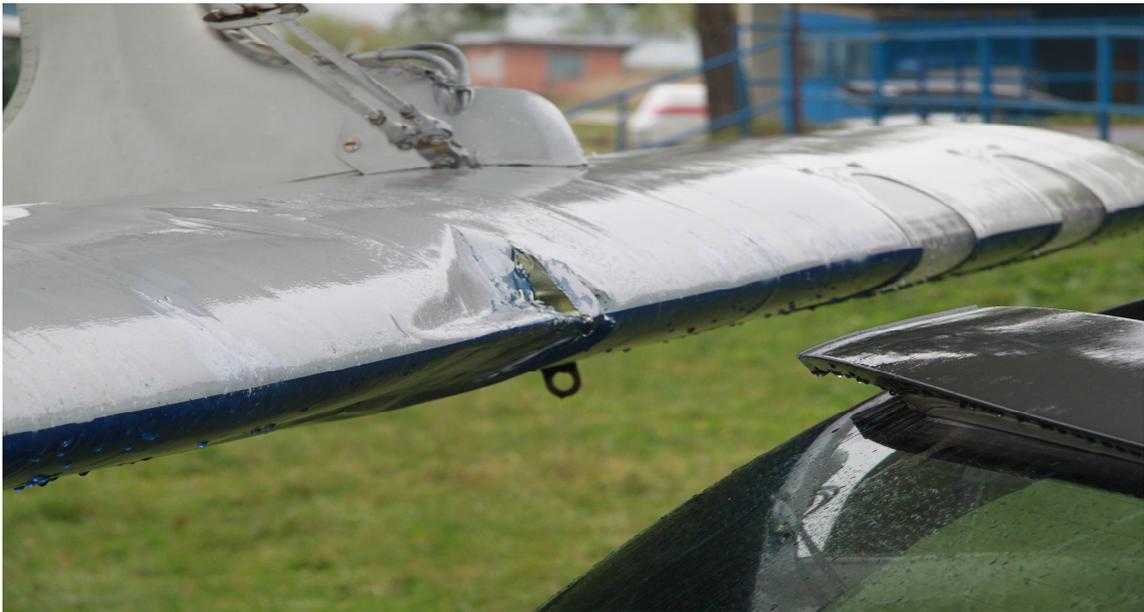
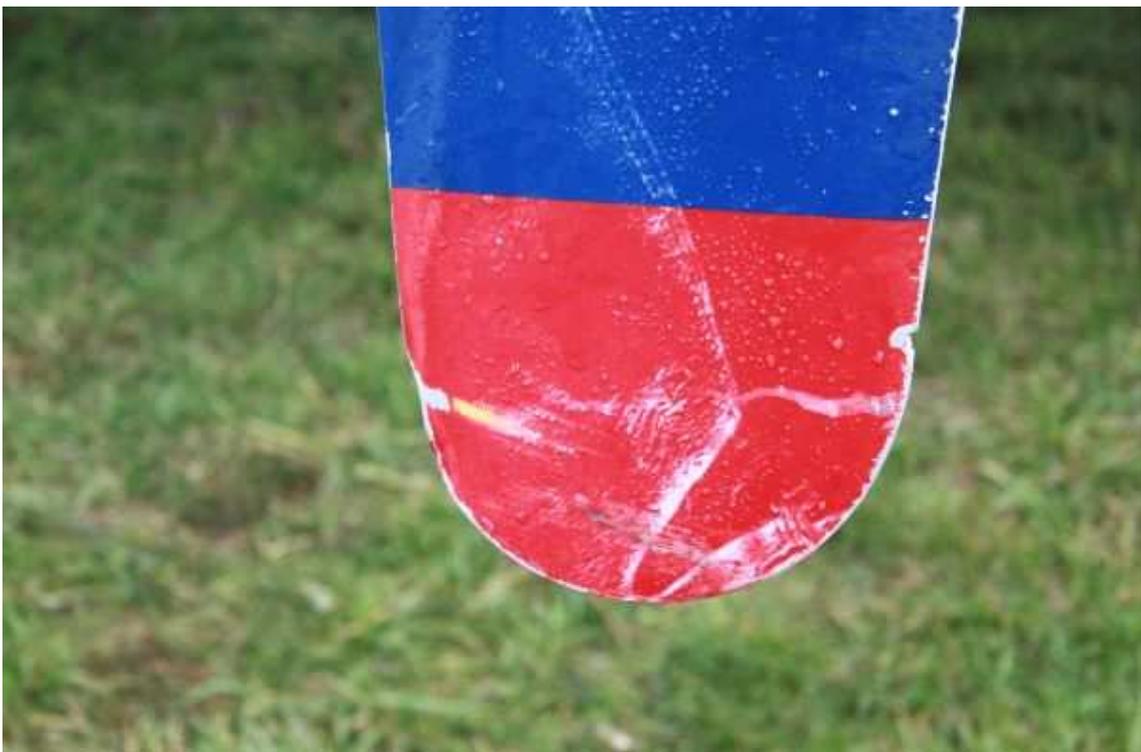
The left wing and propeller of the aircraft were damaged in the air incident.

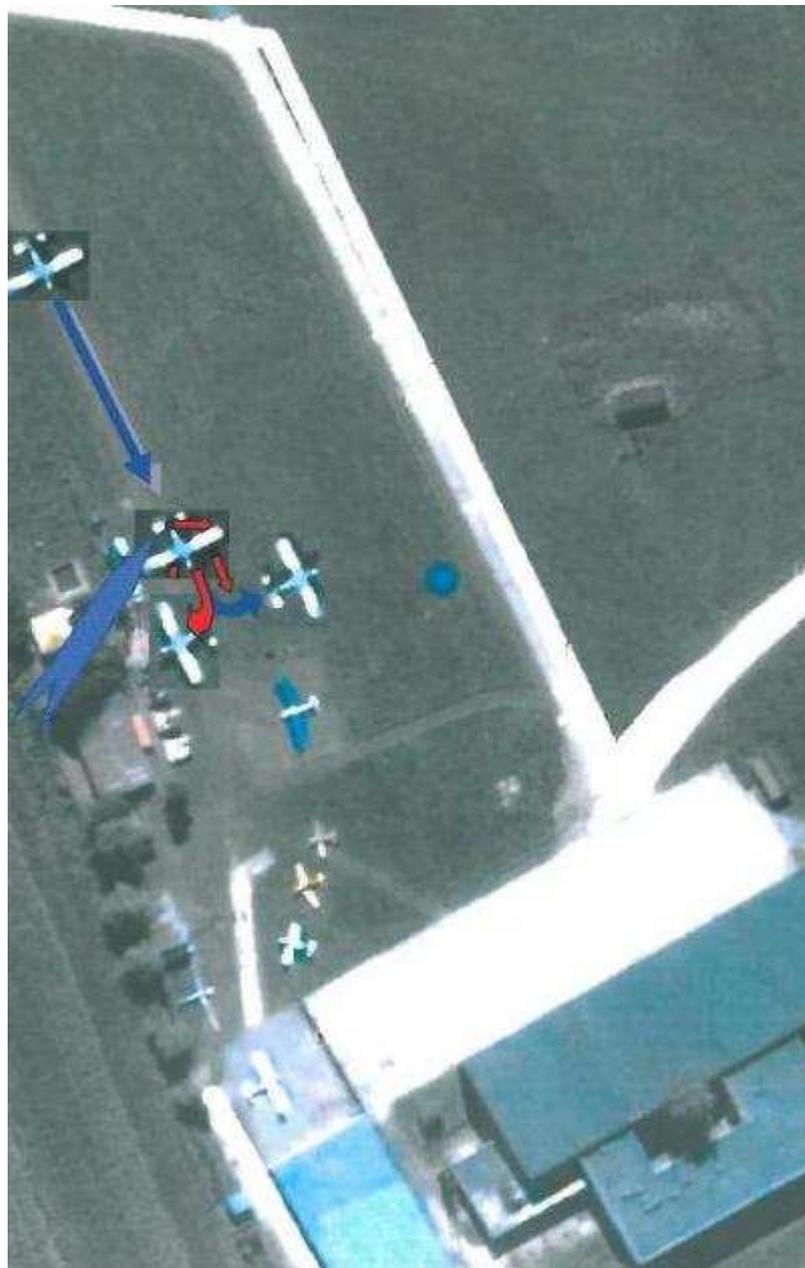
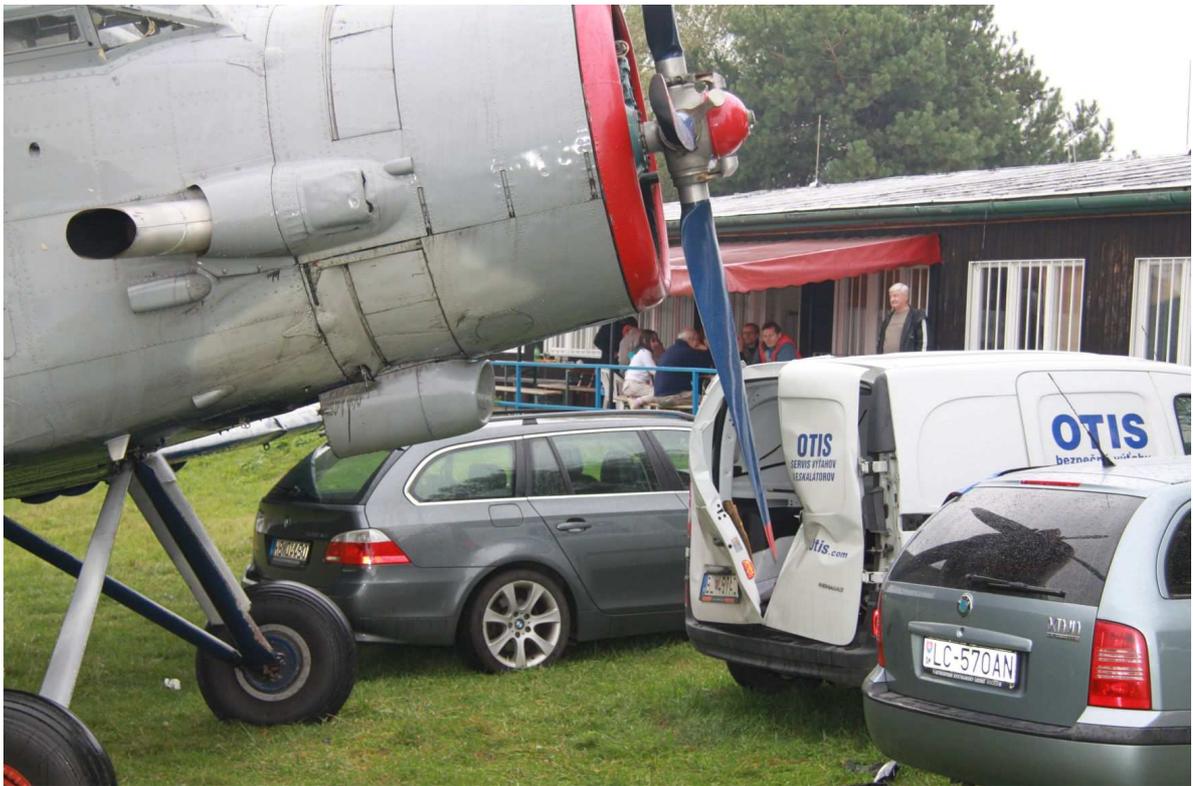
The final position of the aircraft after the impact to the passenger cars was documented, including the photo documentation.

In the effort to park the aircraft at the stand in front of the operations building of the Aero Club near the parked passenger cars, the pilot braked the aircraft before starting the turn, deflected the foot controls to the left and opened the throttle enough to be able to turn the aircraft. Due to the increased thrust of the propeller and the right wheel braked by undulated and wet ground, this manoeuvre caused torque to the right, which resulted in the aircraft turning sharply to the right.

- the pilot paid insufficient attention to taxiing and turned with the aircraft just in close proximity of the cars.
- the passenger cars were parked in a close proximity of the taxiing area of the airport.

- to analyse the air incident with the air and technical personnel;
- to implement its own measures for prevention of occurrence of similar air incidents for similar causes.
