FINAL REPORT

on investigation of serious incident

of aircraft type **Z-43**

Registration No. **OM-XON**

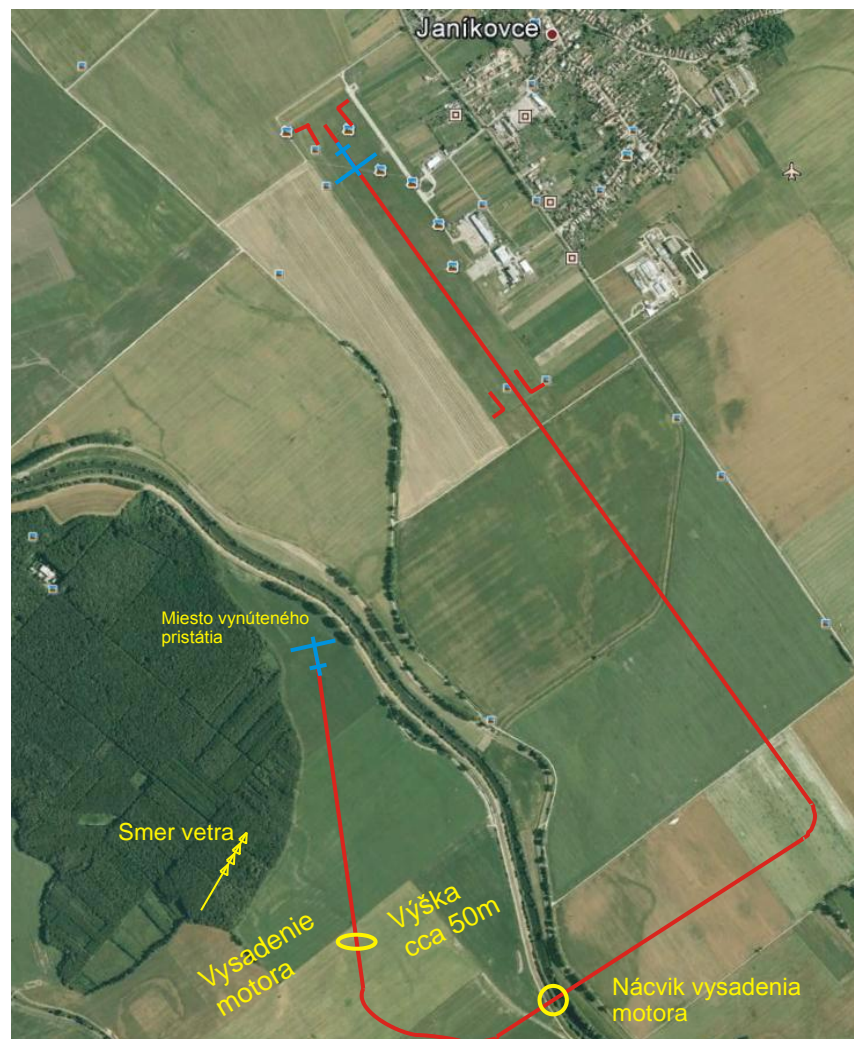
Position of aircraft – a field in the operation area of the airport LZNI
