**MINISTRY OF TRANSPORT, CONSTRUCTION
AND REGIONAL DEVELOPMENT
OF THE SLOVAK REPUBLIC**

FINAL REPORT

on investigation of an air accident
of powered hang glider **PROFI 14 TL / JOKER TRIKE**
Registration No. **OM - H737**

Date: 12.9.2010

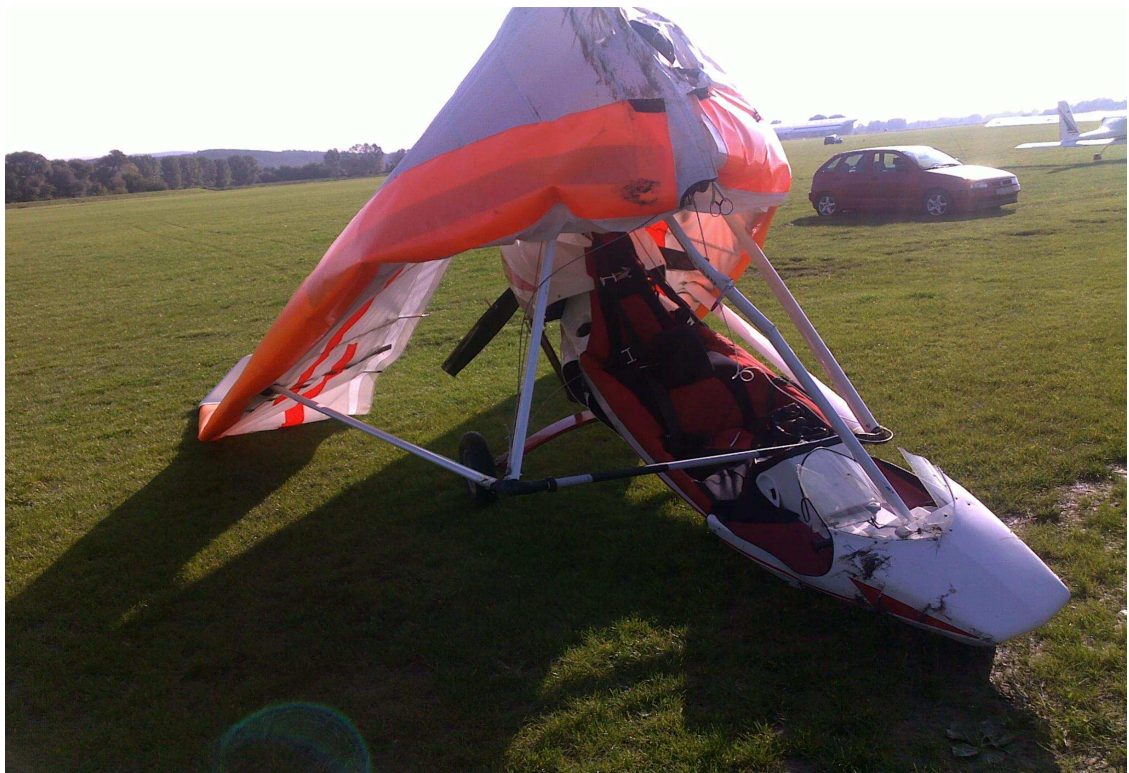
The PHG wing was seriously damaged and its repair seemed to be ineffective. The propeller blades were damaged (split in the length). The PHG landing gear was damaged in the front section.

Fig. 1: Damaged PHG (picture taken after PHG positioning on landing gear wheels)

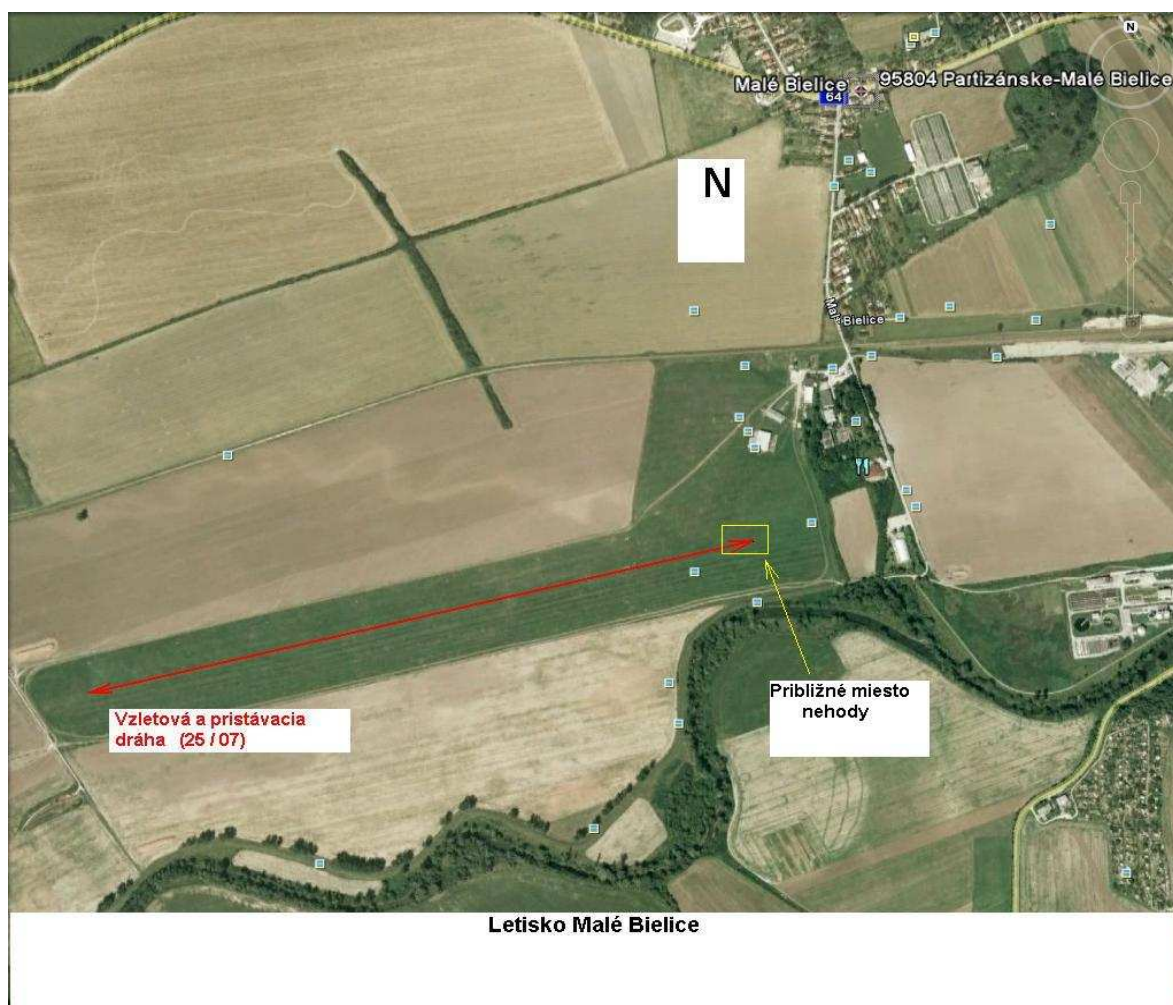
The place of accident is situated in the first third of the runway 25R at LZPT. A trail left by the sliding front end of PHG landing gear in the length of 6 m is visible in grass. The damaged PHG is situated approximately 5 m from this trail, with the PHG wing turned on the "back" (upper end of the wing facing the ground) in the direction of the runway 07 of LZPT and with the landing gear lying on the lower end of the wing and turned on its left side vertically to the direction of the runway 25R. The right front wing spar is destroyed in three points and the wing sail, its individual details and design details of the wing are substantially damaged. The landing gear is damaged in the front section. The fastening belts of the crew and the crew compartment are undamaged and in one piece. The individual propeller blades are situated on the boss, but were damaged by longitudinal splitting of the blades. Fuel, oil and coolant leaks in the ground did not occur. The wing shows signs of substantial damage when its repair seems to be ineffective. The landing gear is reparable in conditions of the manufacturer. After the accident the axis of the PHG system is situated 90°right from the axis of the runway 25R.

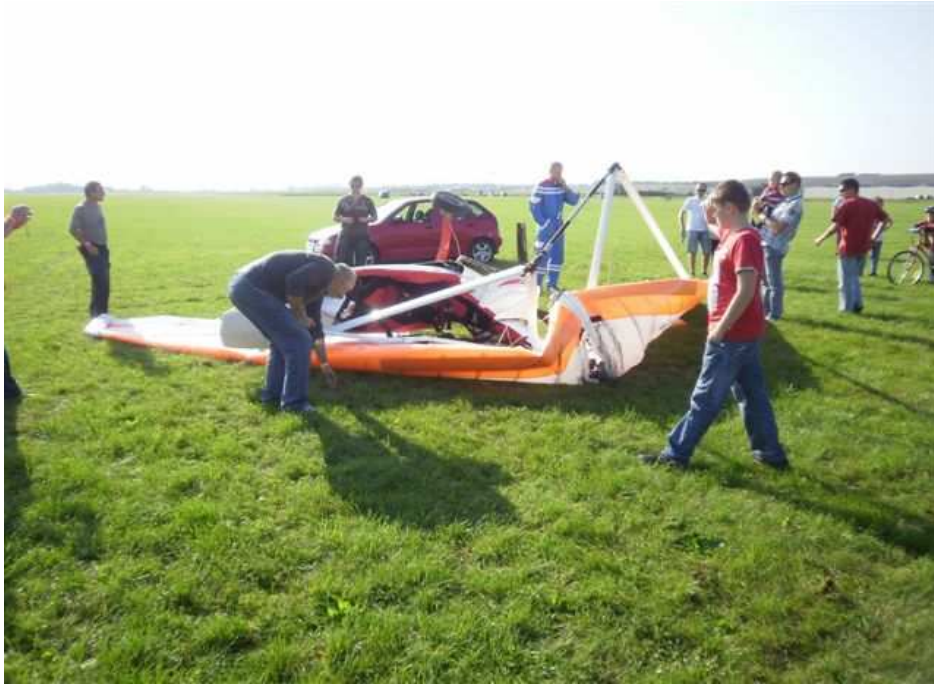
Fig. 3: PHG after accident (view in the direction of runway 25R)

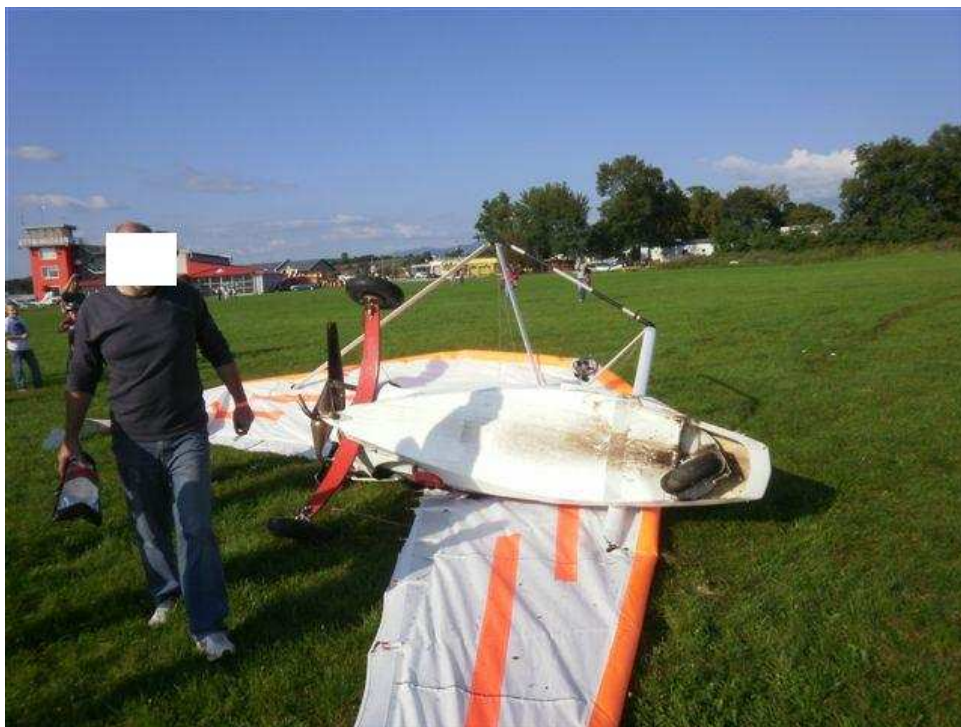
Fig. 4: PHG after accident (airport buildings on the background)
