Reg. No: SKA2010022

FINAL REPORT

on investigation of an air accident
of aircraft type **Antares 18S**
registration No. **D - 0074**

Place: 1 km east of the municipality of Čel'adice

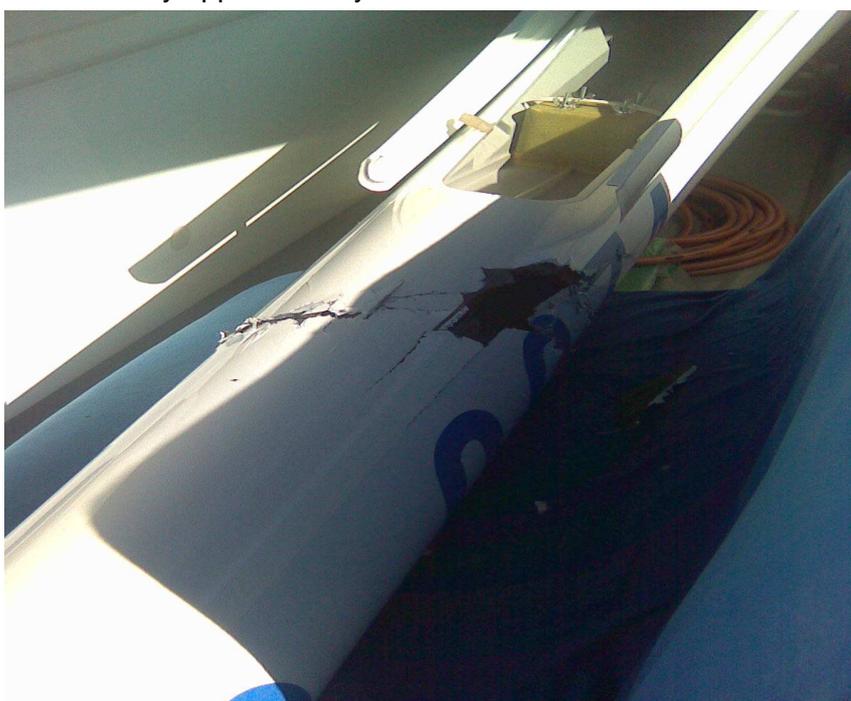
After the accident the aircraft Antares 18S remained in one piece, with small-scale damage and rupture of the body approximately 1 m in front of the keel.

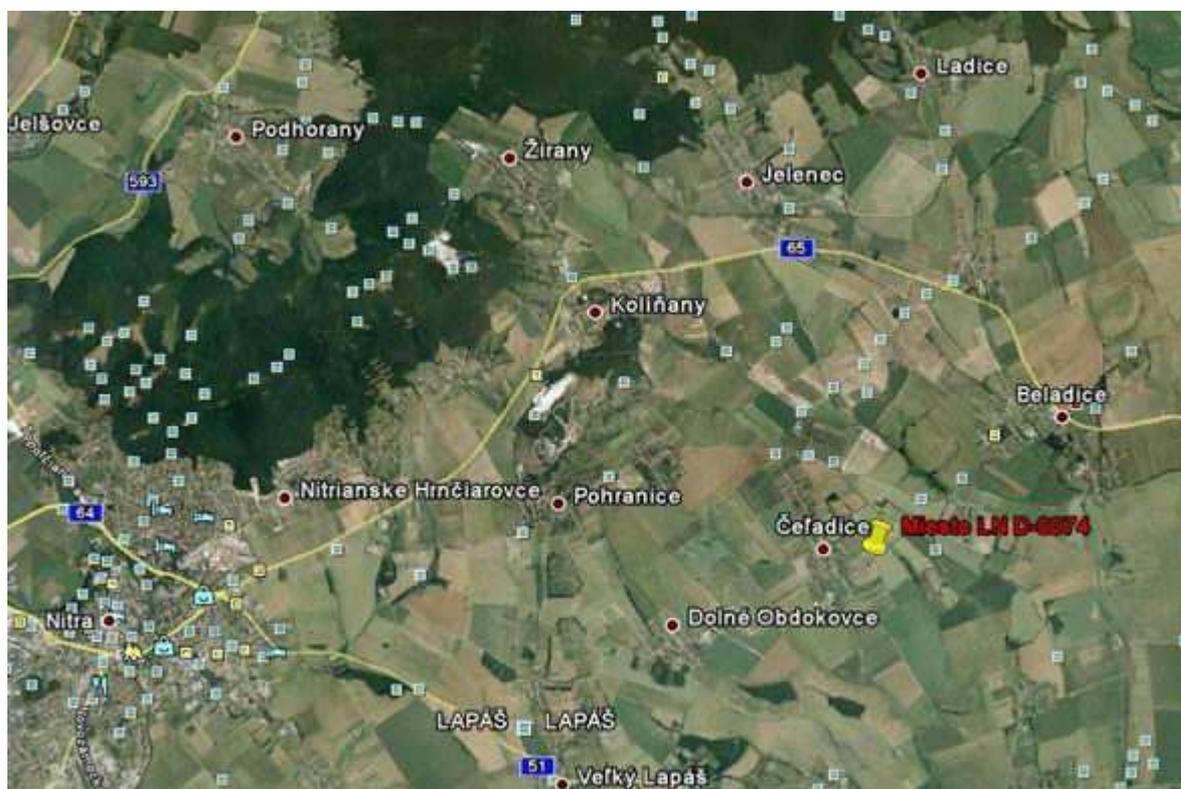
The aircraft landed on flat ground without major obstacles 1 km east of the municipality of Čeladice. The accident site is delimited by the geographical coordinates:

N 48° 19' 23'', E 018° 15' 06''.
