**MINISTRY OF TRANSPORT, POSTS AND
TELECOMMUNICATIONS
OF THE SLOVAK REPUBLIC**

FINAL REPORT

of paraglider **VEGA 2M**

Date: 03.04.2010

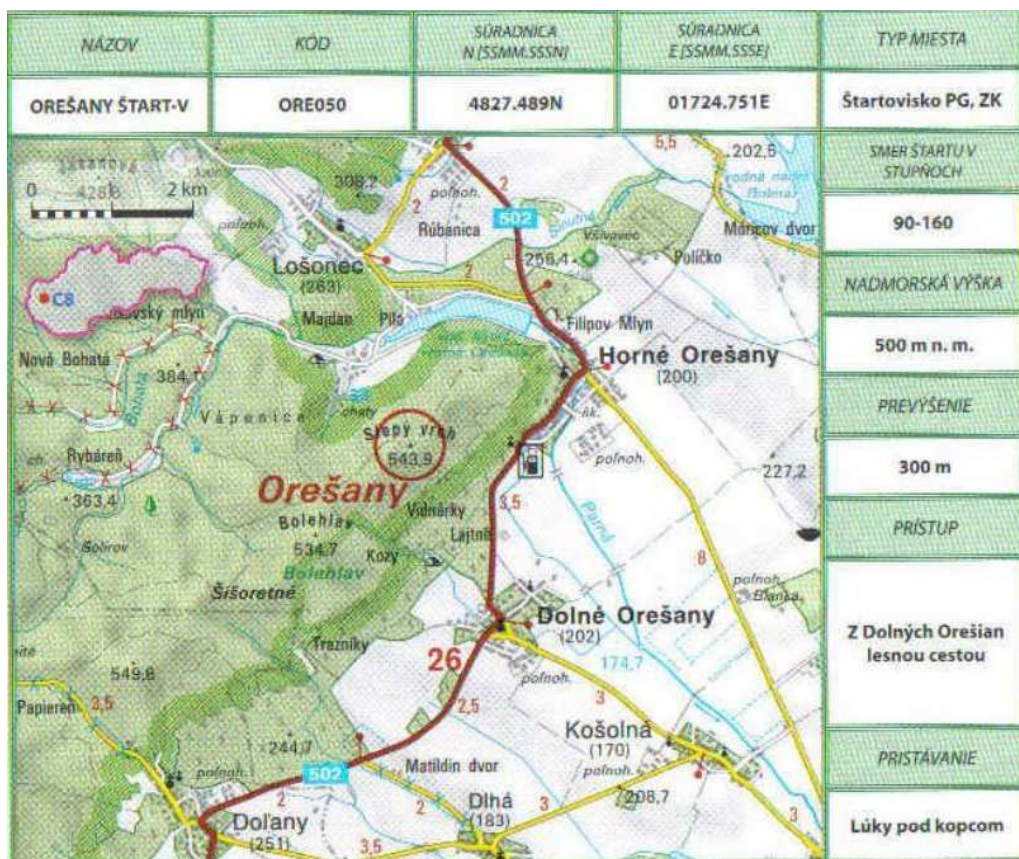
The point of impact of the paraglider with a pilot is situated in one third of the flat section of road No 502 slanting toward the south, approximately 30 m from its left verge (at the sight in the north direction). The impact point is situated in a flat grass area without obstacles.
