MINISTRY OF TRANSPORT, POSTS AND TELECOMMUNICATIONS OF THE SLOVAK REPUBLIC

Reg. No: SKA2010002

FINAL REPORT

on air accident investigation
of paragliders **VEGA 2XS** and **VEGA 2M**
Identification No: **OM-P124** and **OM-P069**

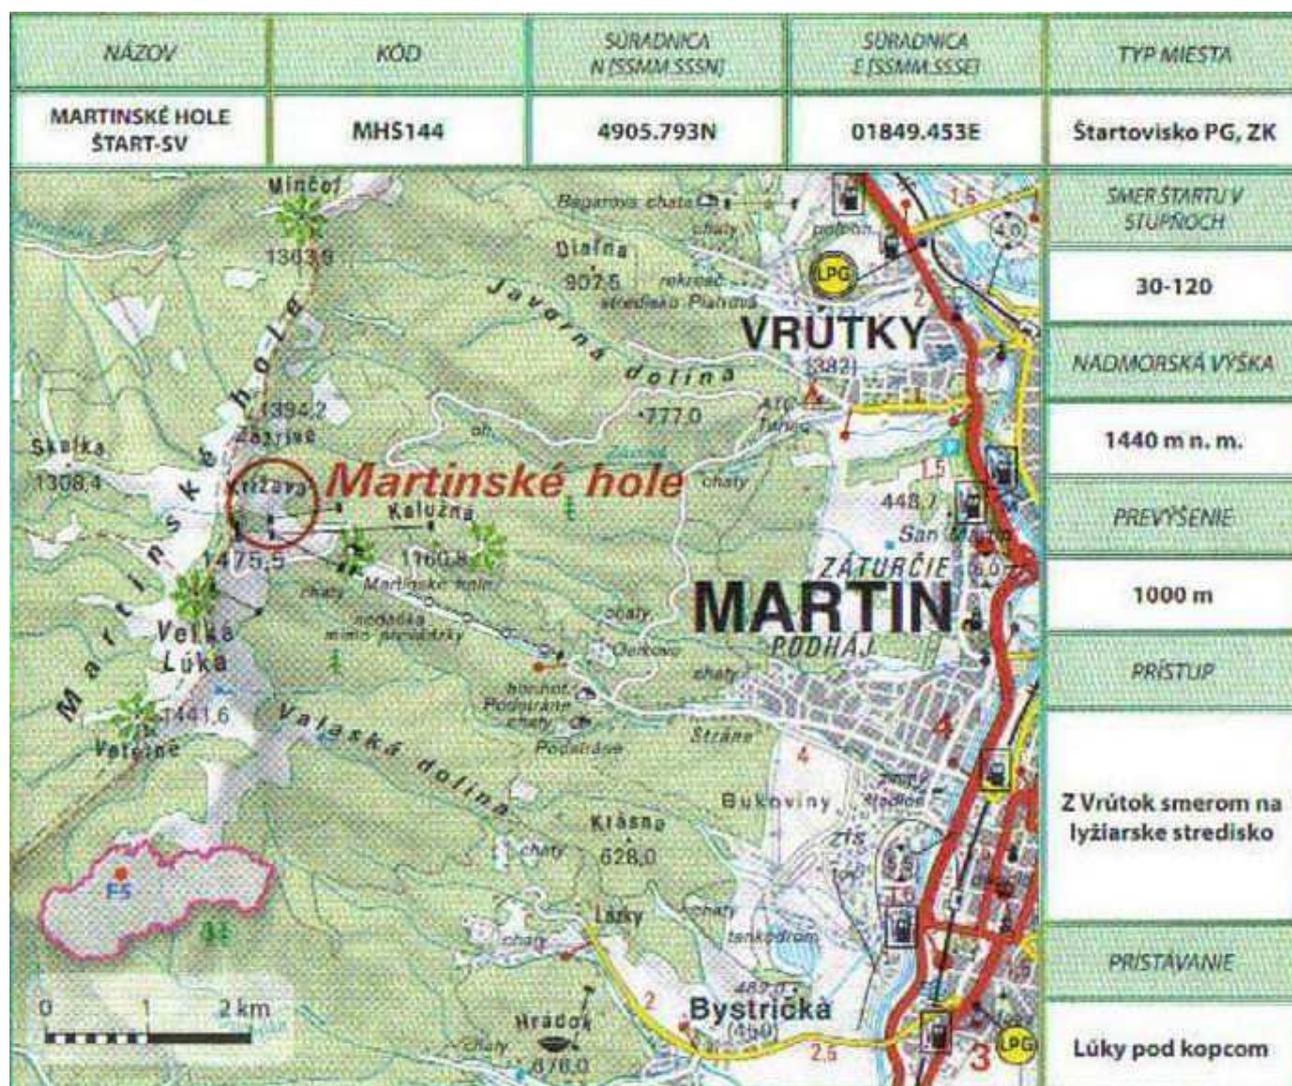
The point of impact of paragliders with pilots is situated in the lower part of the ski downhill course, approximately 5 m from the forest border. The impact point is a grass area without obstacles. The paraglider pilots fell to the ground approximately in the direction of a contour line.
