Reg. No: SKA2010004

FINAL REPORT

on air accident investigation
of aircraft type **WT-9 Dynamic**
registration: **OM-DYD**

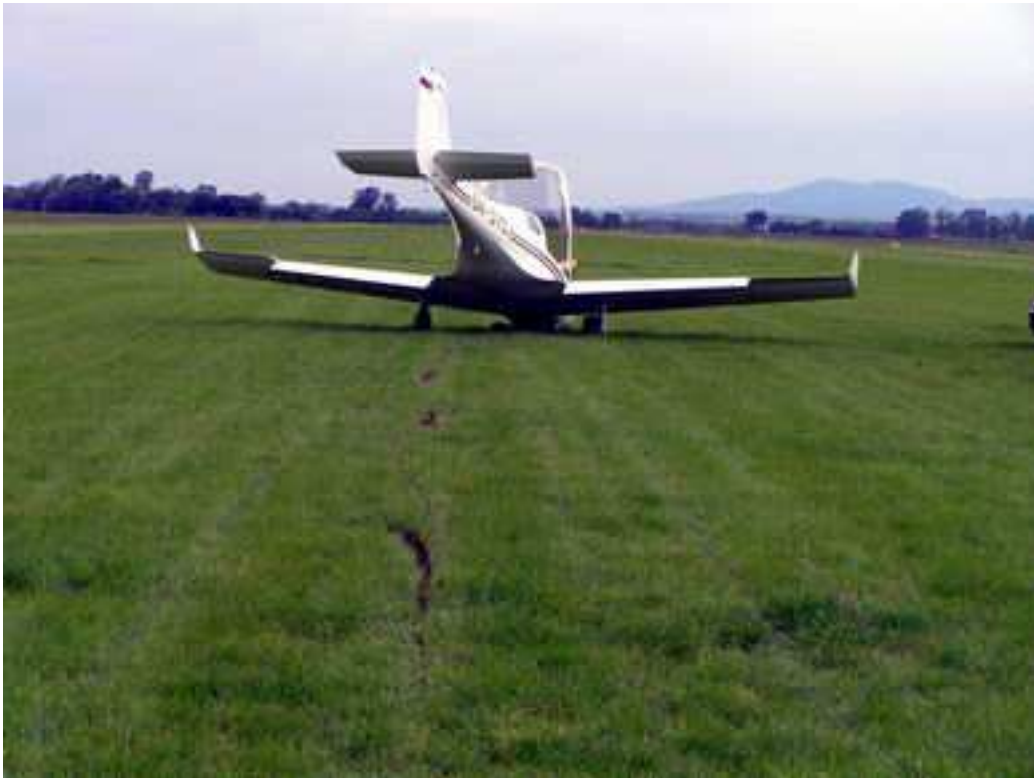
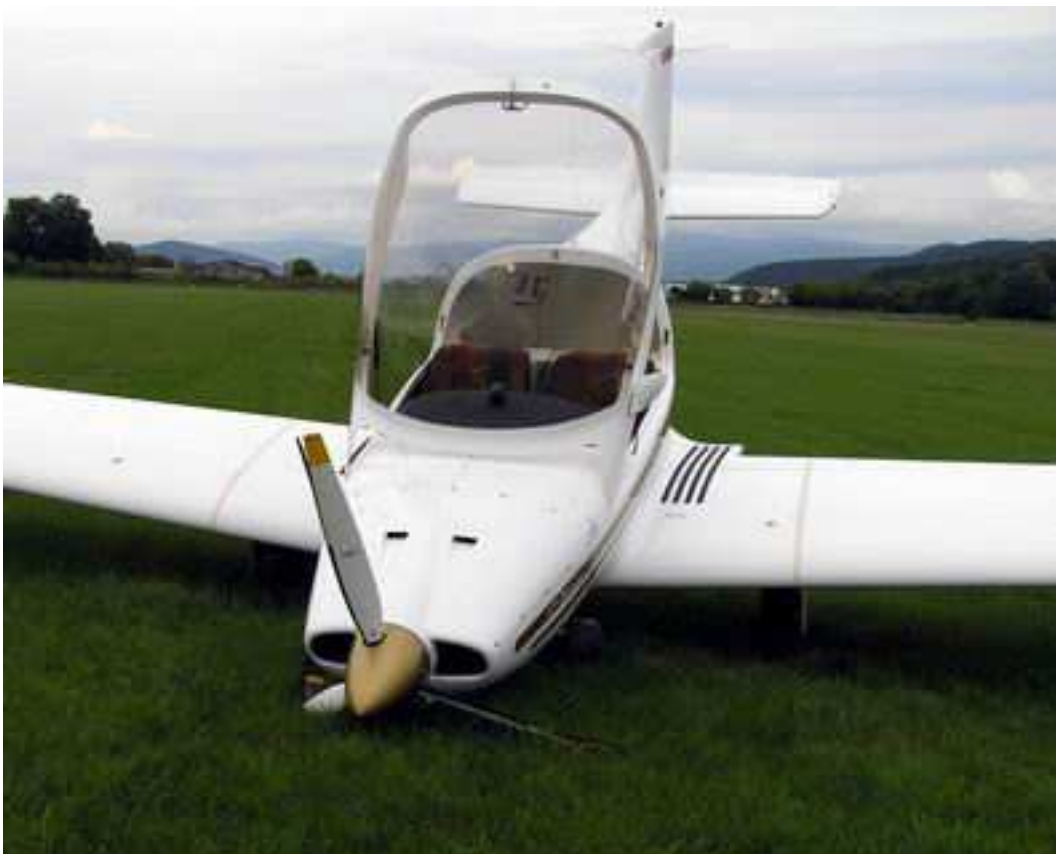
The aircraft was minor damaged in the air accident.

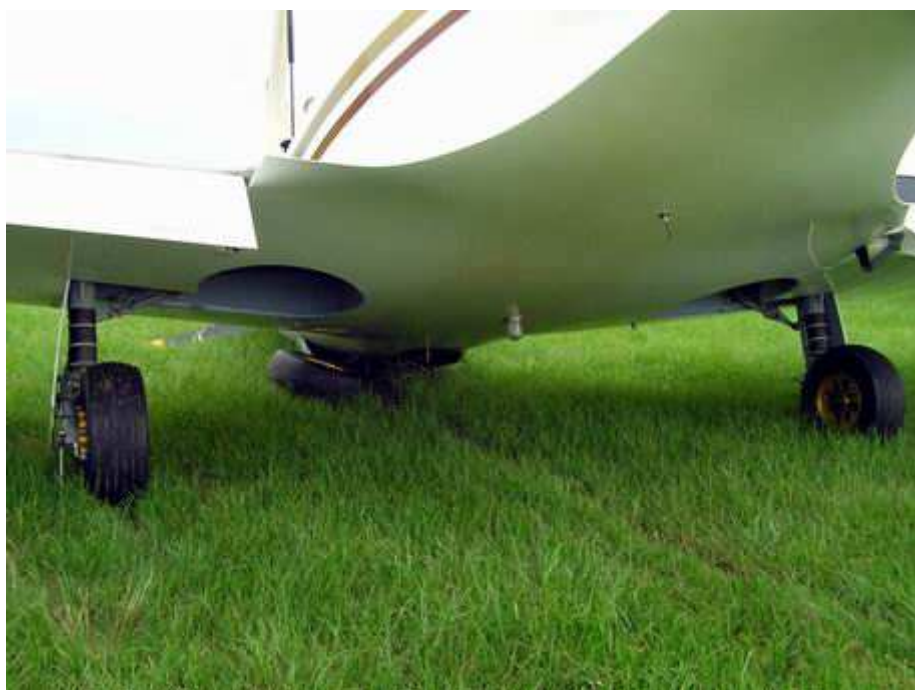
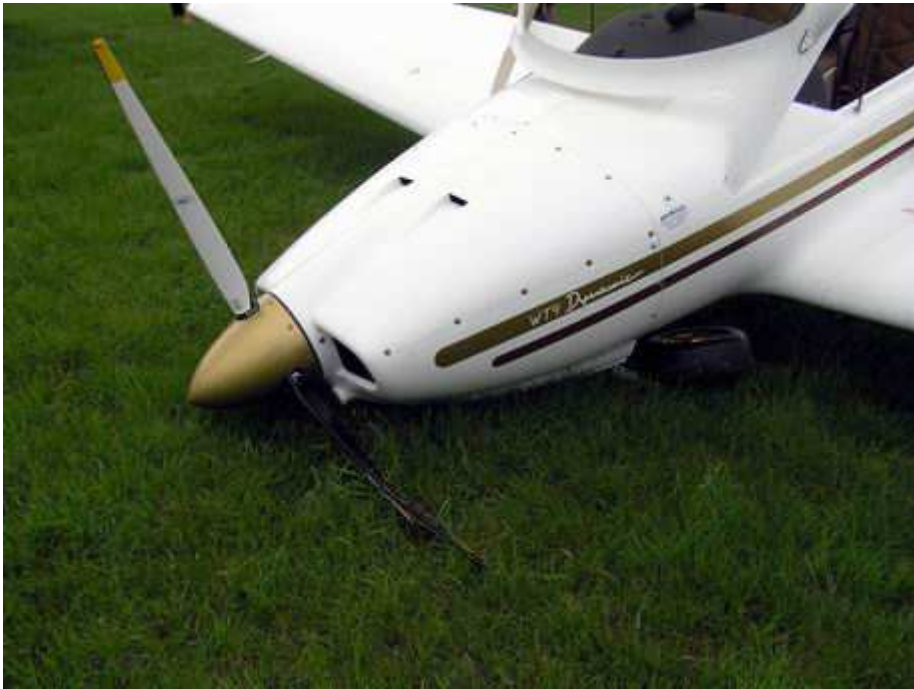
After the air accident the aircraft stopped at the level of threshold marking of the runway 25 with the front landing-gear leg bent backwards and broken propeller blades.

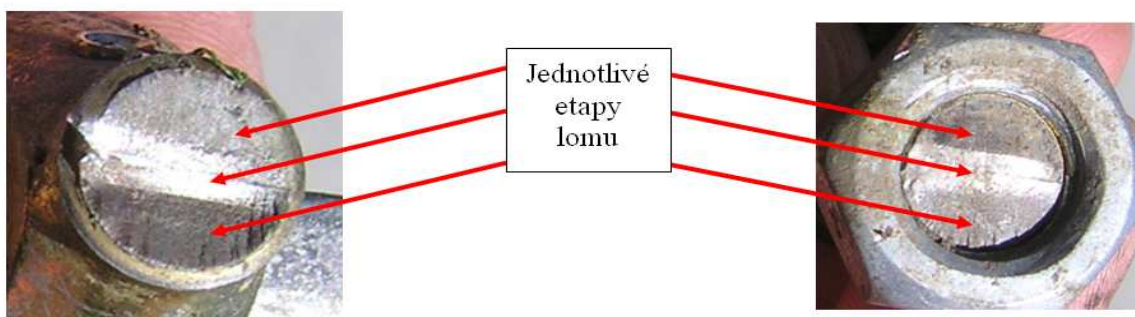
The threaded part of the bearing was broken off. Presence of progressive strips typical for fatigue mechanism of material damage was not detected on the fracture surface.

In the initial area of fracture spreading certain marks of bruised fracture surface caused by power closing of the fracture slot were visible. The fracture can be described as a progressive material damage, where the fracture was spreading step by step across the damaged area under the influence of very short dynamic power impulses (dynamic stress).

The expertise showed a progressive breaking-off of the threaded part of the friction bearing of the attachment of the front landing-gear leg suspension. The loading of this component is characterized by forces generated in movement (taxiing, take-off and landing) of an aircraft. The size and frequency of these forces depends on the speed of the aircraft, on the runway bumps and on the landing mode. When an aircraft is used for example for training flights, an increased load of the aircraft structure and hence of the individual elements of the landing gear caused by forces generated in case of hard and repeated landings can be anticipated.

Based on the analysis it can be determined that the cause of the damage was a repeated excessive loading which affected the tear resistance of material used in the examined component.

The cause of the air accident was the breaking-off of the threatened part from the eye of friction bearing SMG 12-40 under the influence of excessive loading of the front landing-gear leg.

The aircraft manufacturer took a preventive measure relating to a one-off check of the component in question with use of colour defectoscopy for all aircrafts that are maintained in its service centre.

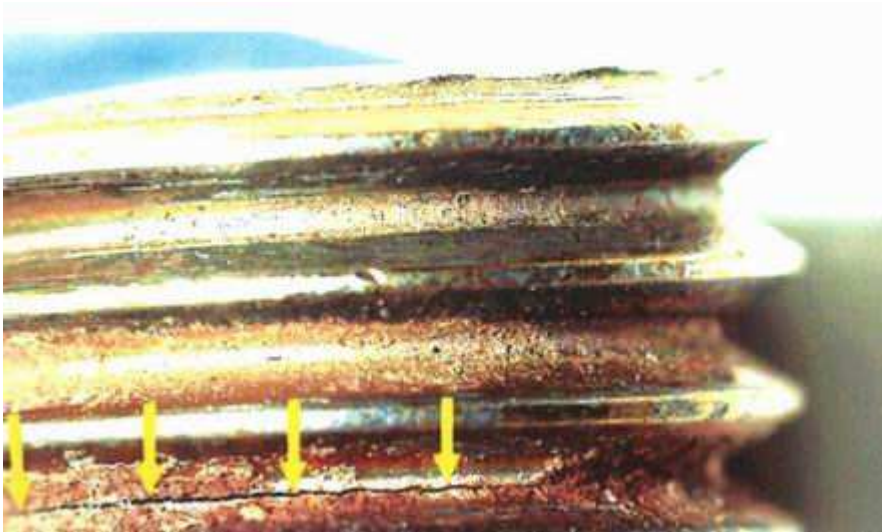
In the proximity of the fracture surface, three threads down (the distance corresponds to the height of the nut used in the joint), the presence of a parallel crack with the same orientation was detected.
