**MINISTRY OF TRANSPORT, POSTS AND
TELECOMMUNICATIONS
OF THE SLOVAK REPUBLIC**

FINAL REPORT

on air accident investigation
of helicopter type **CH 7 Kompres**
registration: **OM – M415**

Date: 29 May 2010

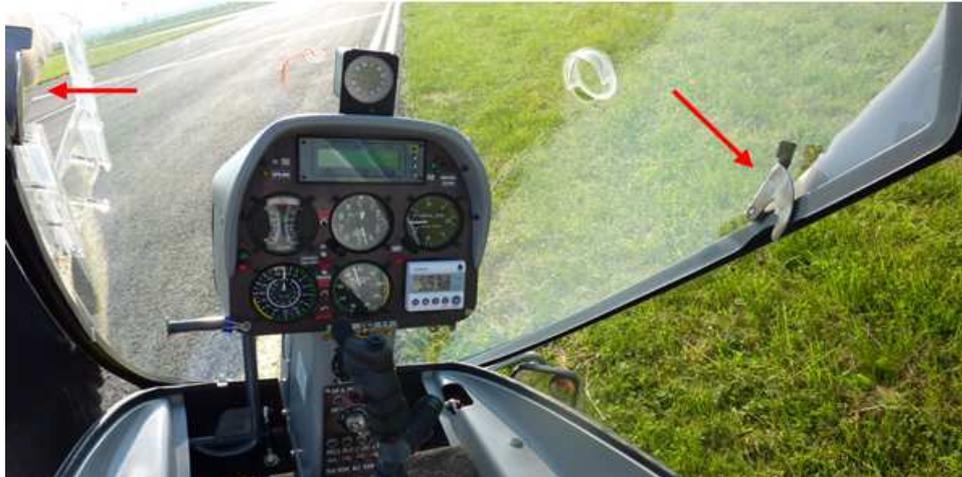
The frame of the all-glass cockpit hood opens upwards by turning in two hinges situated in the front fuselage of the helicopter. In the closed position the cockpit is locked by two simple turn-locks on both sides of the cockpit frame.

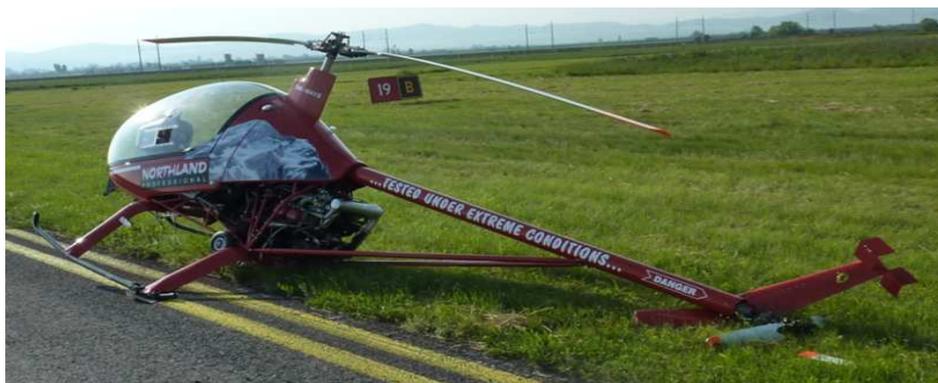
After the fall to the ground the helicopter remained in one piece and was not separated into the individual parts. The ground impact caused deformation of the skid landing gear and damage to tail rotor, end reductor, tail boom and horizontal tail planes.

The helicopter fell on the boundary of the bitumenous runway "B" and the grass surface of the airport.

The final position of the helicopter after the accident was documented, including the elaboration of photo documentation.
