**MINISTRY OF TRANSPORT, POSTS AND
TELECOMMUNICATIONS
OF THE SLOVAK REPUBLIC**

FINAL REPORT

of aircraft **Z - 37A**

registration: **OM - KJS**

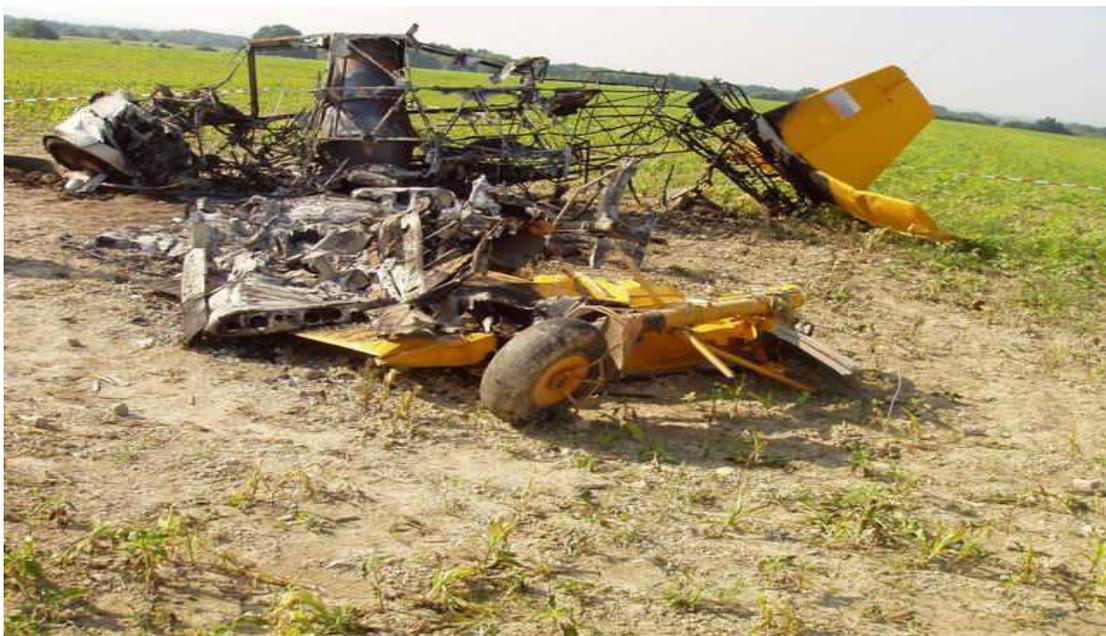
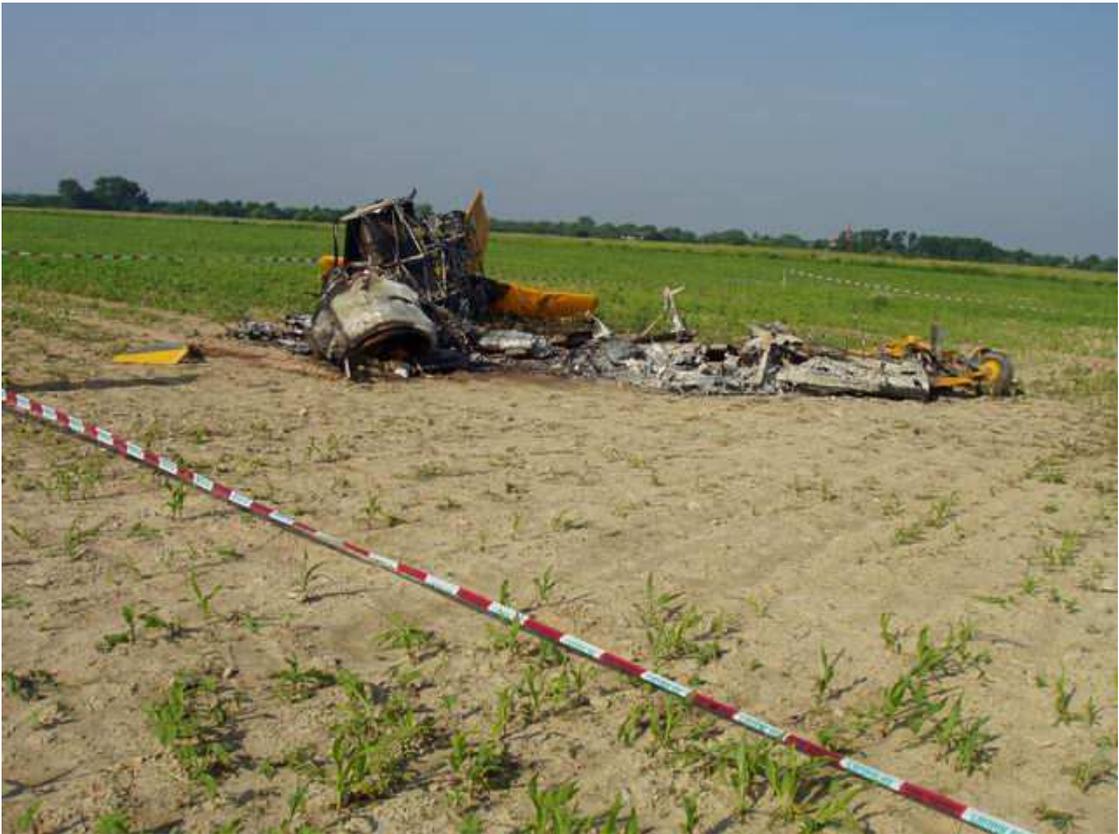
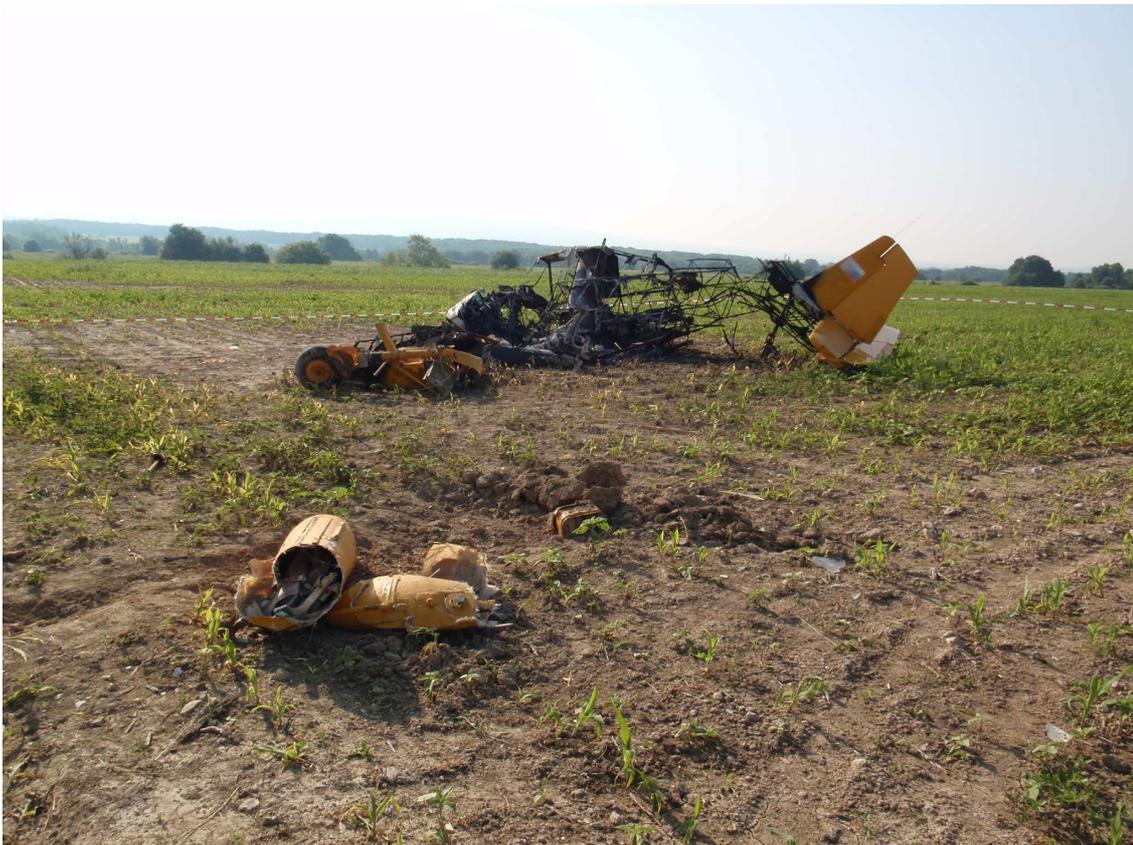
1.3 Damage to aircraft

The aircraft was destroyed in the air accident.

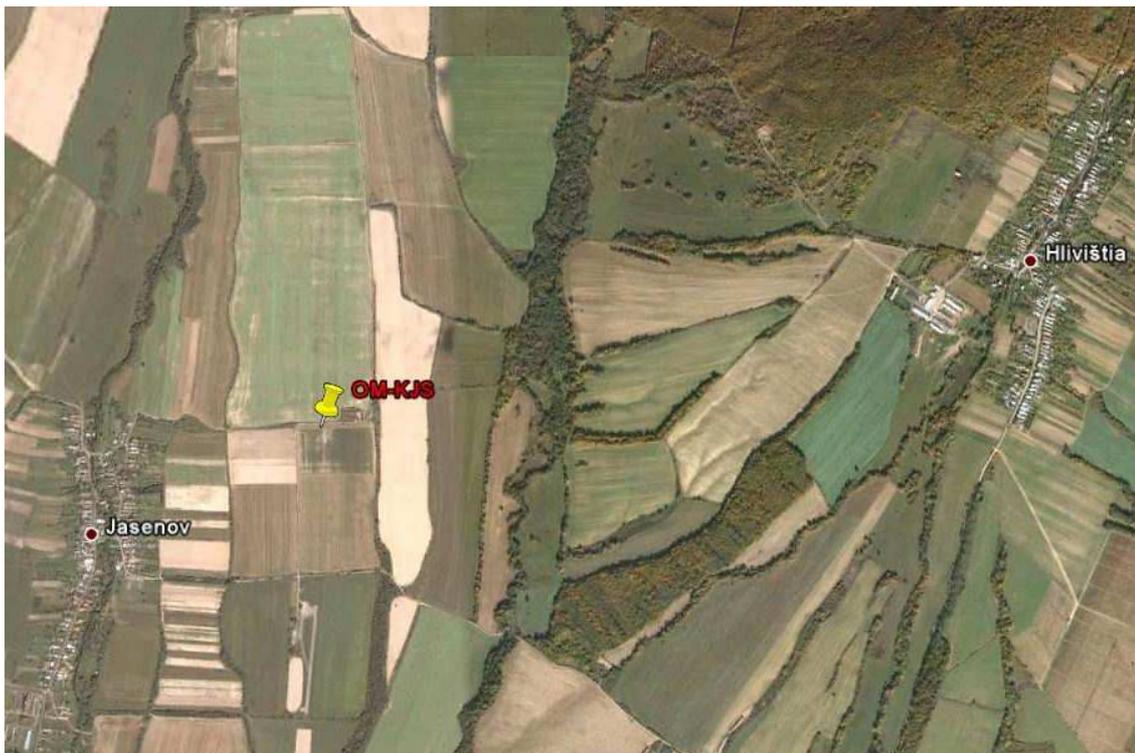
The impact point determined by coordinates N 48°48'00.5'', E 022°10'51.0'' was situated on the shoulder of a reinforced country road and adjacent field seeded with corn. The wreckage of the aircraft was found in the distance of 10 m from the first impact point. The distribution of wreckage was documented by photos.
