Reg. No: SKA2010009

FINAL REPORT

on air accident investigation
of aircraft **Discus 2a** and **Discus 2T**
registration: **OK – 7000** and **SE - UOA**

Date: 04.07.2010

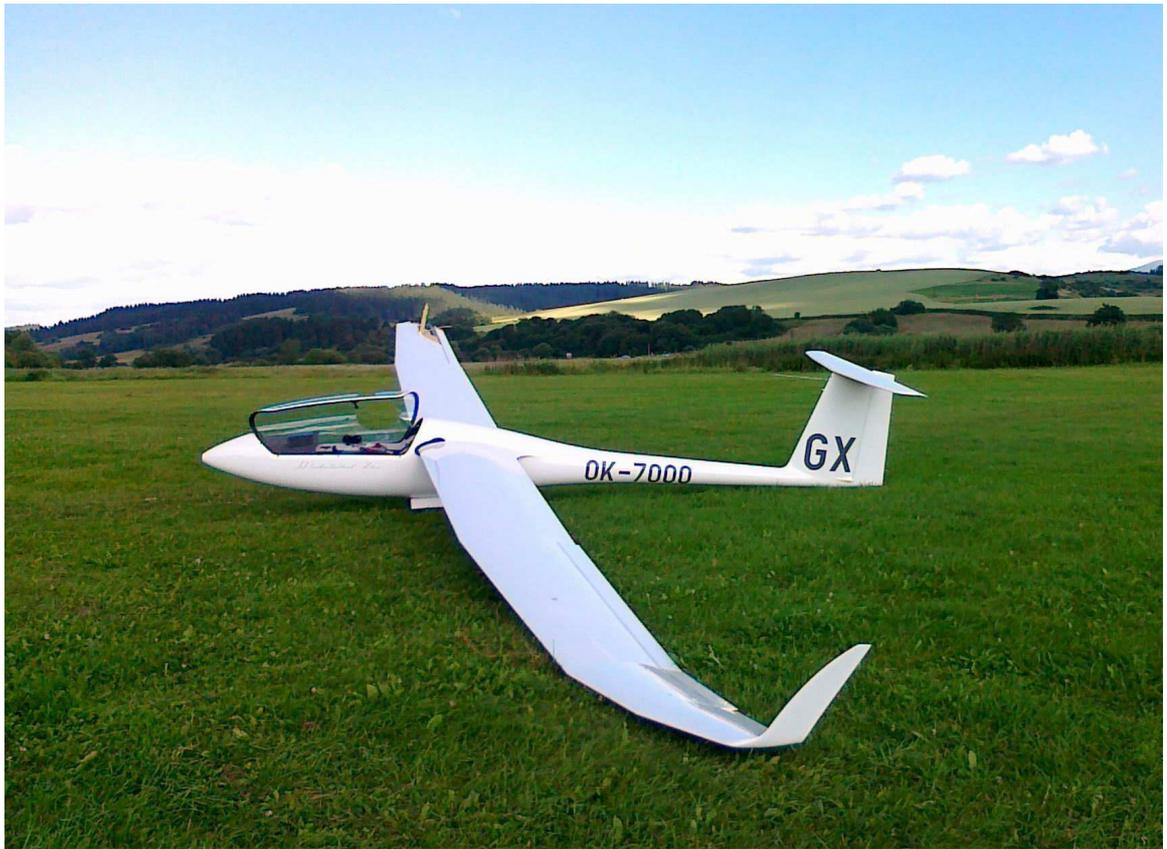
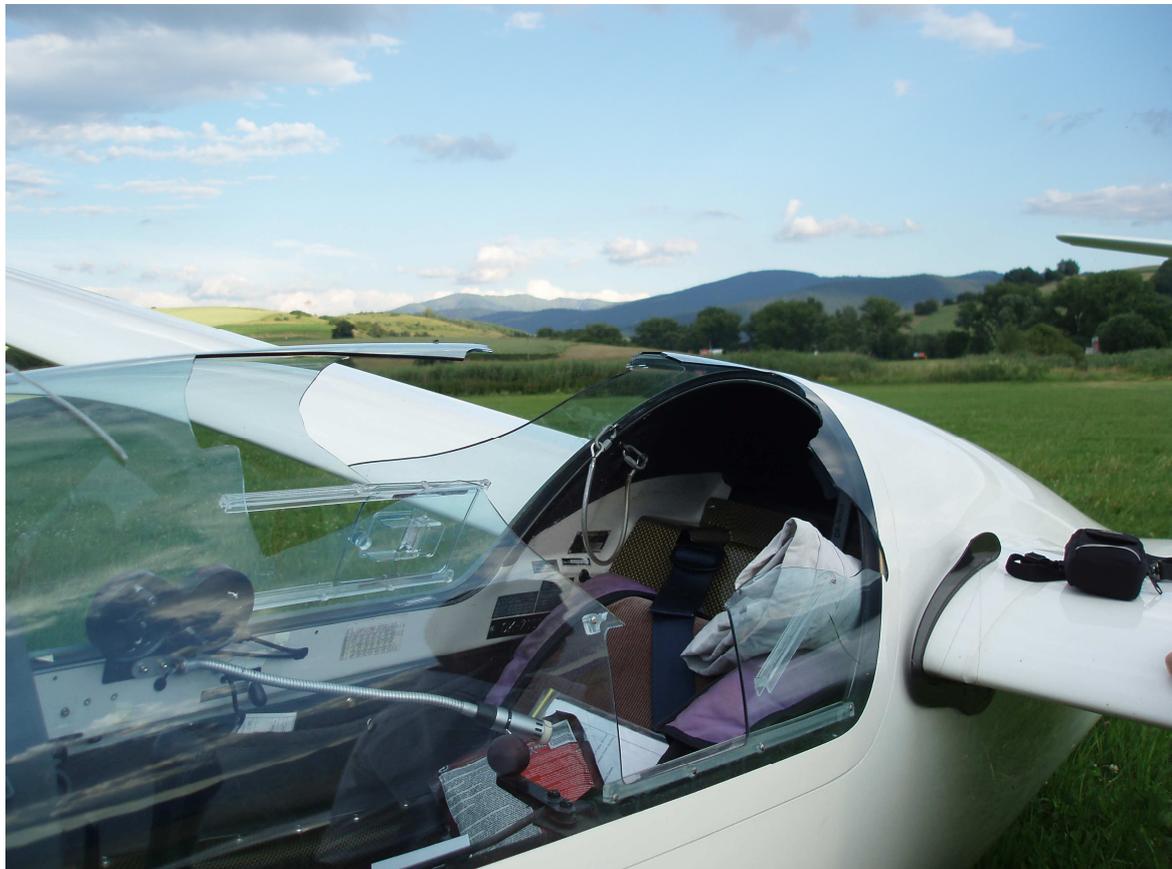
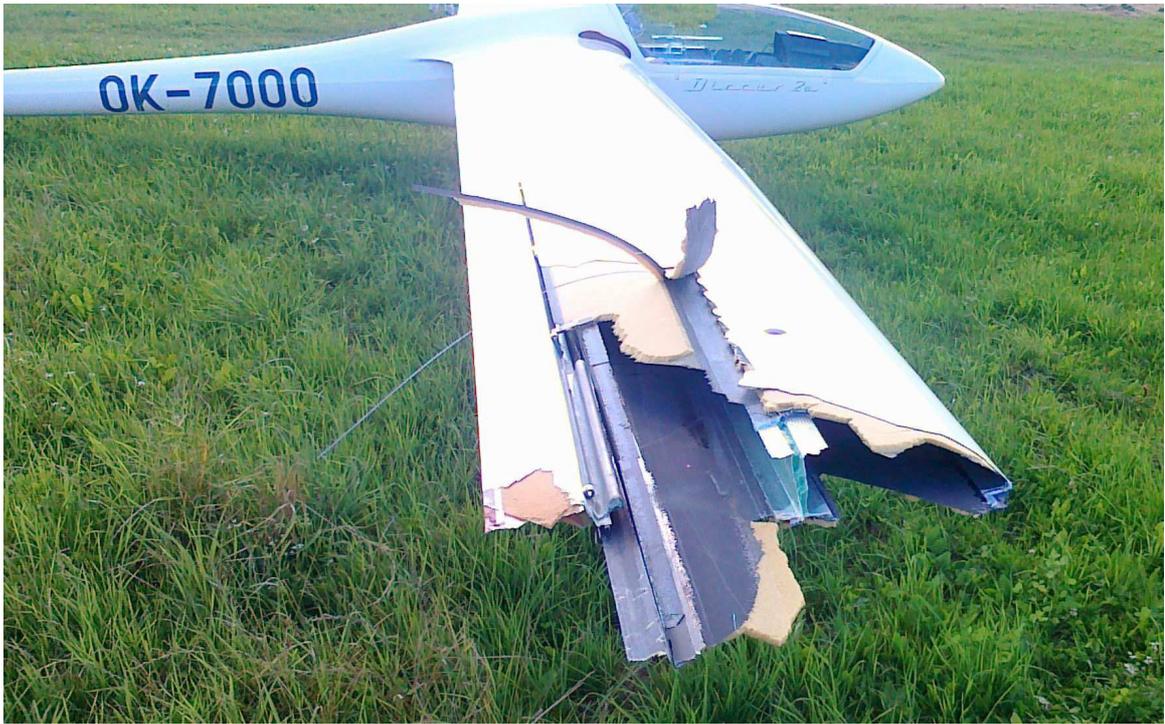
After the crash, the aircraft **Discus 2a** "**GX**" had a broken Plexiglas hood of the cockpit, a broken left venting window of the cockpit, and 35-30 long cracks in varnish behind the right butt rib of the aircraft body. The right wing was fully broken off approximately 2 m from its end. The left wing and tail surfaces were not damaged.

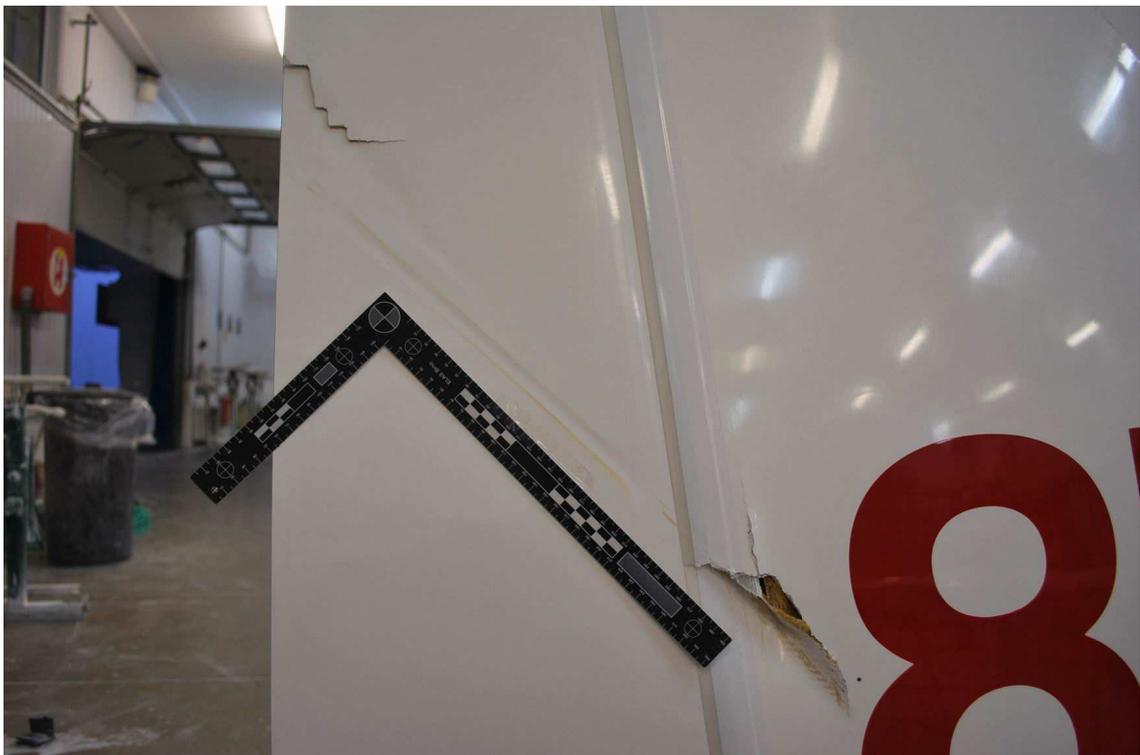
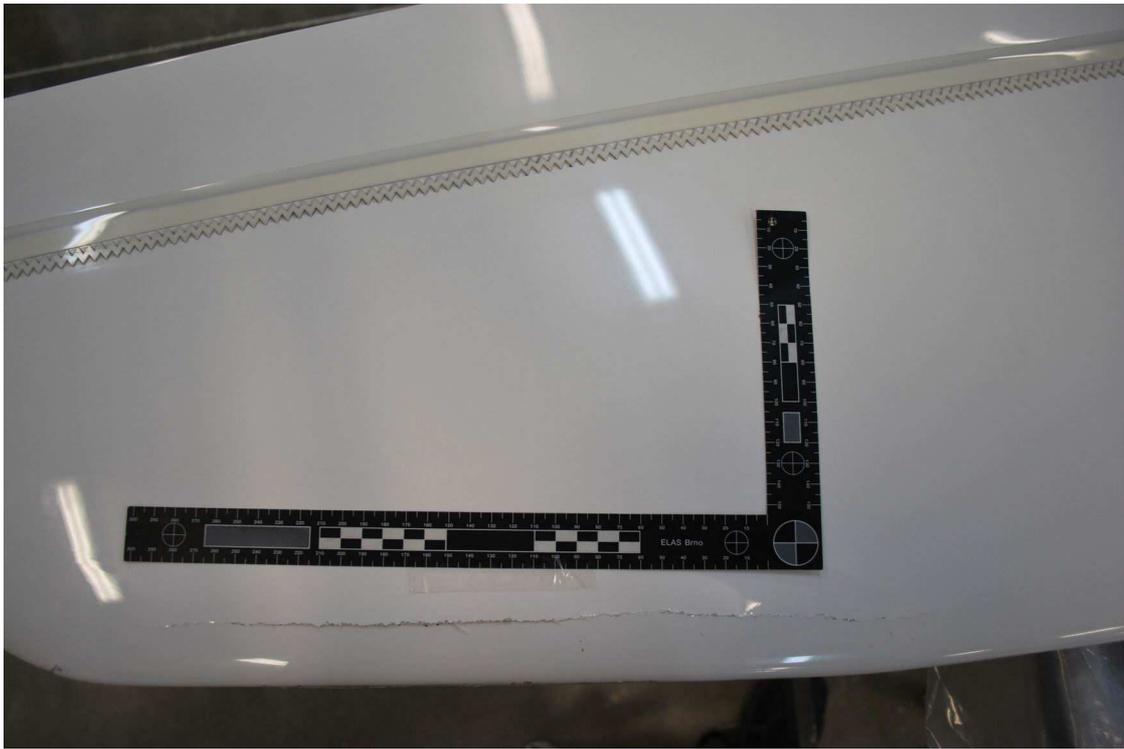
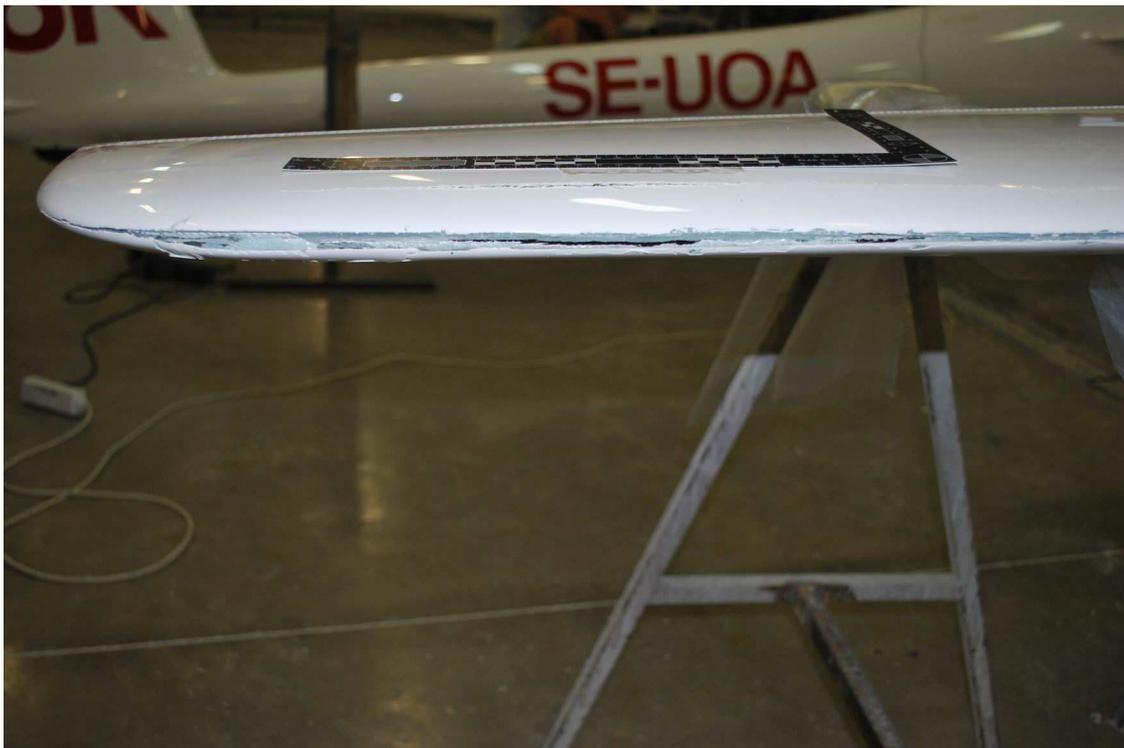
The aircraft Discus 2T "8K" had a ripped skin of the body right of the keel trailing edge in a length of 15 cm and 5 cm, a split keel skin in a length of 60 cm and 15 cm right below the stabilizer, and a delaminated inner sandwich skin on the right rudder bracing in a length of 10 cm. Three delaminations with a length of 3 cm in the corners of the tail battery compartment and a broken hinge of the door of tail battery compartment. One delamination in a length of 15 cm near the landing gear (back right). The rudder had unsealed trailing edge in the whole length and delaminated inner sandwich skin with size of 3x20 cm on the right side. Split skin on both sides of the rudder. The stabilizer had a broken skin behind the leading edge and unsealed leading edge in a length of 70 cm from the end.
