**MINISTRY OF TRANSPORT, POSTS AND
TELECOMMUNICATIONS
OF THE SLOVAK REPUBLIC**

F I N A L R E P O R T

Aircraft type **LAK-19**

Registration No **LY-GED**

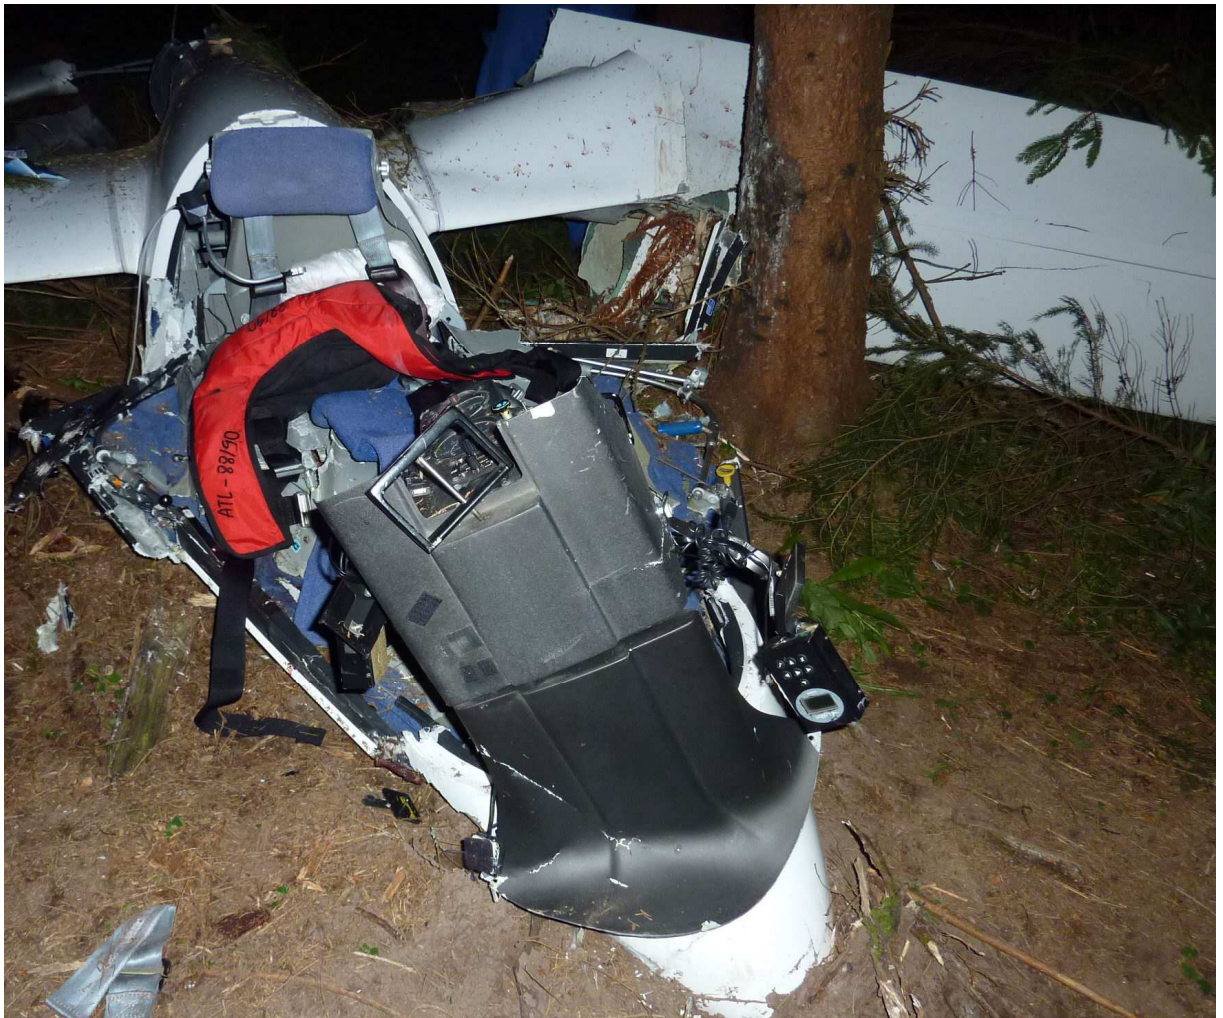
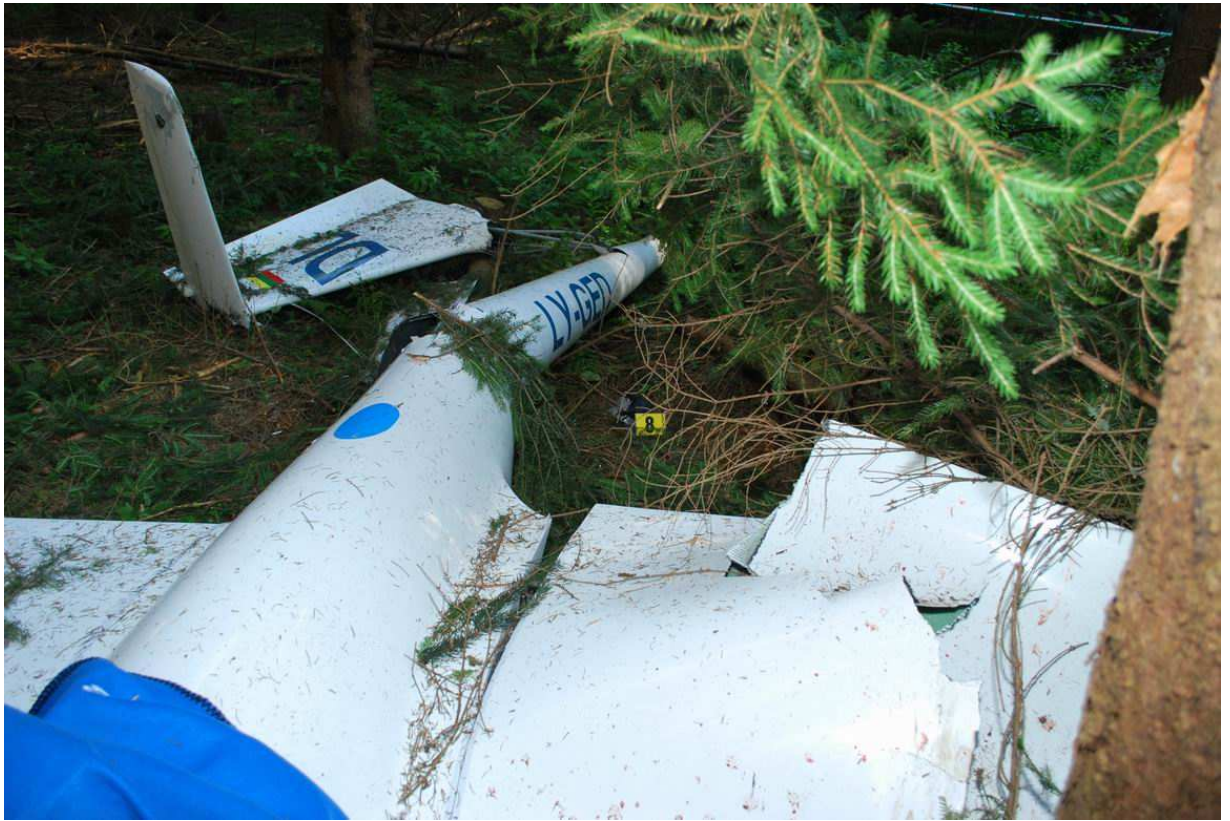
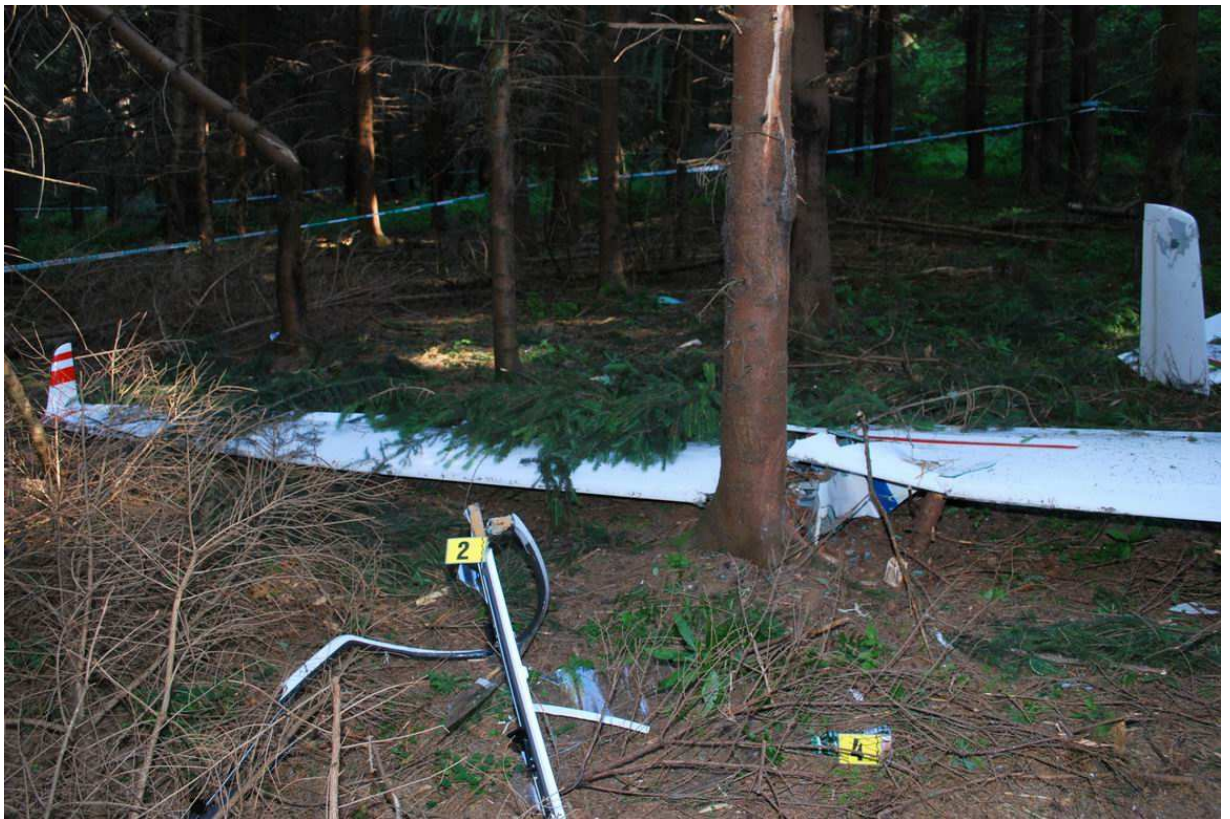
After the crash in the forest cover, the left wing of the aircraft LAK-19 "DL" was completely broken in a distance of approximately 70 cm from the shank, but the water ballast discharge valve remained undamaged. The right wing was completely broken in a distance of 4 m from the shank and 1 m from the end, and the water ballast valve was damaged in the open position. The pilot cabin of the aircraft body was destroyed; the body tube was broken in a distance of 1 m from the transition area to the keel. The attachment of wing stubs in the midsection did not show any visible damage. The water ballast discharge valve in the keel was undamaged. Water remainders were detected in the keel reservoir. The attachment of horizontal stabilizer was undamaged. The right side of horizontal stabilizer and horizontal rudder was completely broken off.

After the air crash the aircraft was completely destroyed.

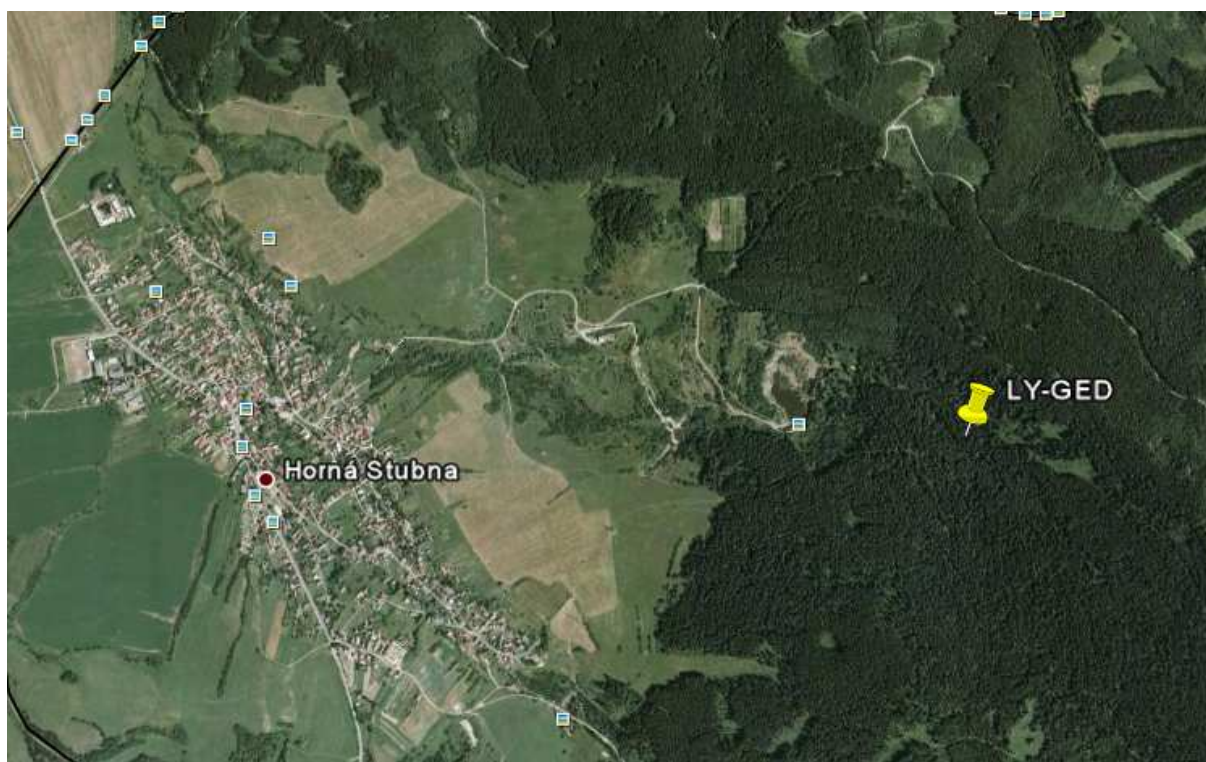
The wreckage was locked on the ground in a group of five 20-years old spruces and the pilot cabin was found near the central spruce. Wings of the wreckage got stuck in both side spruces. The body was broken behind the cabin, the rudder and the elevator were torn off, but connected with the body by control cables.

The final position of the aircraft after the air crash was documented, including elaboration of photodocumentation.
