Reg. No SKA2010012

FINAL REPORT

on aircraft accident investigation

Aircraft type: **Discus 2bR**

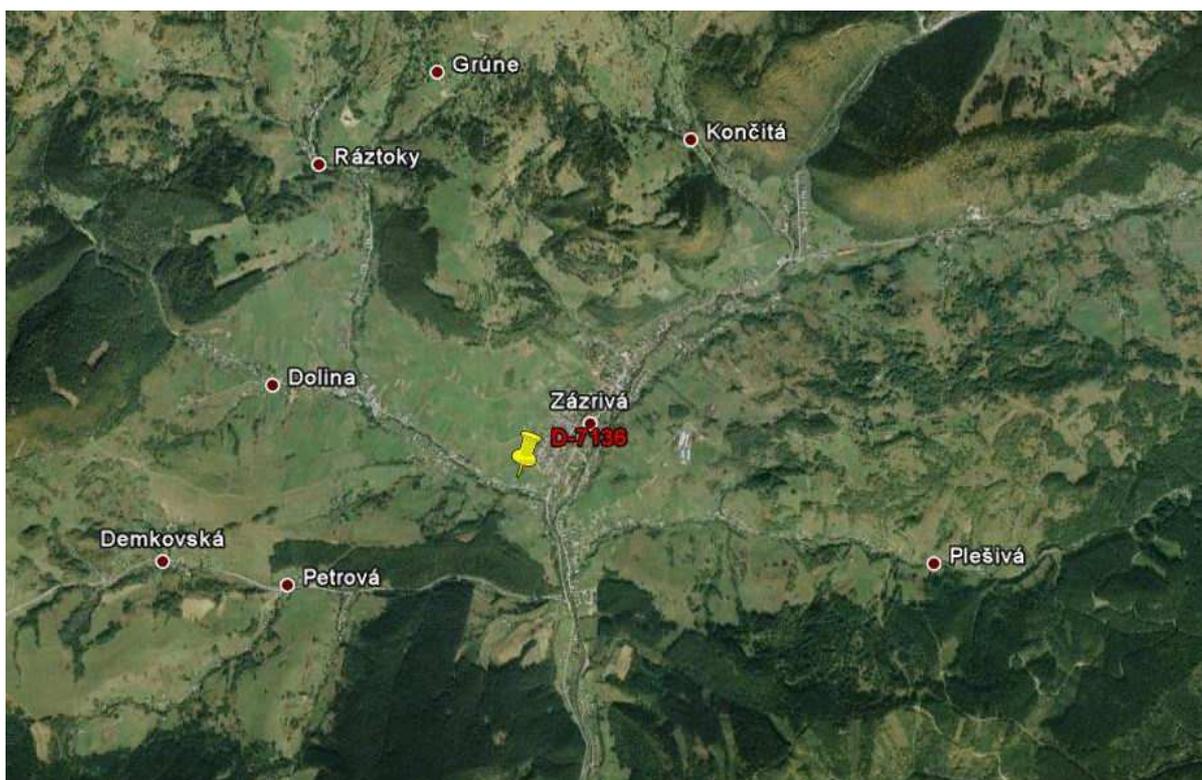
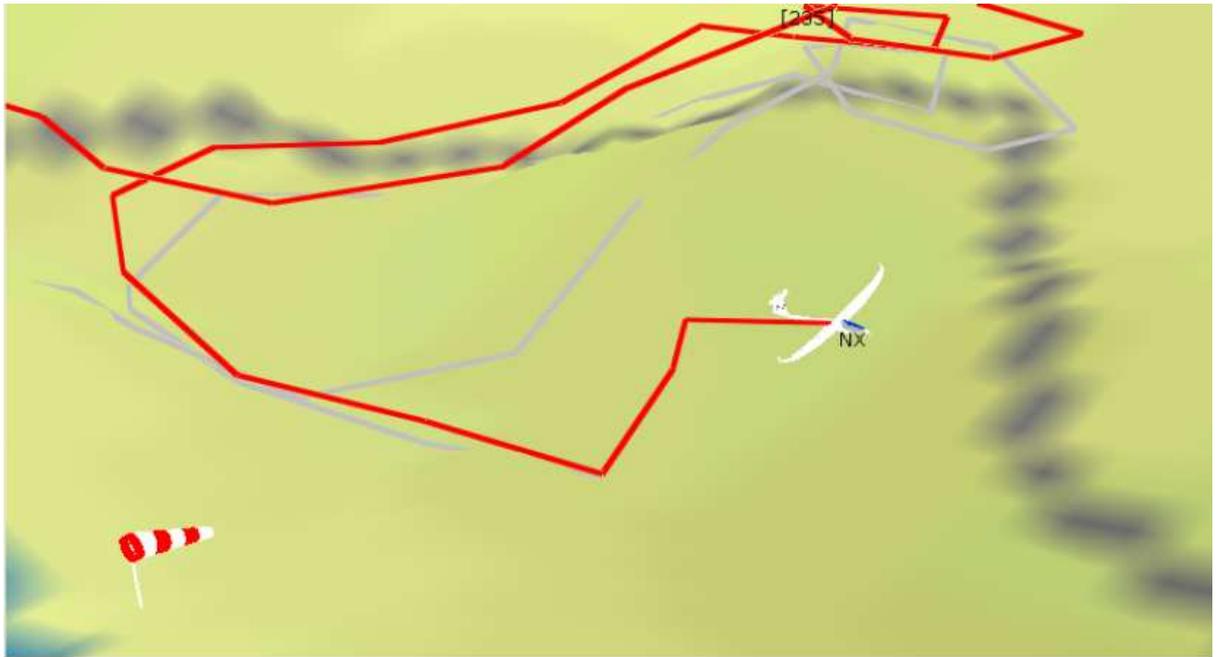
Following the hard landing, the aircraft Discus 2bR "NX" had the parachute of the rescue system shot, the wheel of the main landing gear driven in the aircraft body, the cockpit enclosure deformed, the pilot seat broken, cracks in the aircraft body covering and the CF frame behind the main landing gears several times broken. The rodding of gear attachment and control in the aircraft body was broken on several places, the drive of left-handed aerodynamic brake in the aircraft body was damaged, and delaminations near the emergency parachute shaft (left side) were 10 cm long. Varnish on the lower side and leading edge of the right wing was scratched and skids on both wings were torn off.

After the hard landing the aircraft suffered damage of large extent.

The place of accident is described by geographic coordinates: N 49°16'19''; E 019°08'50''. After the accident the aircraft remained in one piece and was damaged.
