**MINISTRY OF TRANSPORT, POSTS AND
TELECOMMUNICATIONS
OF THE SLOVAK REPUBLIC**

FINAL REPORT

on investigation of accident

of parachutes **Pilot-124** and **Safire 2-139**

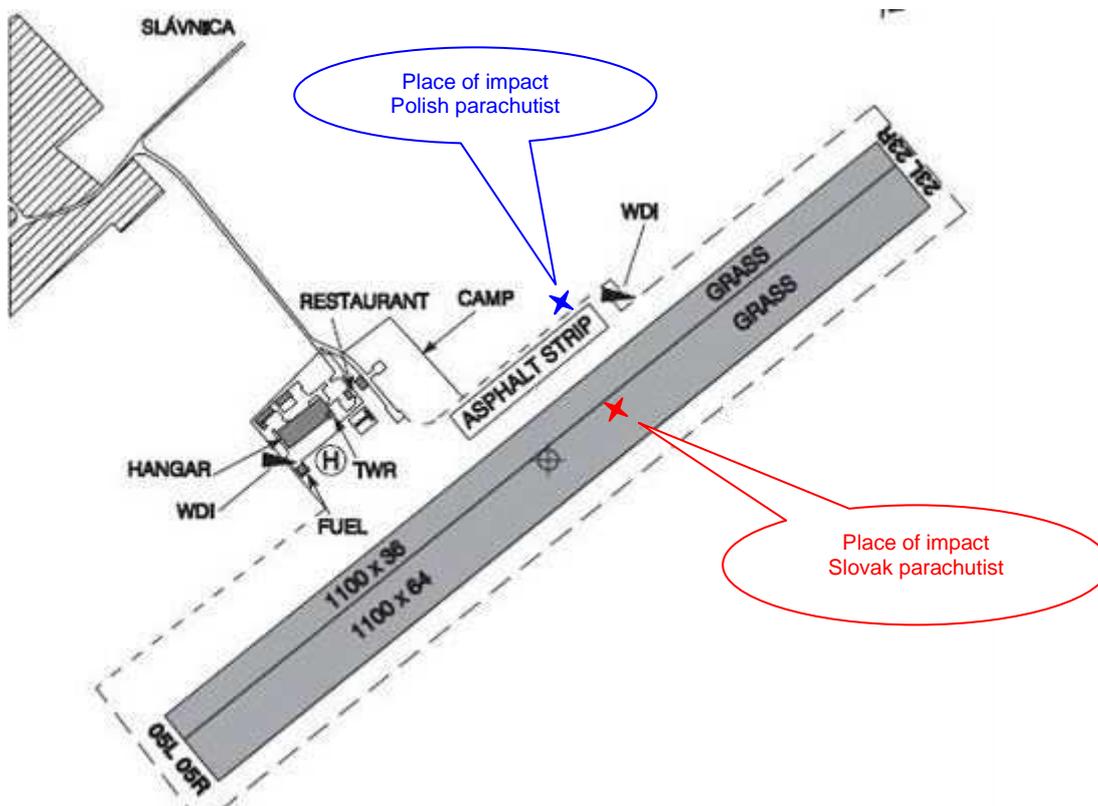
1.12 Wreckage and impact information

Due to the collision the Slovak parachutist's main parachute canopy warped approximately to 2/3 of its total surface area, which caused the decrease of the speed of advance and significant increase of the speed of fall with slight rotation. In this configuration the Slovak parachutist landed hard on the runway. After the collision, the Polish parachutist's main parachute canopy was refilled with air, but three to four twists were made on the parachute ropes which made the parachute uncontrollable. It continued the perpendicular downward flight over RWY 23 to its right edge and landed 10 m from the edge of airport in the corn field.

Parachute Pilot 124 – The inspection of the Slovak parachutist's main parachute canopy detected damage – rupture of two rigging cords on the central channel of „A“ and „B“ series. The damage – rupture of rigging cords was caused by strong dynamic stress generated by collision. No other damage to the main parachute canopy was detected. Based on the video recording, the main parachute canopy was fully functional before the collision and its condition did not influence the accident. The inspection of other parts of parachute equipment and its documentation detected no other matters that could have influenced the accident. The parachute equipment was operated in accordance with valid legislation and properly maintained.

Parachute Safire 2 - 139 - The inspection of the Slovak parachutist's parachute canopy detected damage – rupture of parachute fabric on the margin of the leading edge of two left-handed channels. The damage – rupture was caused by the collision. No other damage to the main parachute canopy was detected. Based on the video recording, the main parachute canopy was fully functional before the collision and its condition did not influence the accident. The inspection of other parts of parachute equipment and its documentation detected no other matters that could have influenced the accident. The parachute equipment was operated in accordance with valid legislation and properly maintained.
