FINAL REPORT

on investigation of an air accident

of aircraft type **B1-PW-5**

registration No. **SP-3662**

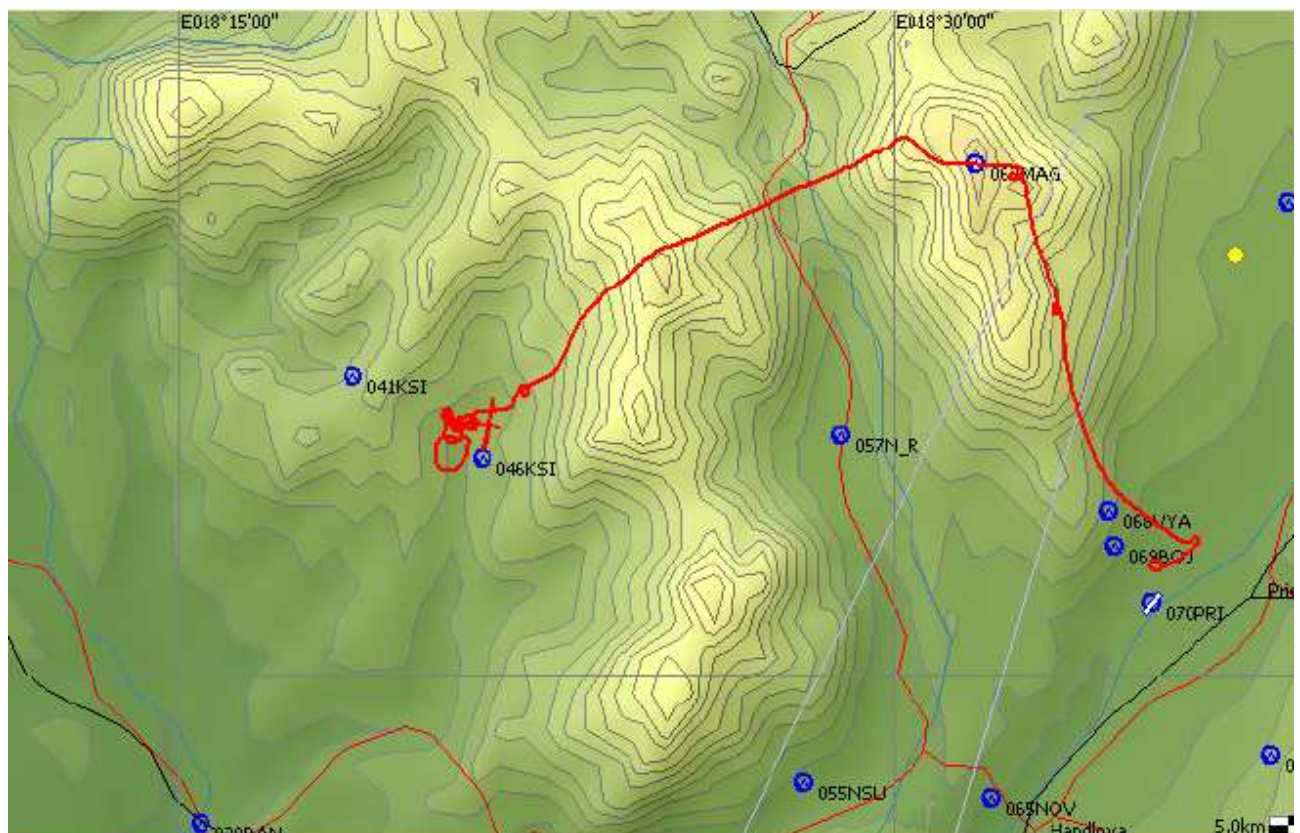
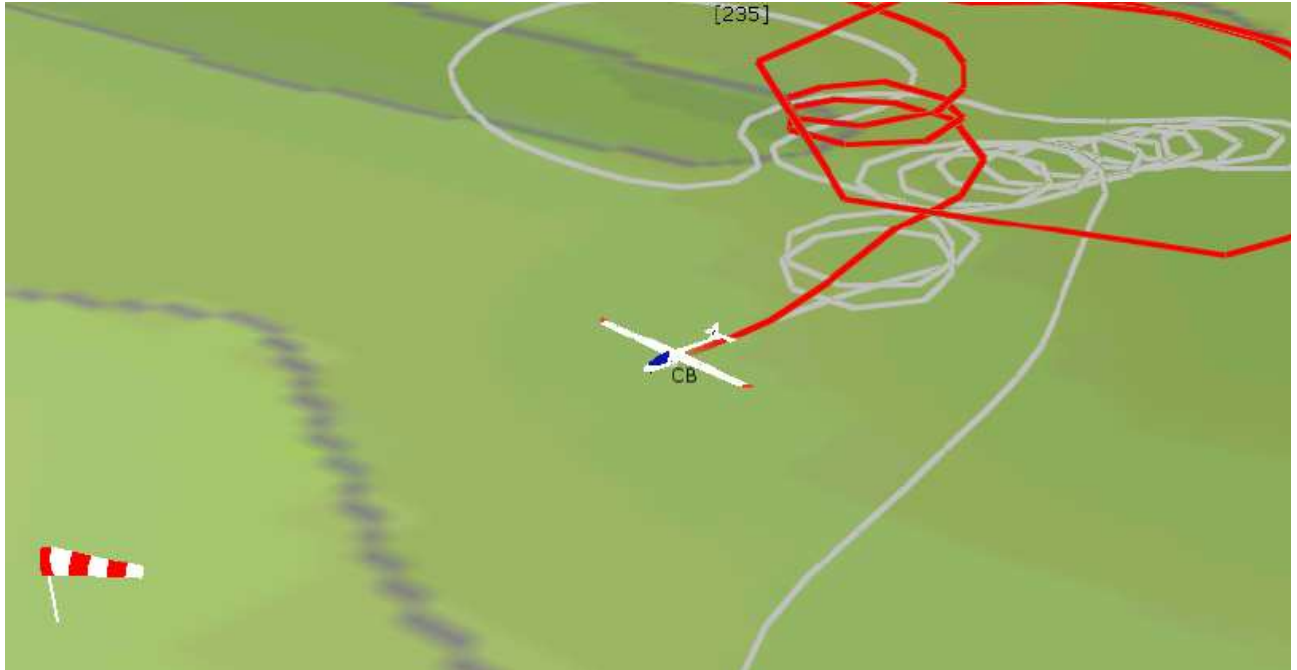
The aircraft B1-PW-5 "WI" got off the air accident with medium-size damage, broken tube of the body approximately 1 m behind the midsection on $\frac{3}{4}$ of the perimeter, bonded seam of underbody coming apart in a length of 80 cm and scratched varnish on the left wing from the leading edge to the trailing edge under the angle of 45°.

The accident area was a mown pasture with a moderate longitudinal uphill gradient, starting with a line of fruiters.
