**MINISTRY OF TRANSPORT,
CONSTRUCTION AND REGIONAL DEVELOPMENT
OF THE SLOVAK REPUBLIC**

FINAL REPORT

on investigation of an air accident

Registration No. **OM-EGA**

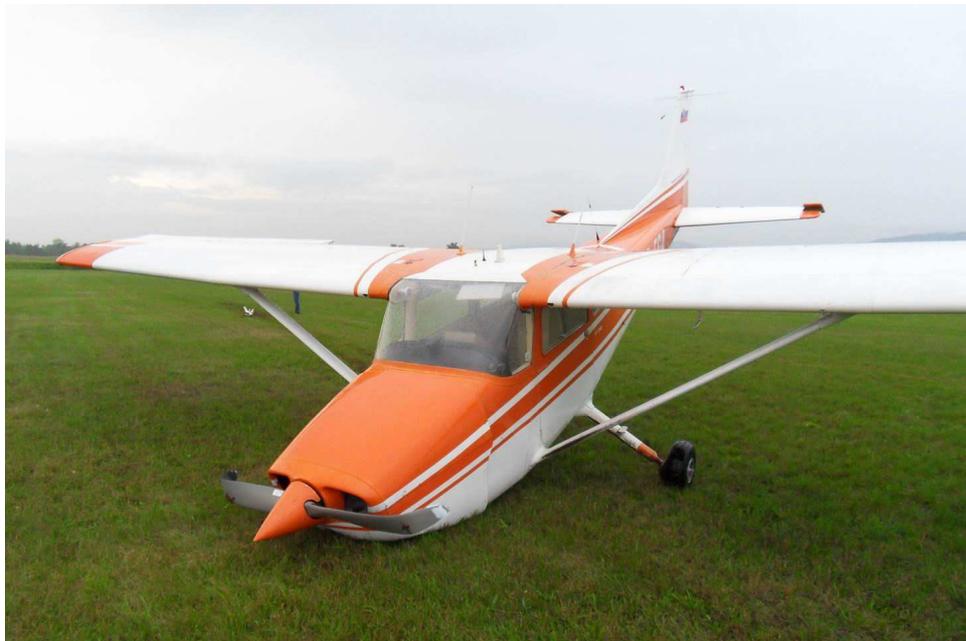
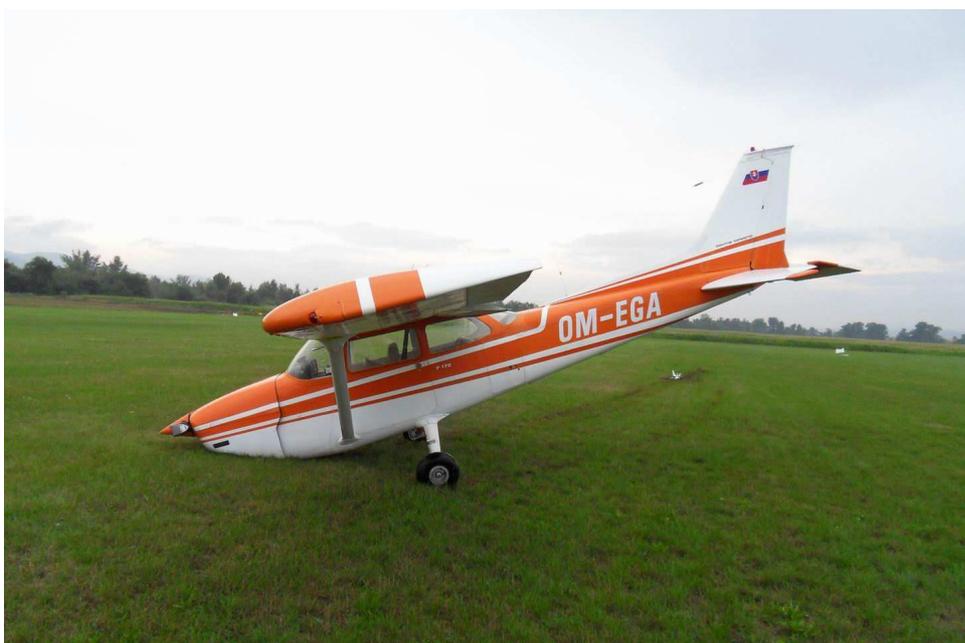
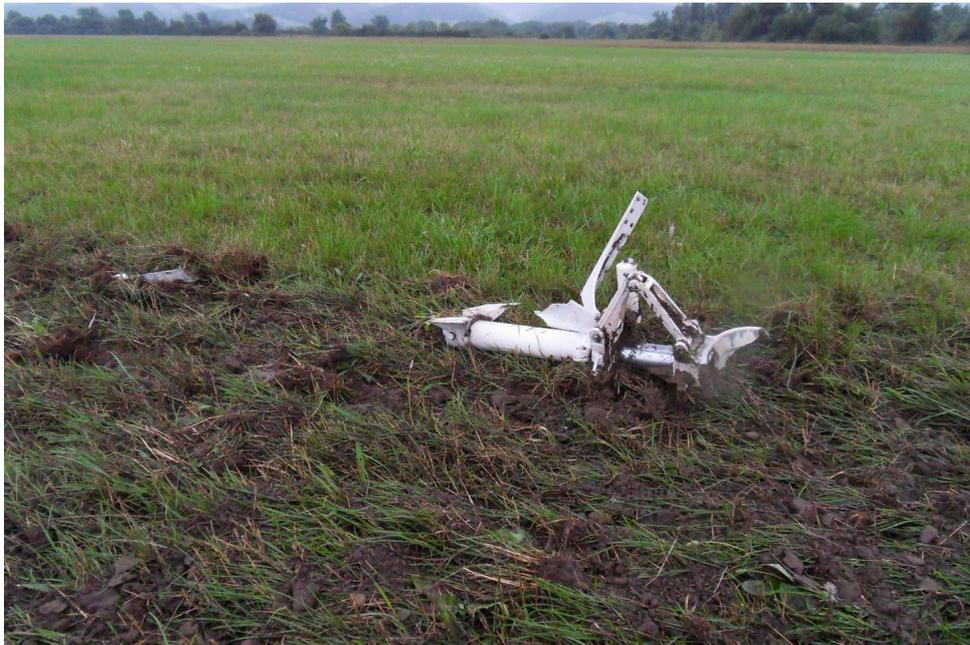
Following the hard landing on the runway ("RWY") 05L the front landing gear leg got broken.

During the return from the training navigation flight the pilot reported the end point of the track "Nová Dubnica". He received instructions for landing on RWY 13 in use. Then he was offered the direct approach to RWY 05, with regard to the wind and airport traffic. The final approach phase was at very low speed, with aircraft substantially "stretched" above the horizon. In this configuration the aircraft flew over the threshold of RWY 05 and when the pilot reduced throttles to idle, the aircraft landed very hard (fell) from the height of 2 m on the main landing gear. Subsequently the aircraft bounced and landed on the front landing-gear leg which got broken.

1.3 Damage to aircraft

The detailed damage caused to the aircraft was not ascertained by the investigation board.
