**Reg. No: SKA2010018**

**FINAL REPORT**

of aircraft **FOX 912 3K**

registration No: **OM-DARO**

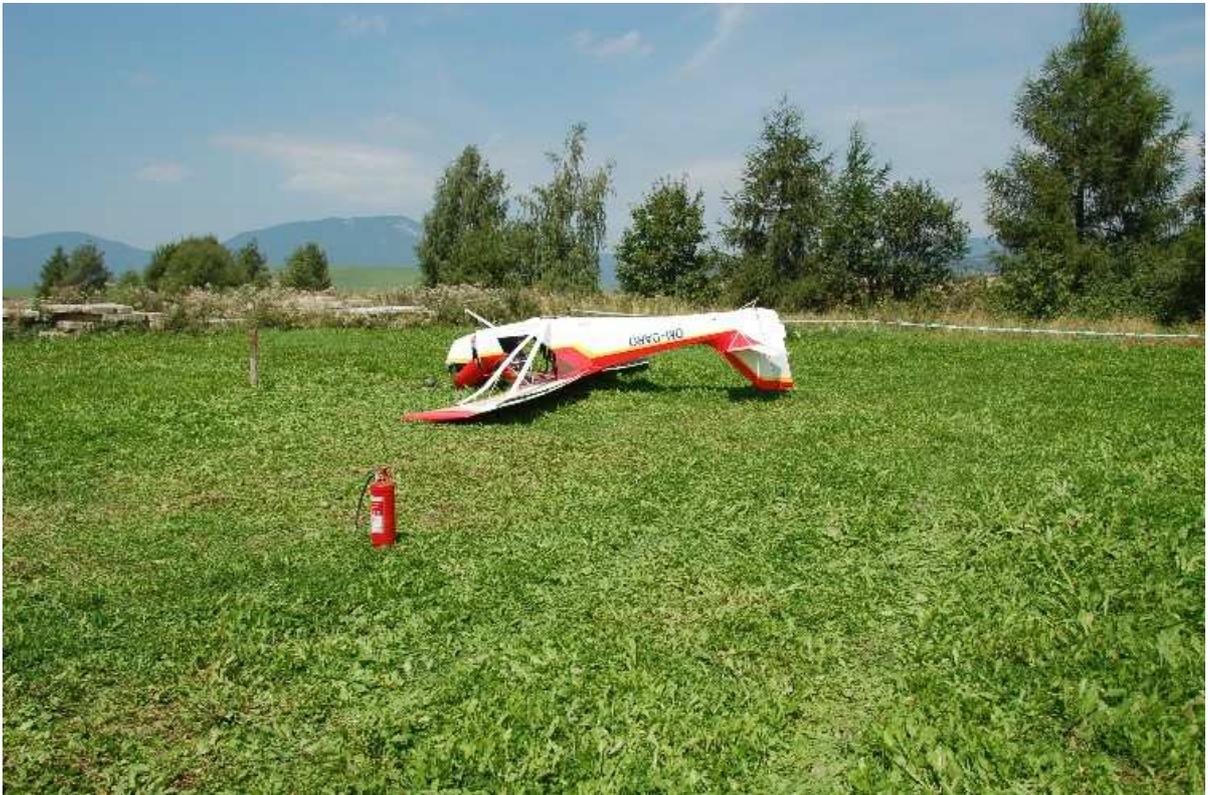
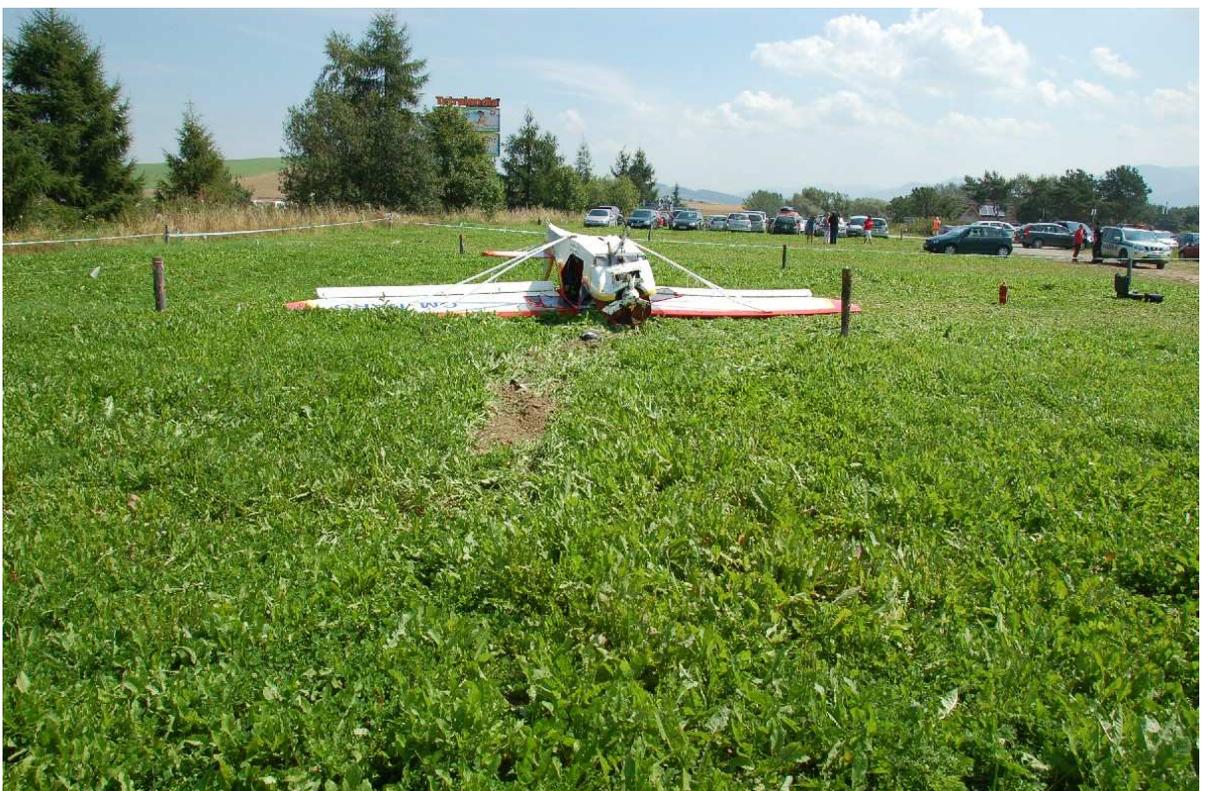
After the turn-over the aircraft remained in one piece and was not separated into the individual parts. The barrier impact caused deformation of the body of midsection and one wing bracing strut, destruction of the main and front landing gear, distortion of engine attachment, destruction of the cockpit hood and damage to the engine and the front part of the aircraft body.

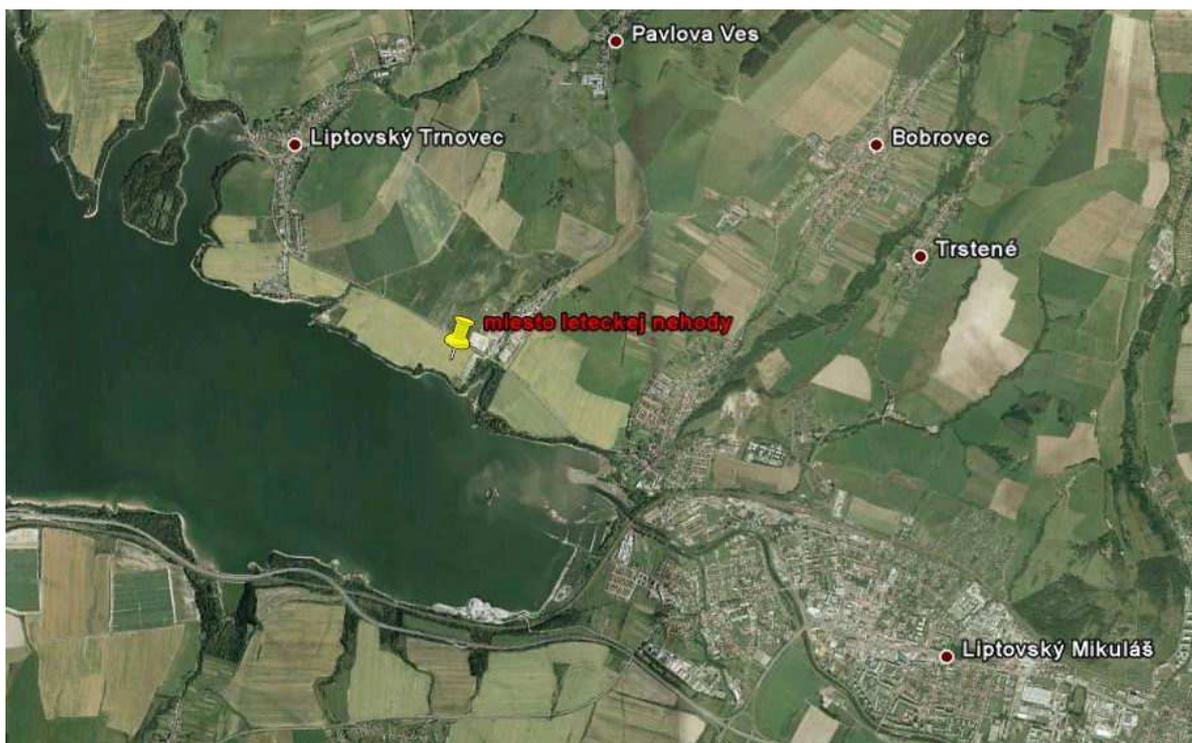
The place of air accident is situated on a meadow opposite the Tatrallandia Aquapark in the proximity of a grass parking area, in the cadastral area of Liptovský Trnovec.
