**Reg. No: SKA2010019**

**FINAL REPORT**

on investigation of an air accident  
of aircraft type **CESSNA 172 S**  
registration No. **OM-AKT**

Date: 12.08.2010

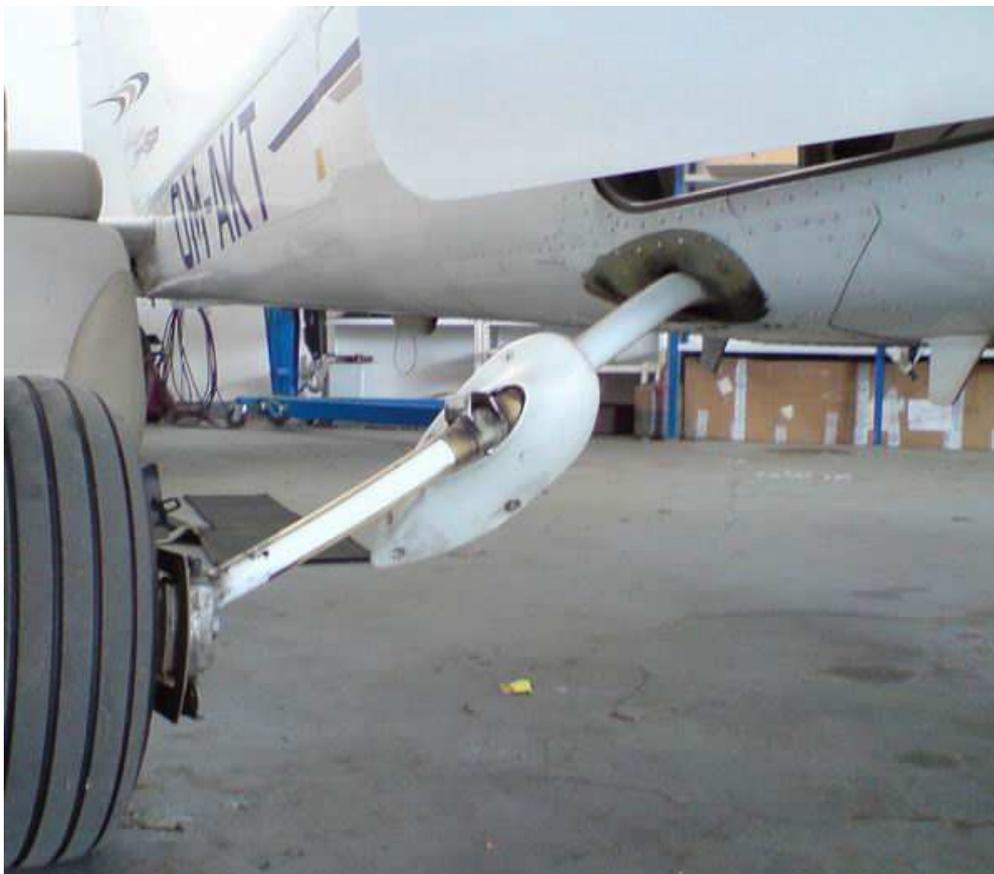
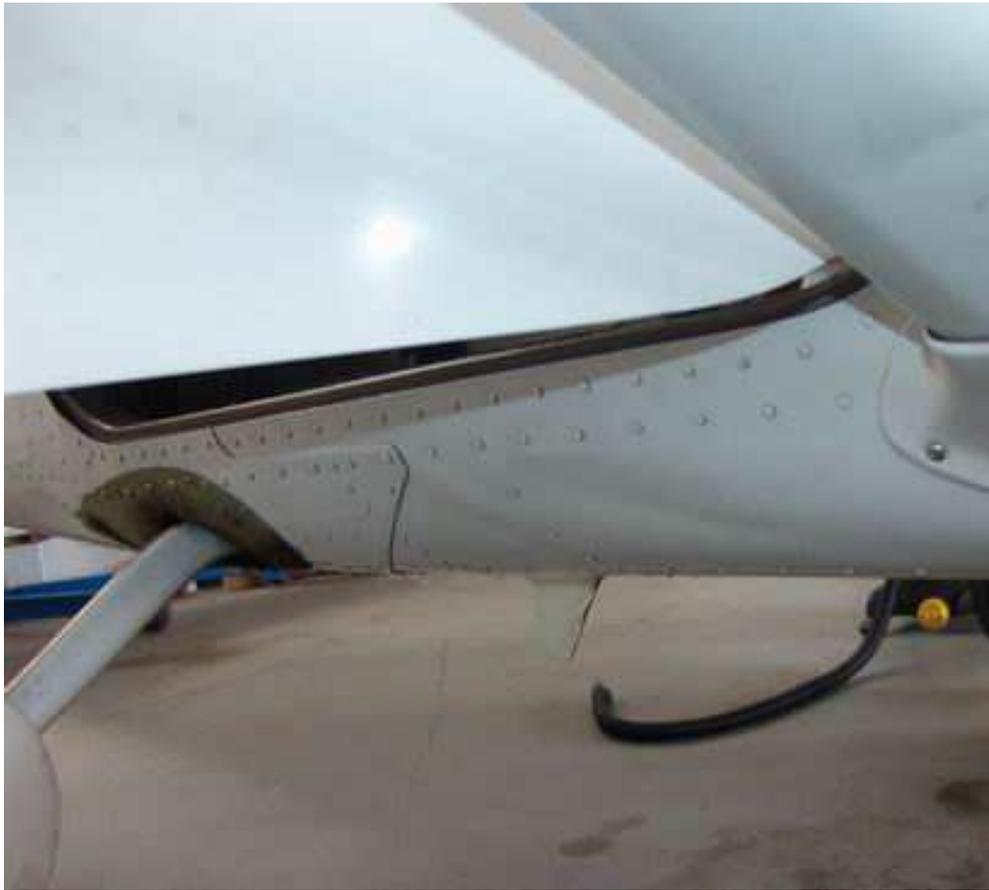
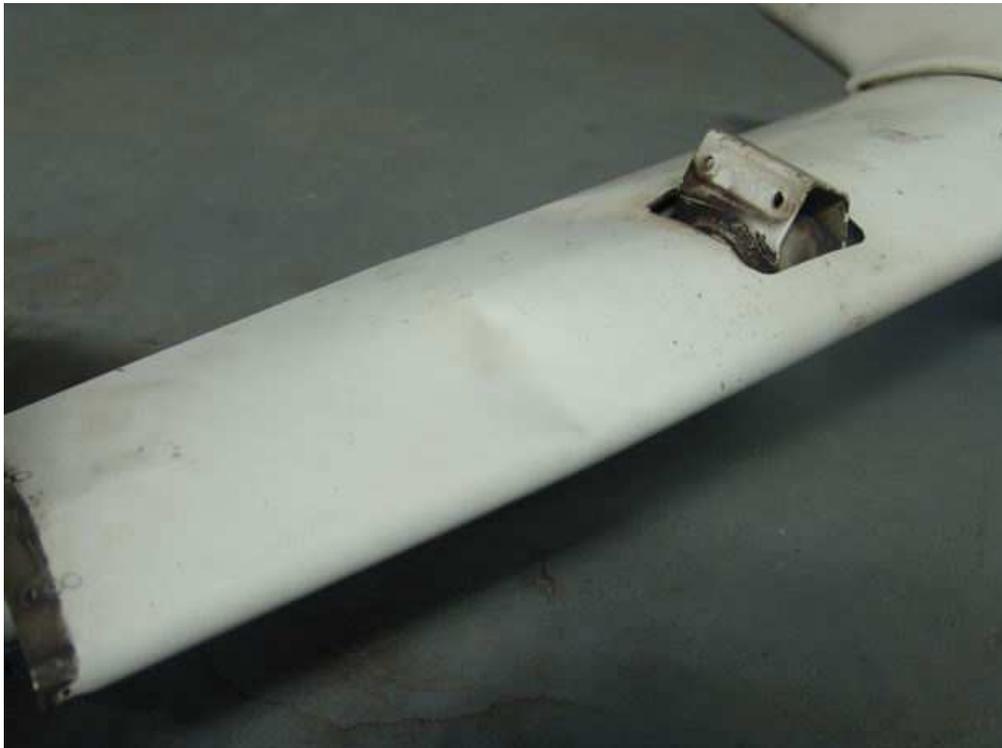
The aircraft hard landed from the height of approximately 2-3 m on the right wheel of the main landing gear, and then it landed simultaneously on the left wheel of the main landing gear and the nose landing gear.

- Corrugated skin between the front door frame (wing strut) of the right pilot and attachment of the right MLG
- Deflected tube of right-hand landing gear and deformed covering in the area of the right-hand landing gear riser
- Broken (plastic) aerodynamic cover of vertical rudder
- Deflected end (approx. 2 cm) of the right horizontal rudder
- Depressed covering of body
- Broken bracing of the right-hand elevator.

- poor mastering of flying technique by the crew
- overflaring and wing stalling of the aircraft, followed by hard landing.
