FINAL REPORT

on investigation of an air accident

of aircraft type **Z-726**

registration No. **OM-RMS**

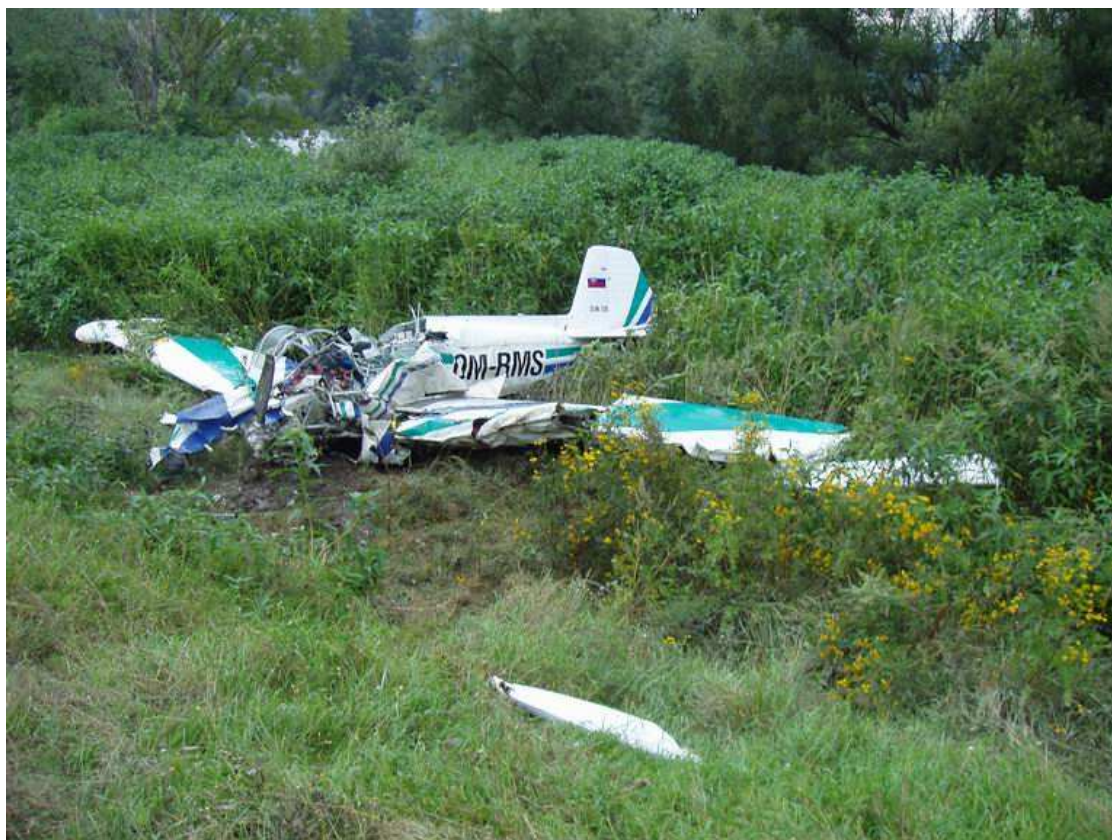
1.3 Damage to aircraft

The aircraft was destroyed in the accident.

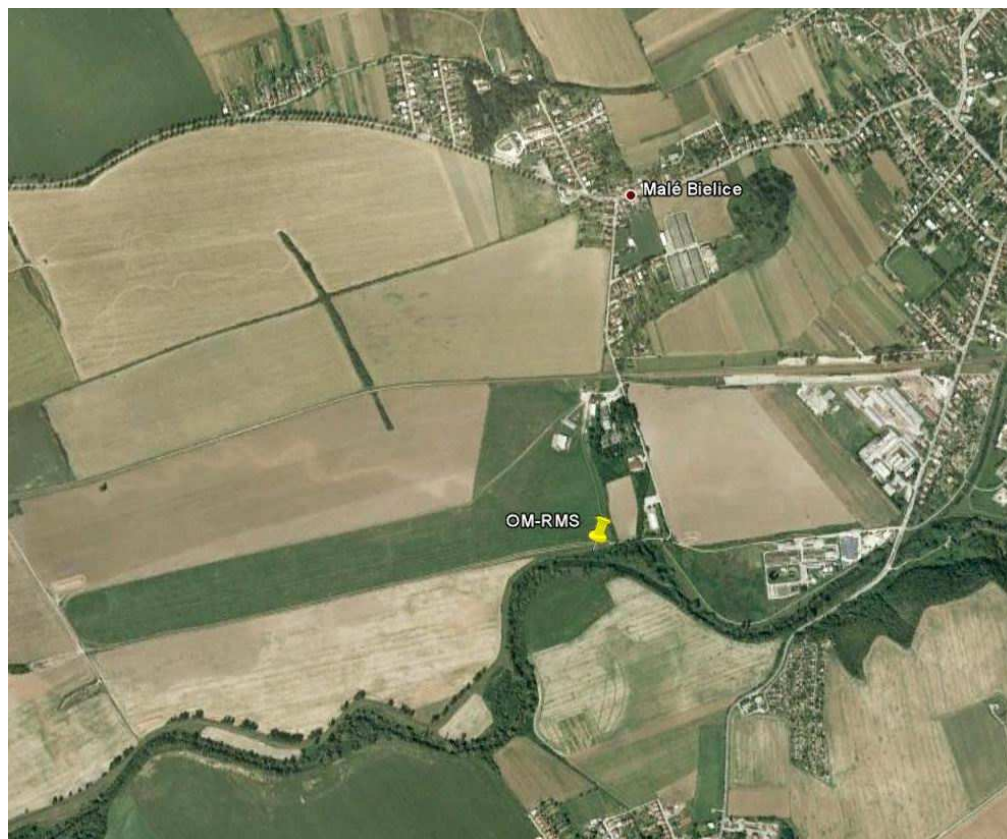
The aircraft fell to the ground near the aircraft LZPT under an angle of 70°, in the close proximity of the dam of the river Nitra. The final position of the aircraft after the air accident was documented, including performance of photodocumentation. The bodies of the pilot and the passenger were found in the area of wreckage.
