**MINISTRY OF TRANSPORT, CONSTRUCTION
AND REGIONAL DEVELOPMENT
OF THE SLOVAK REPUBLIC**

FINAL REPORT

on investigation of an air accident
of powered paraglider **ANTEA L / RODEO 125**
Registration No – **not assigned**

Date: 15.10.2010

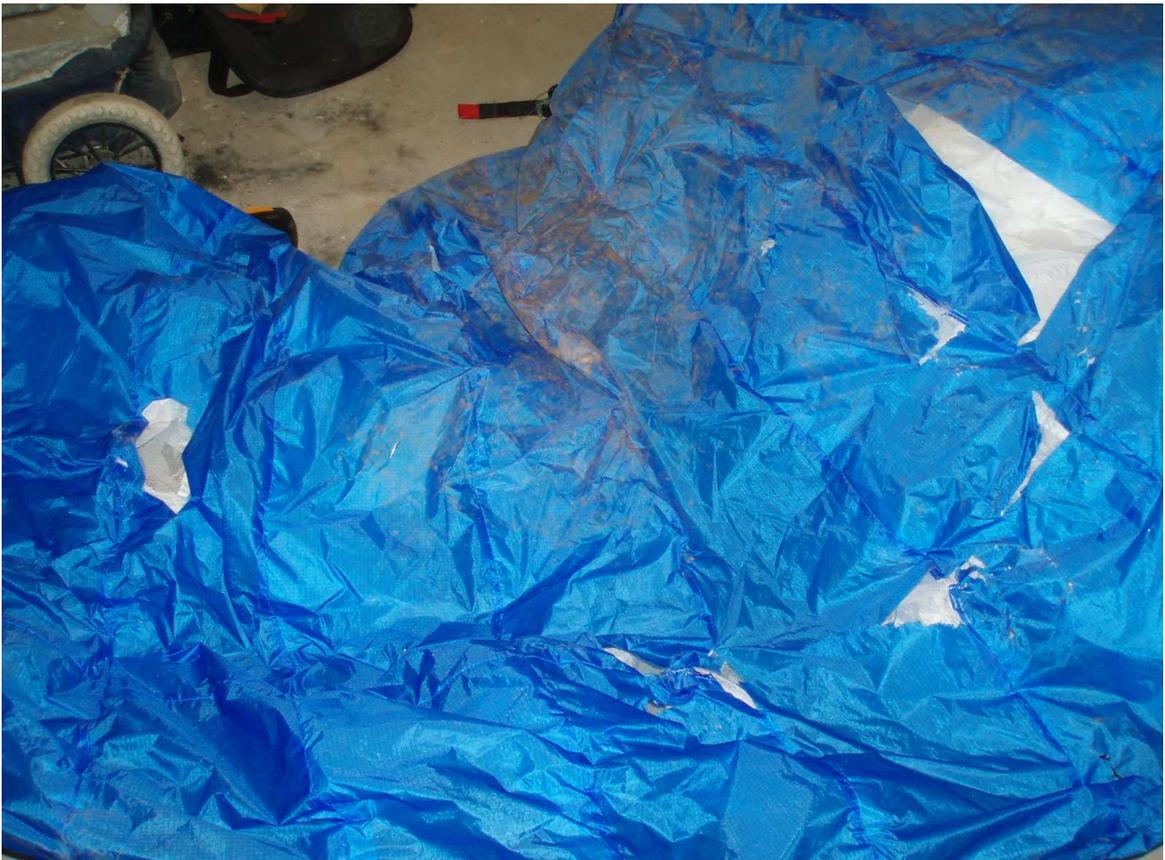
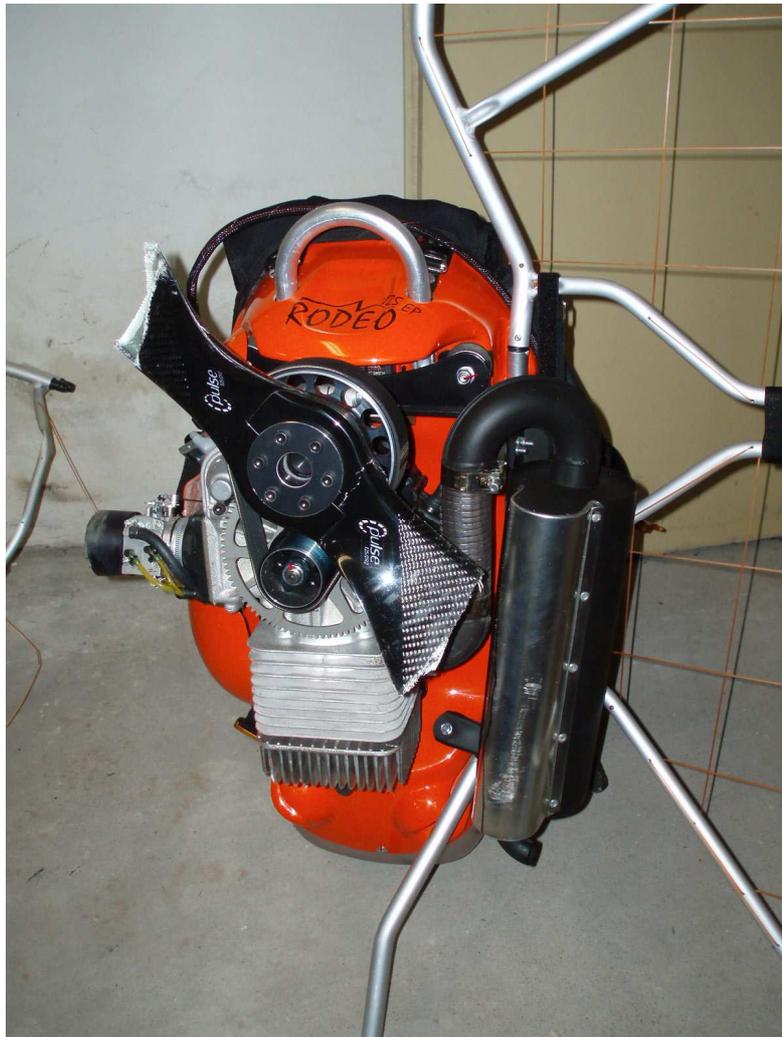
Significant damage to the PP canopy, where its repair seems to be ineffective, damage to the power unit caused by total propeller damage and minor damage to the propeller protection frame and the engine bonnet.

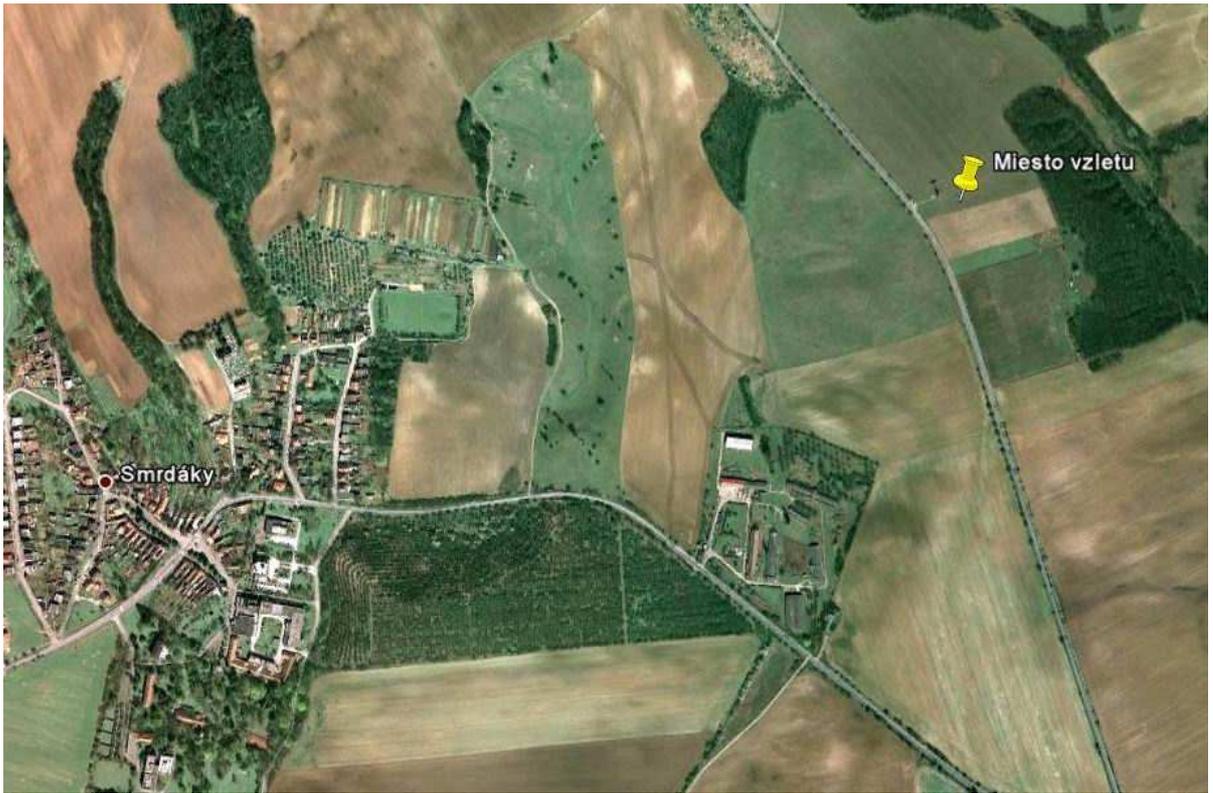
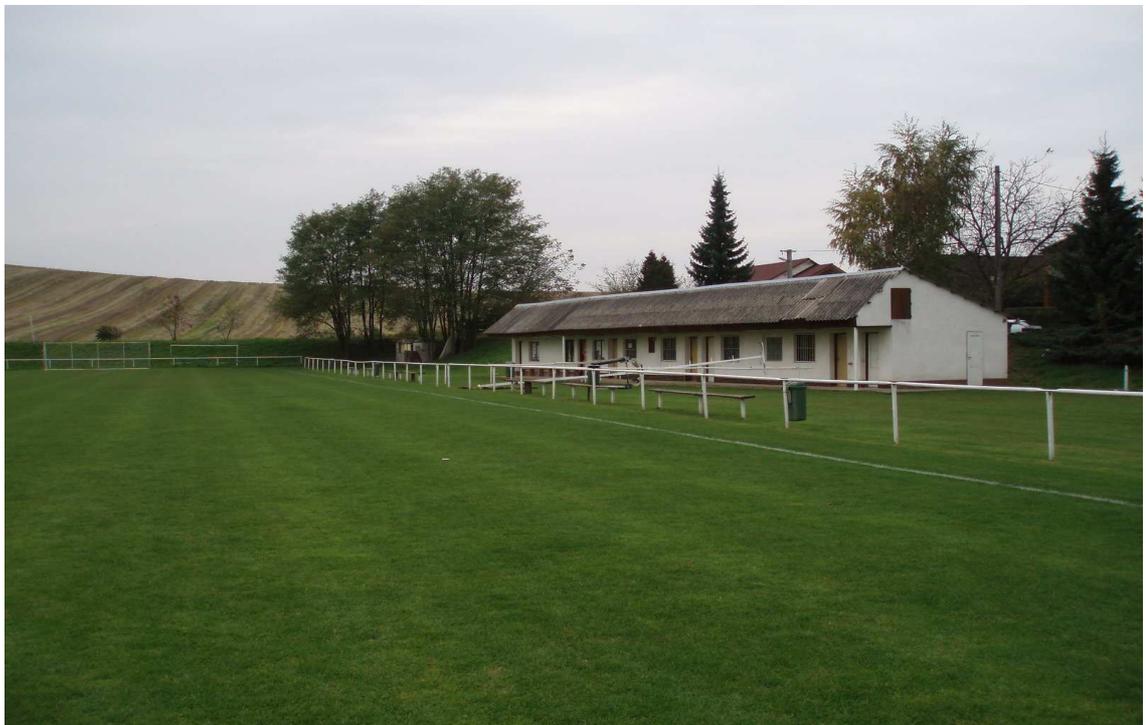
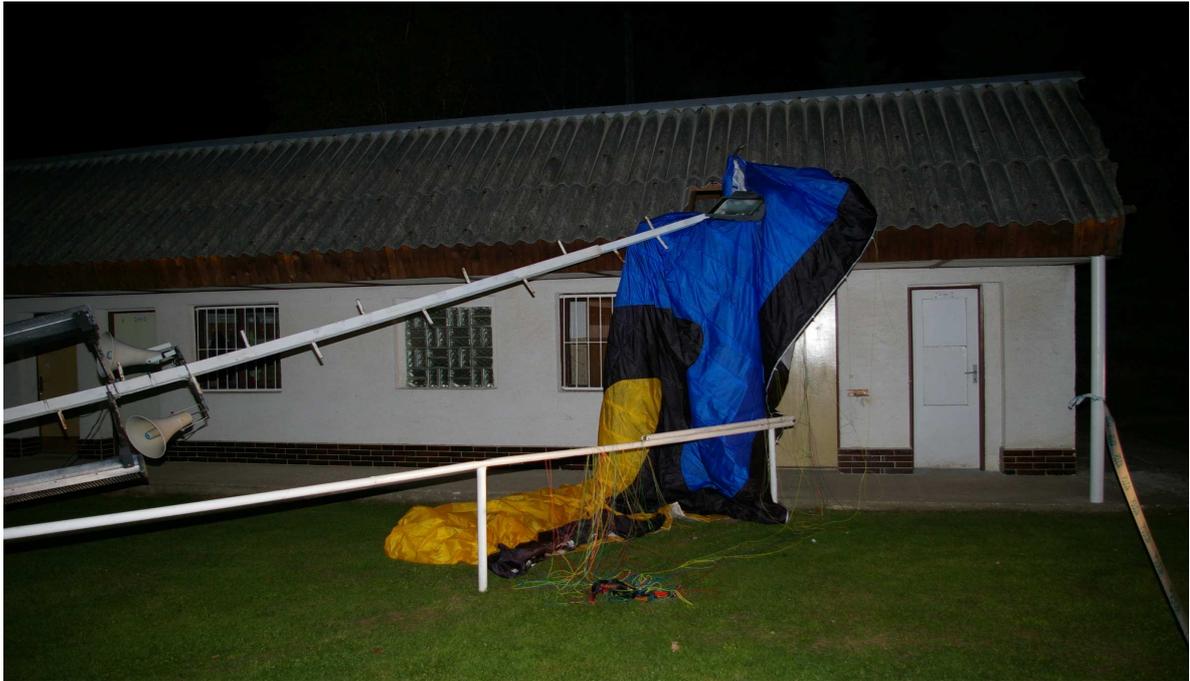
When approaching the low change-room building with tall trees behind it, he started a right-handed turn to avoid the trees and the building. In this flight phase the right side of the canopy and its ropes got caught on a football ground light pole. The canopy and the ropes got stuck so firmly that the PP flight was interrupted. Under the influence of the inertial and centrifugal force the pilot made another turn of 180° with the centre of PP rotation around the top of the light pole. The light pole started to bend to the course of 45° under strain from inertial and centrifugal forces and was stopped by the roof of the change-room building. The pole beam became permanently deformed in its root end.

The ground impact occurred in the following sequence – the pilot, and in particular the left side of his body, impacted the ground first (which is proved by his injuries) and absorbed a significant amount of the remaining energy of the PP system, followed by the power unit, where the deformation of the left side of the propeller protection frame started upon the contact with the ground (it is proved by complete fragments of the propeller found in the close proximity of the impact point); at that moment the propeller got caught on the deformed propeller protection frame and propeller blades were destroyed. The propeller boss remained in the engine gearbox body.

The place of accident is situated on the west fringe of the municipality of Rybky, in a football ground in the proximity of the change-room building. The point of impact is created by a flat grass surface outside of the playing field of the football ground. The light pole of the football ground became deformed near the pole root in the right direction at the sight from the north-west and its upper part got caught on the change-room building roof. The paraglide canopy remained wrapped around the upper part of the light pole. The power unit remained on the flat grass surface, with a slightly damaged left side of the propeller protection frame, slightly damaged engine bonnet on the left side and with total propeller damage. The propeller root including screws remained in the engine drive gearbox. Fragments of the propeller blades were found in the perimeter of 4 m from the point of impact. The fuel installation was tight and undamaged. No fuel leakage was detected.
