**No.: SKA2010025**

**FINAL REPORT**

of aircraft type **PA 34 – 220T**

registration No. **D-GACR**

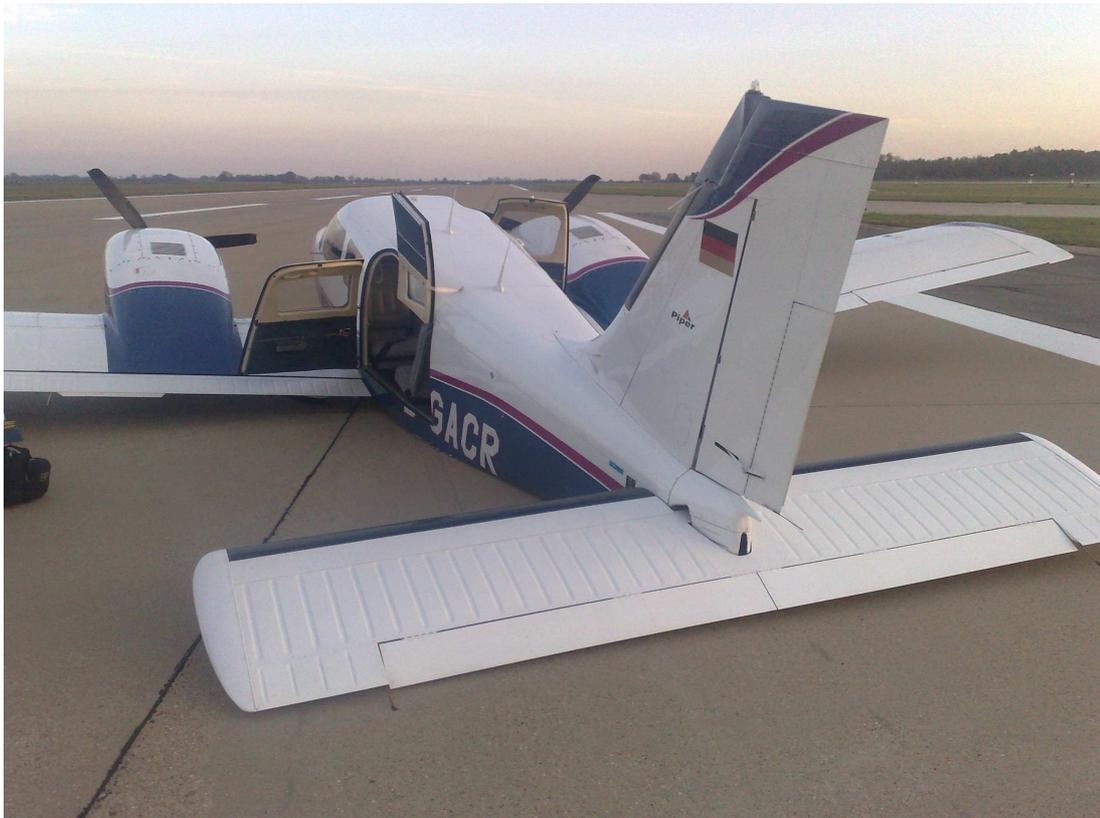
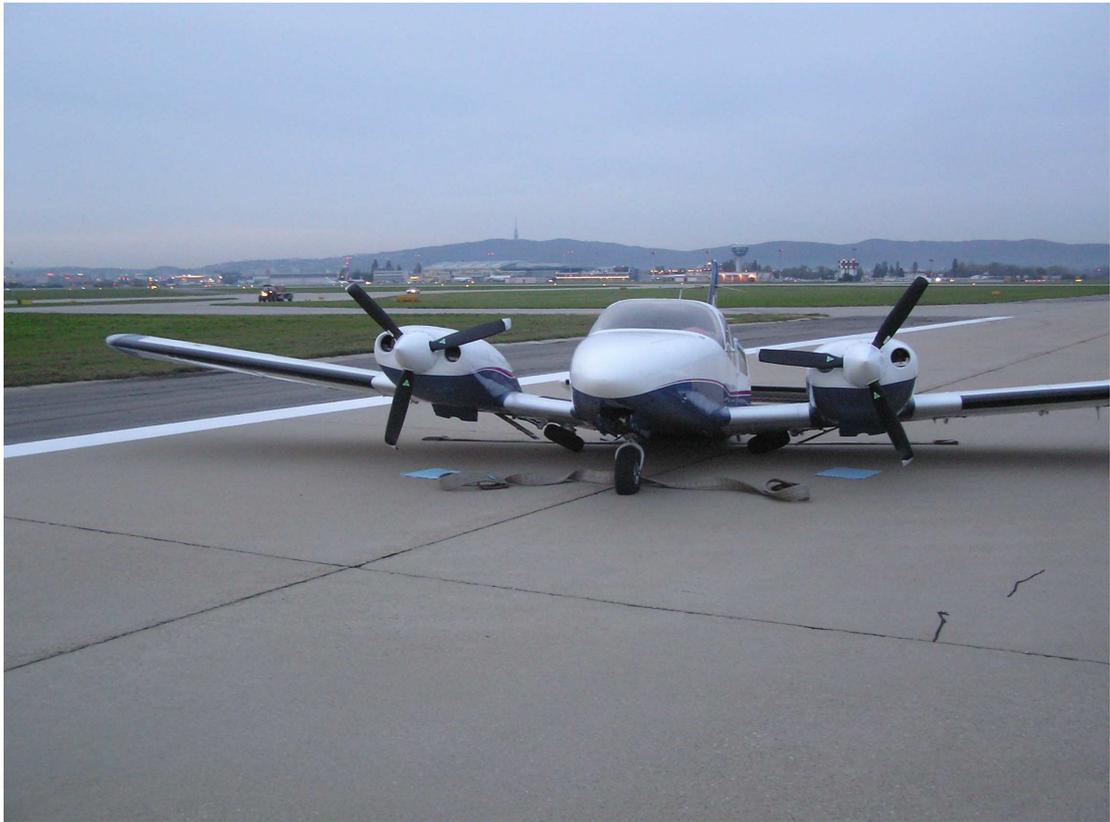
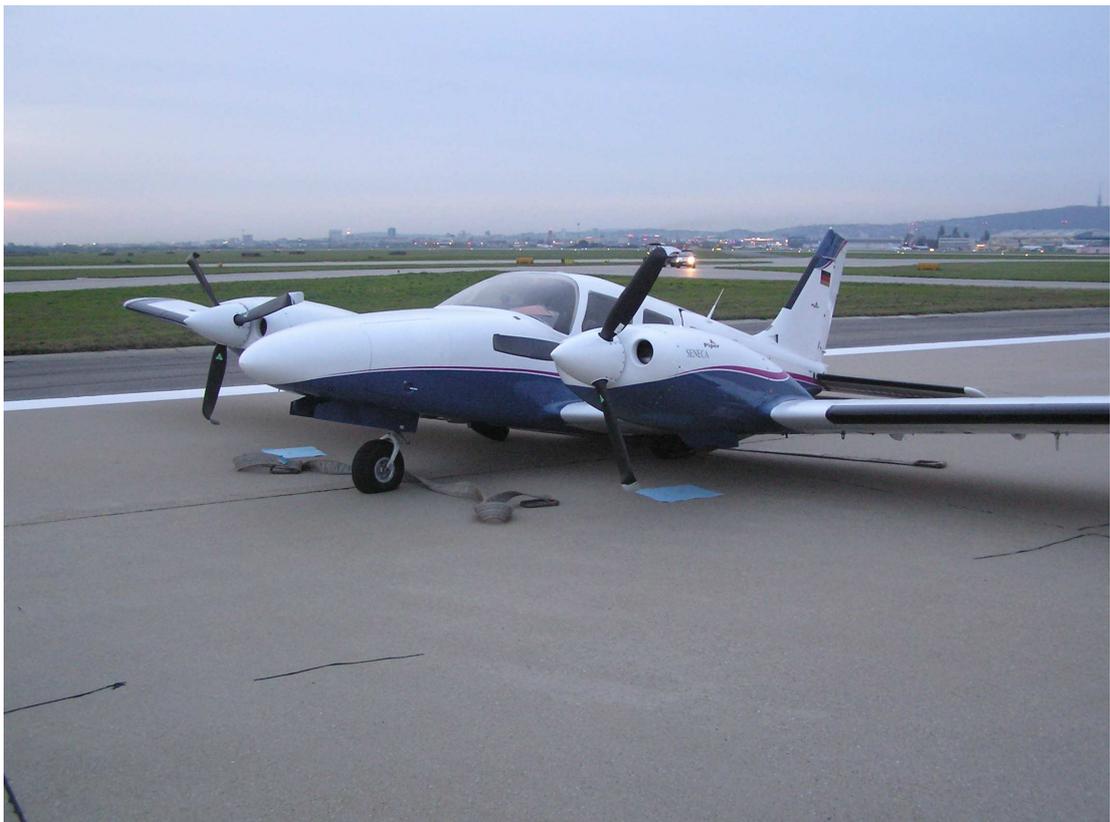
The aircraft suffered extensive damage – damage to the carrier and bottom part of aircraft body, forced engine shutdown, bent ends of both propeller blades.

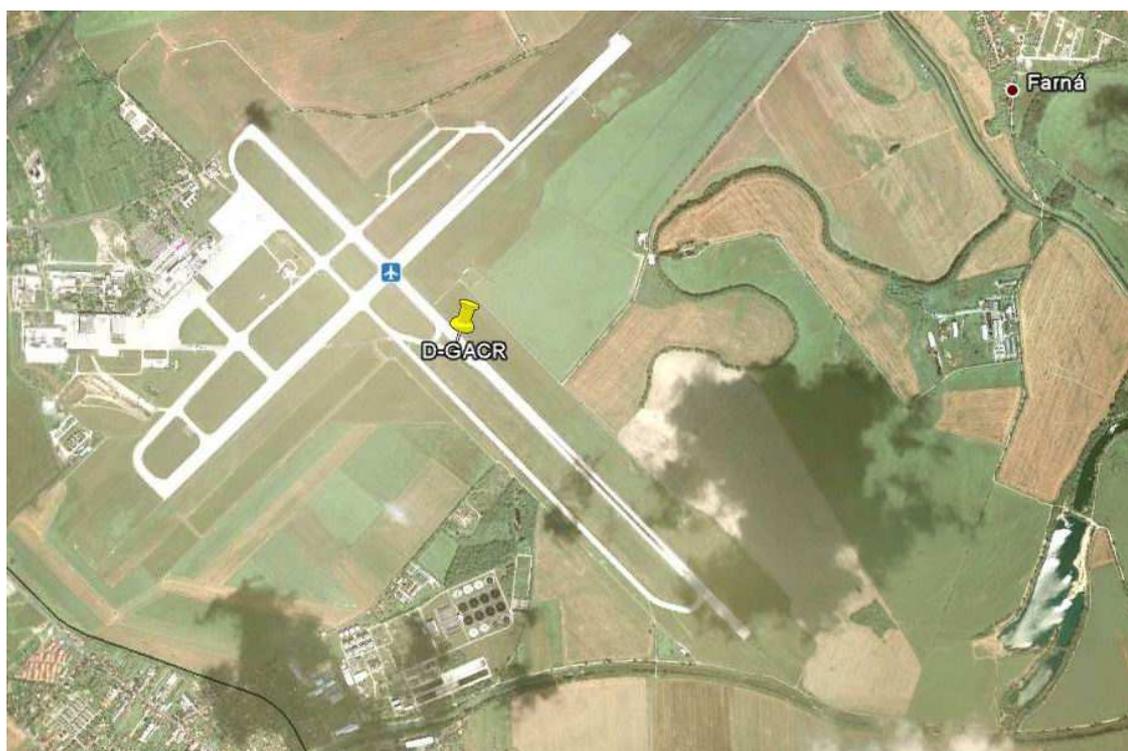
The damaged aircraft remained standing right from the centre line of RWY 13 with semi-retracted landing gear.

The final position of the aircraft after the air accident was documented, including preparation of photo documentation.
