**Reg. No.: SKA2010026**

**FINAL REPORT**

on investigation of an air accident  
of aircraft type **Viper SD-4**  
Registration No. **OM-M252**

Date: 29.10.2010

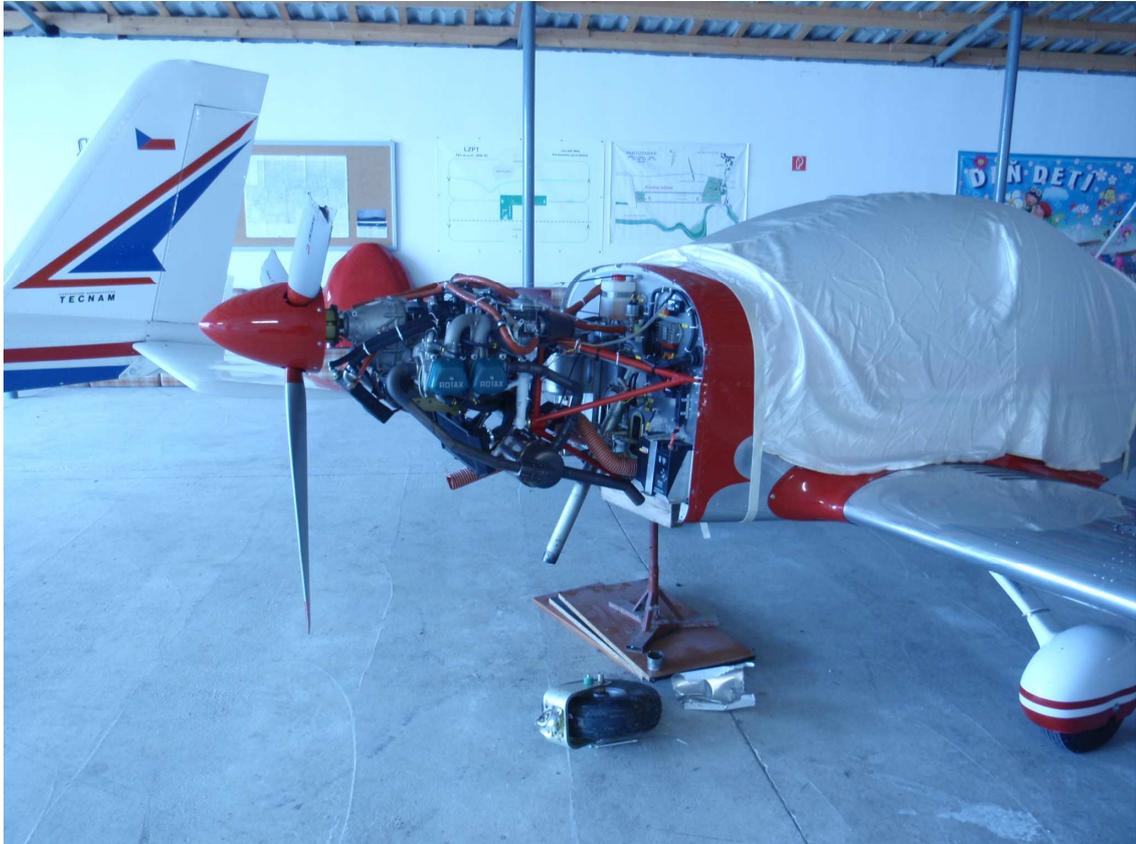
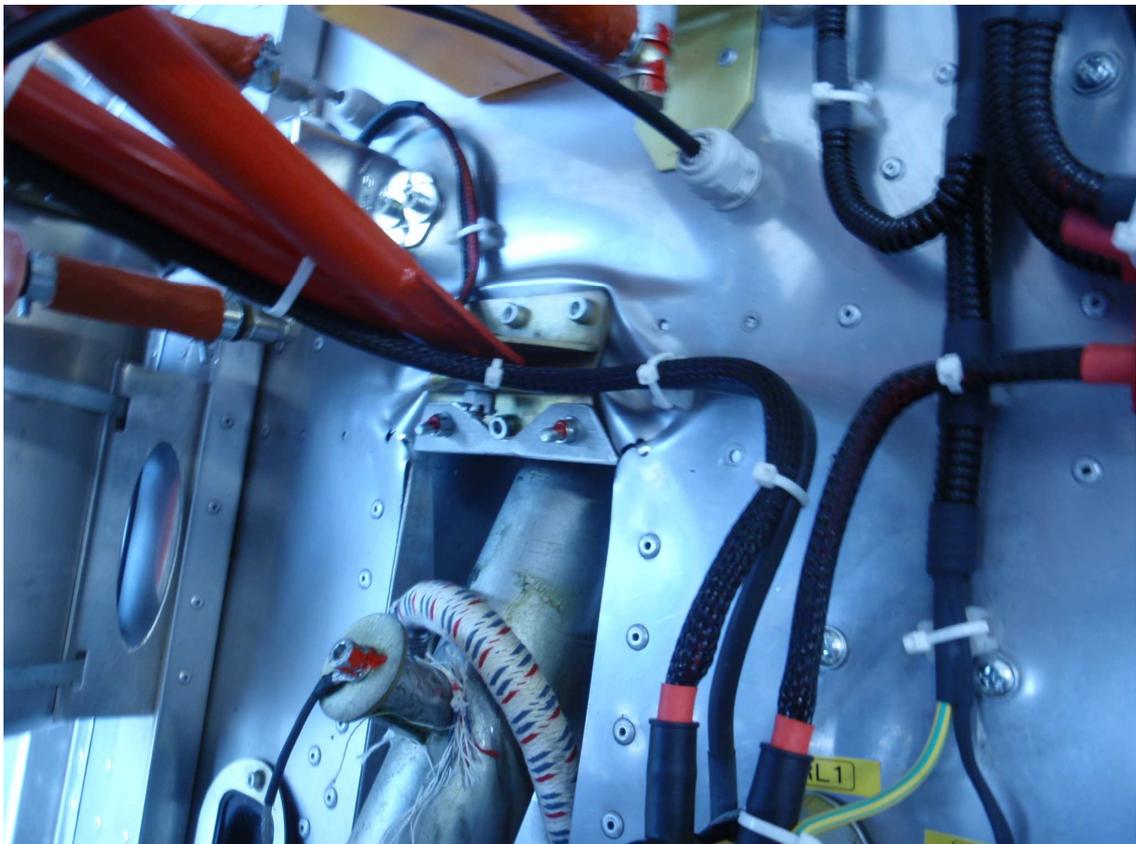
Three-blade propeller – destroyed, fireproof bulkhead – damaged to a large extent, front landing-gear leg – destroyed, spring and damper unit of the front landing gear – destroyed, front wheel cover – destroyed. Inspection of the engine for damage due to the contact of the propeller with the ground.

The pilot did not master the flying technique following the aircraft bounce or try to correct the error when the aircraft floated to the height and kept the joystick pulled back. When the aircraft lost the flight speed, it tilted over to its nose and landed hard on the front landing-gear leg.
